Our Ref: KP/FLM/14989

7th September 2018

STRUCTURAL INSPECTION OF LOCHSIDE LEISURE CENTRE, FORFAR

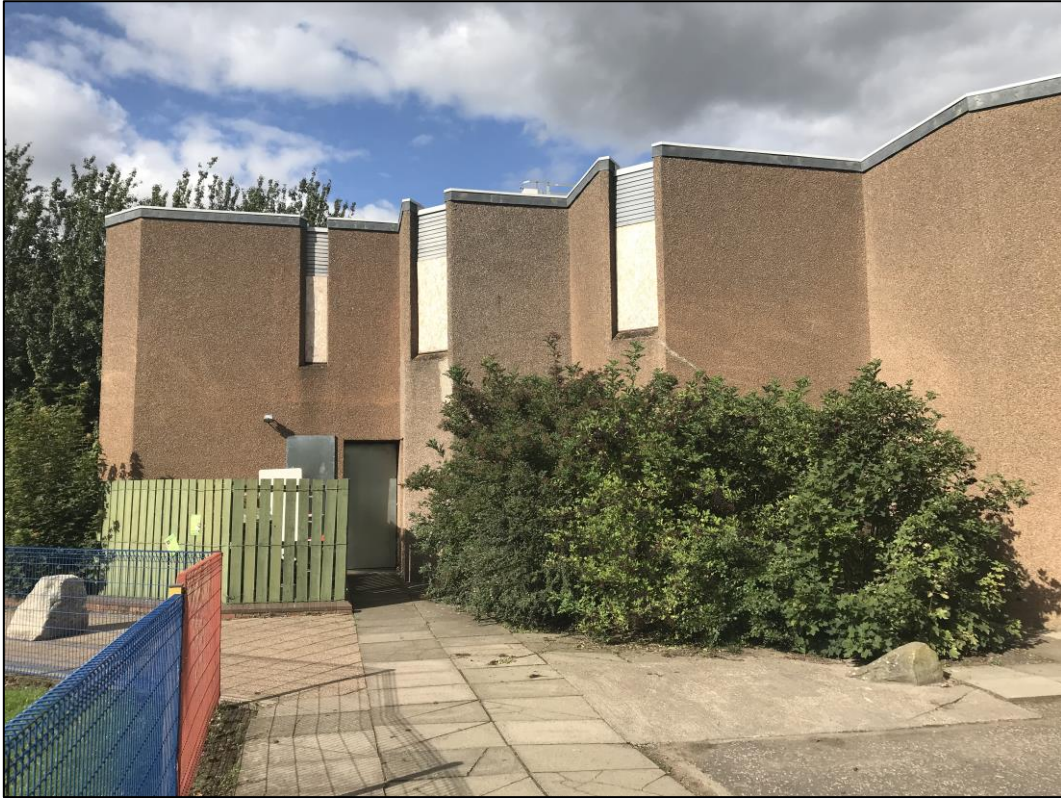
Cracking was noted on the external façade at the south west corner of the building, with two diagonal cracks propagating away from the sill of the first-floor fitness suite windows, refer to Figures 3 and 4. There was evidence that this cracking had been subject to remedial repairs. No movement joints were noted in this section of the building; therefore, the cracking could be attributed to thermal shrinkage of the masonry wall panels. Generally, no evidence of cracking or evidence of ongoing structural movement was noted elsewhere on the external walls.

Figure 3 – South West Corner of Lochside Leisure Centre

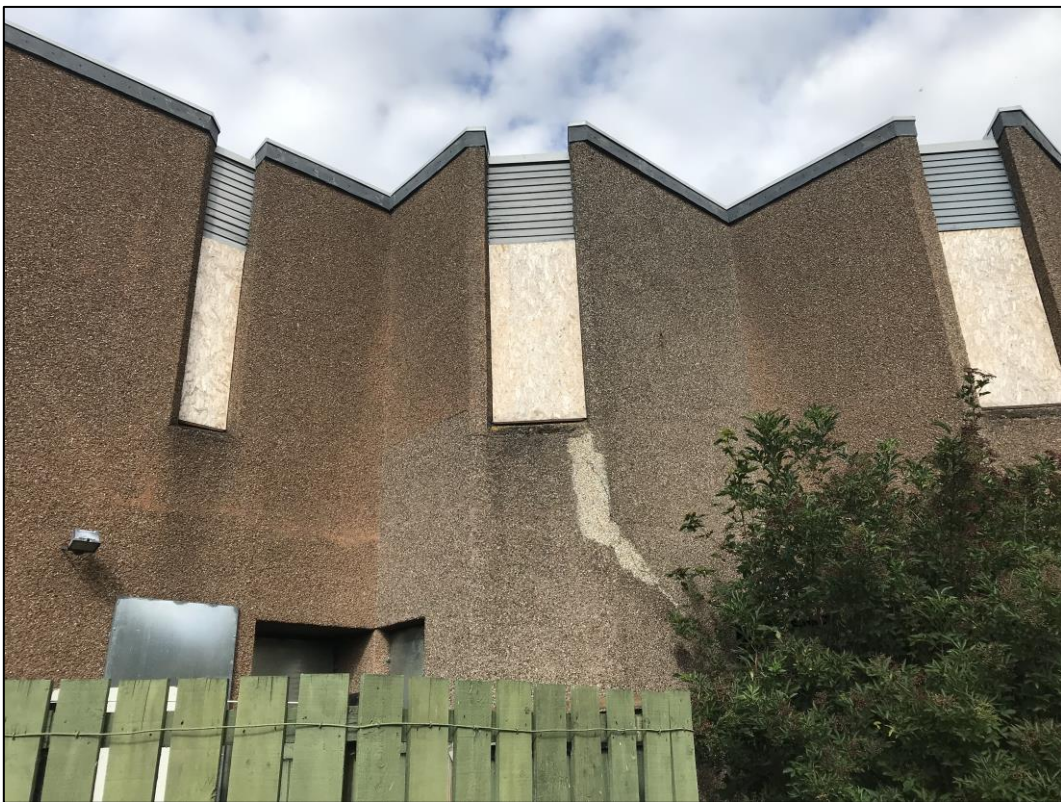
Figure 4 – Diagonal Cracking from Sill on South West Elevation

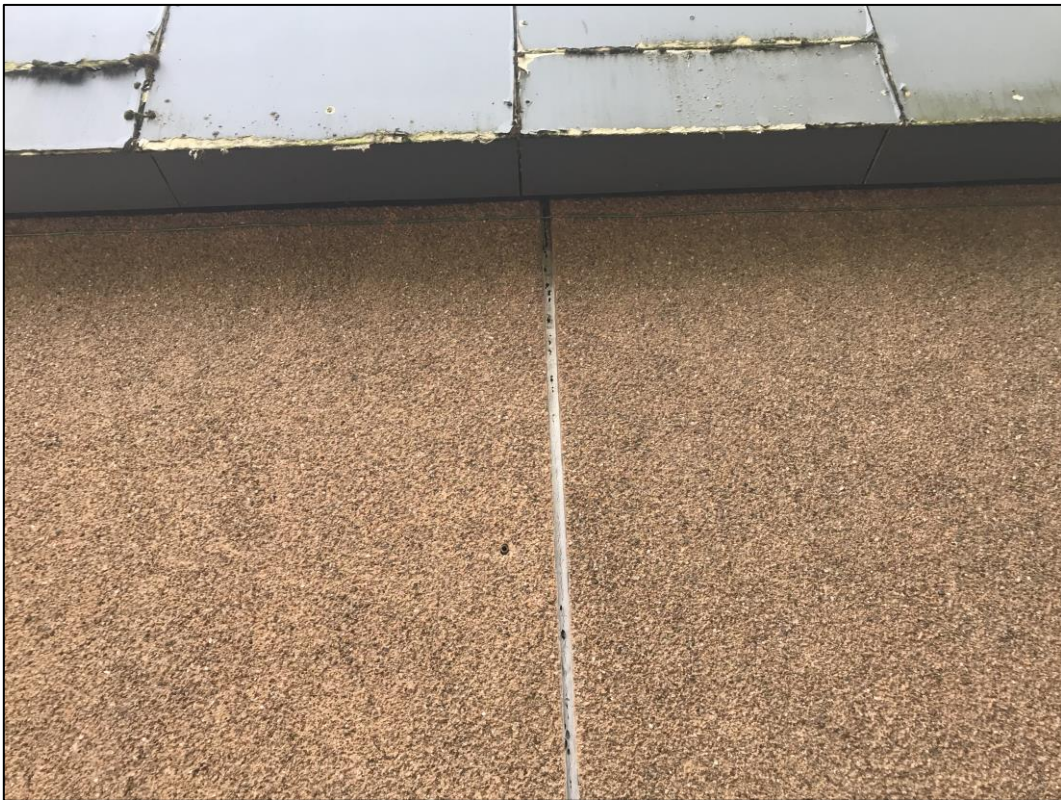
Generally, the movement joints appeared to be a consistent width up the full height of the building. On the wall forming the east elevation of the Drama Studio the movement joints appeared to have opened at the wall head location, refer to Figure 8.

Figure 8 – Opening of Movement Joint on East Elevation

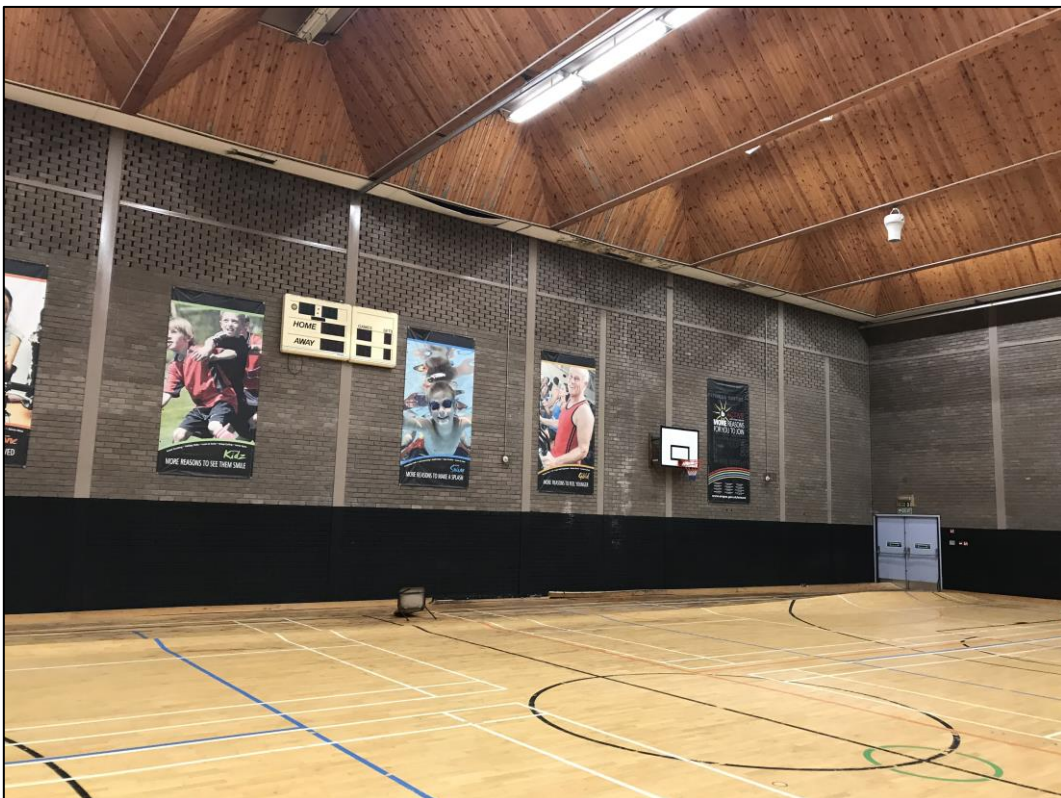
The exact nature of the roof structure could not be established as it was concealed by the ceiling finishes. Evidence of water ingress was noted towards the north west corner of the sports hall. The sprung timber floor system had warped in a number of locations; however, it is thought that this is symptomatic of a lack of building maintenance since the facility closed.

Figure 10 – Double Storey Sports Hall showing Water Ingress

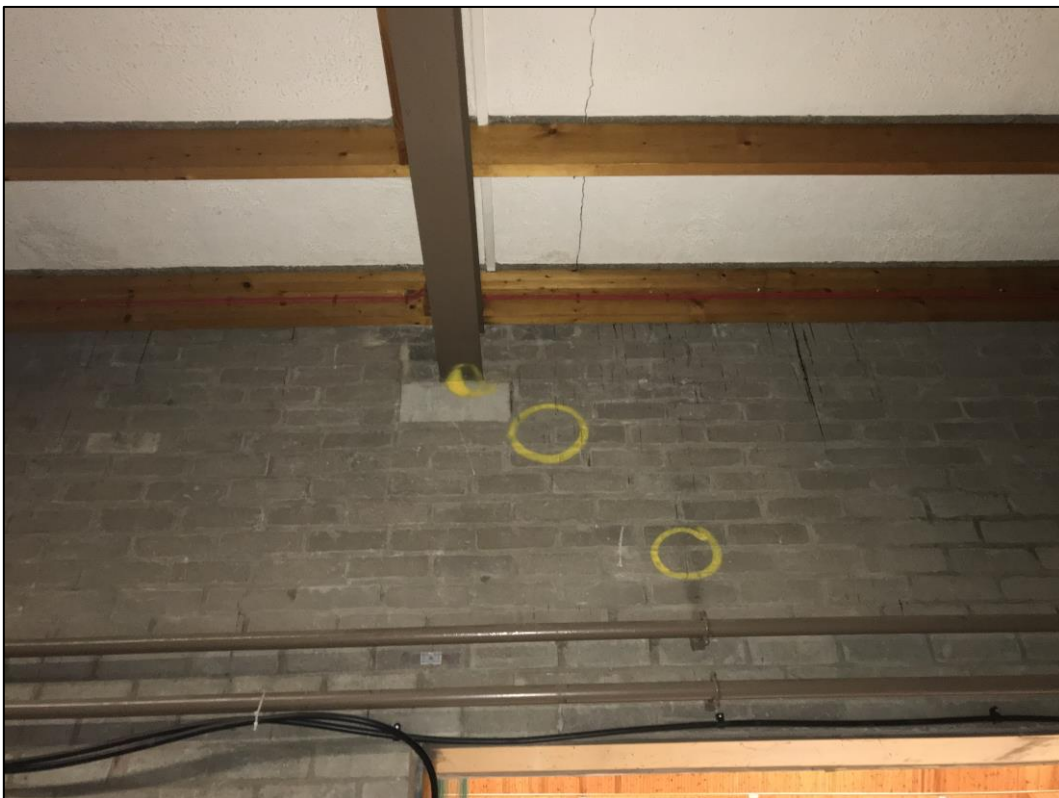
Towards the north end of the hall a single storey storage area had been constructed, refer to Figures 11 and 12. This consisted of flat timber roof joists which spanned between steel beams subsequently supported on the load bearing brickwork walls. Cracking was noted in this area of the building; however, it was not severe and was unlikely to have been caused by ground movement.

Figure 12 – Cracking Propagating Away from Padstone in Sports Hall Store

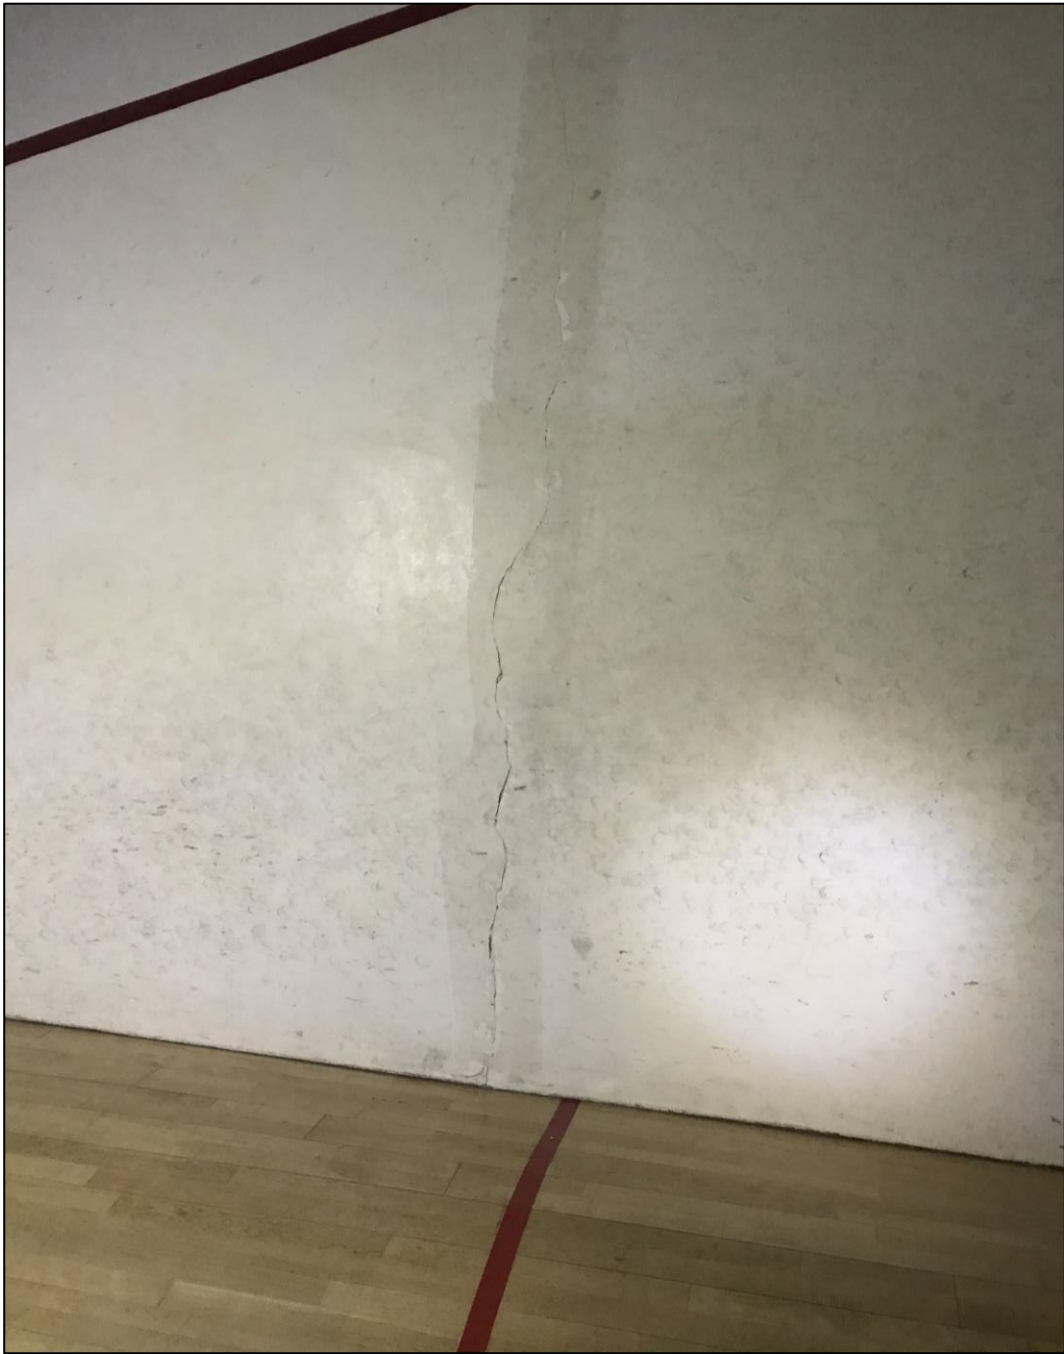
of the walls they appeared to be plumb with no bulging or lack of alignment observed. Vertical hairline cracking was noted on the plaster finish, refer to Figure 14. This cracking had the appearance of being a product of thermal shrinkage, which is a common occurrence in spaces of this size and construction.

Figure 14 – Vertical Cracking on Finishes in Squash Court Area

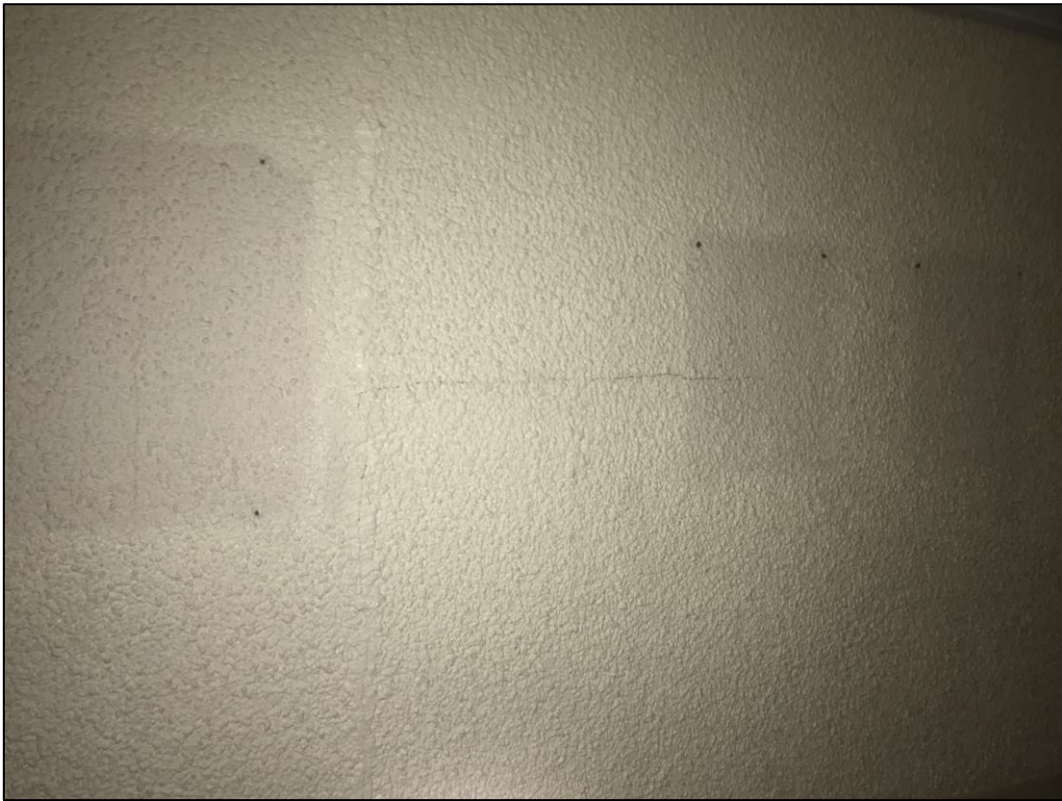
The changing rooms were contained within the single storey area located towards the north west corner of the building. The walls in these areas were of masonry construction and finished in a wet dash render system in the corridor areas, and tiled in the changing room and toilet areas. On inspection of the walls they appeared to be plumb with no bulging or lack of alignment observed. Minor hairline cracking was observed in the corridor area, refer to Figure 15, however this had the appearance of cosmetic cracking induced by thermal shrinkage.

Figure 15 – Hairline Cracking on Finishes of Wall in Changing Room Corridor

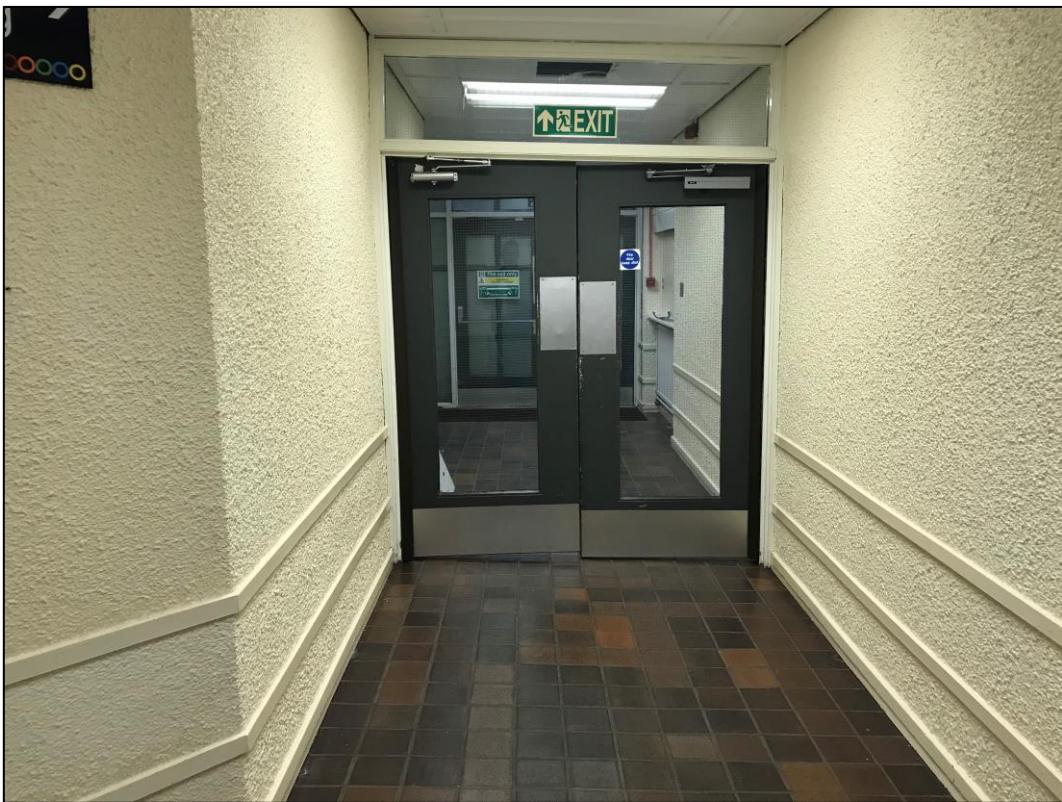
The floor did not feel level throughout, this was particularly evident in the corridor area where it sloped significantly towards the sports hall. This is shown on Figure 16 which illustrates that the doors have been altered to accommodate the drop in the floor level. It was noted that the floor in this area had a tile finish. No evidence of loose or boss tiles was noted thus suggesting that the floor settlement was historic and had not significantly moved since the floor finishes had been applied.

The ground floor appeared to be significantly sloping in areas, particularly in the areas adjacent to the sports hall. The floors appear to be sloping down towards the sports hall and squash courts suggesting that separate parts of the structure have settled at differing rates. In this area of the building it was noted that the floor was finished in tiles. In a tiled floor finish any recent ground movement is generally characterised by cracking and tiles becoming boss. No such defects were noted thus suggesting that the ground movement is historical and not progressive.

Figure 16 – Evidence of Floor Movement in Changing Room Corridor Area
