Structural Survey Report

Lochside Leisure Centre, Forfar

09 July 1998

ANGUS COUNCIL ROADS DEPARTMENT CONSULTANCY UNIT
STRUCTURAL SURVEY REPORT
LOCHSIDE LEISURE CENTRE, FORFAR
09 JULY 1998

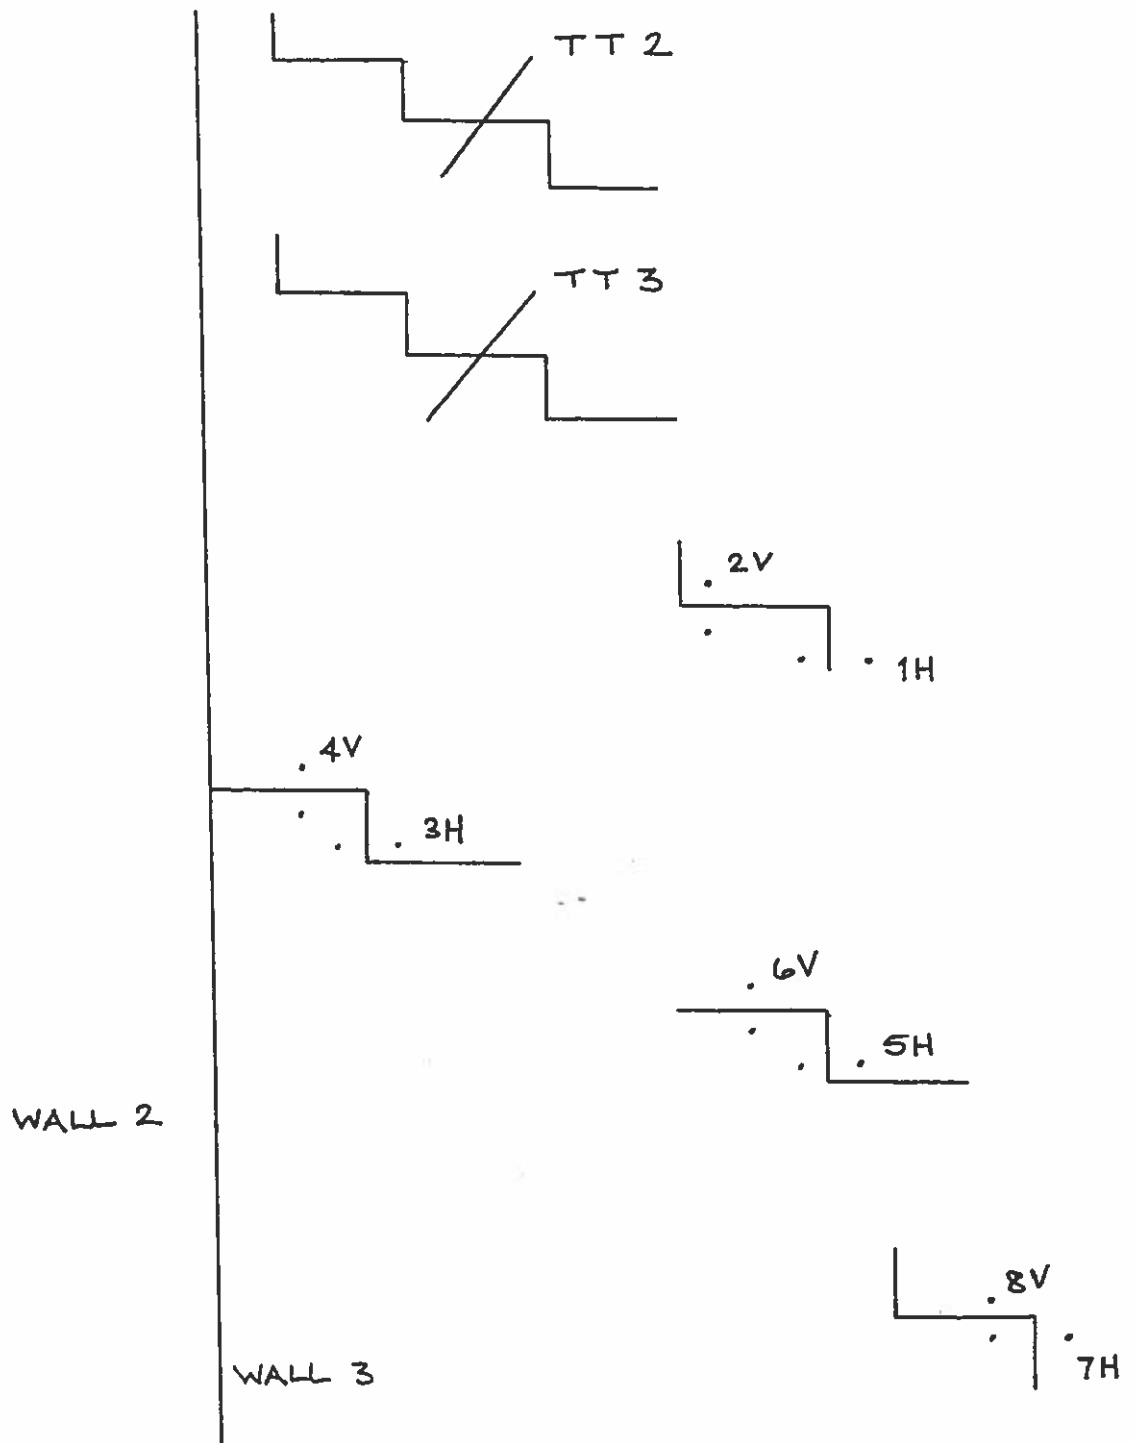
Wall 3 - Partition Wall Between Sports Store and Weightlifting Area / Crèche

Diagrammatic Representation of Cracks

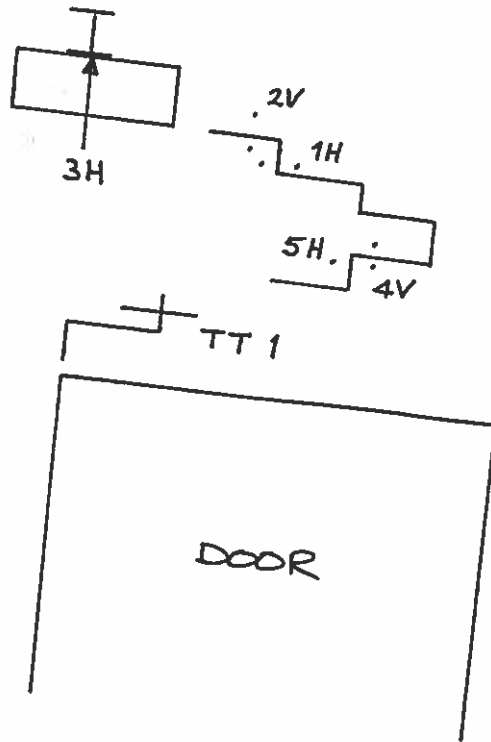
Sports Store Side

Diagrammatic Representation of Cracks

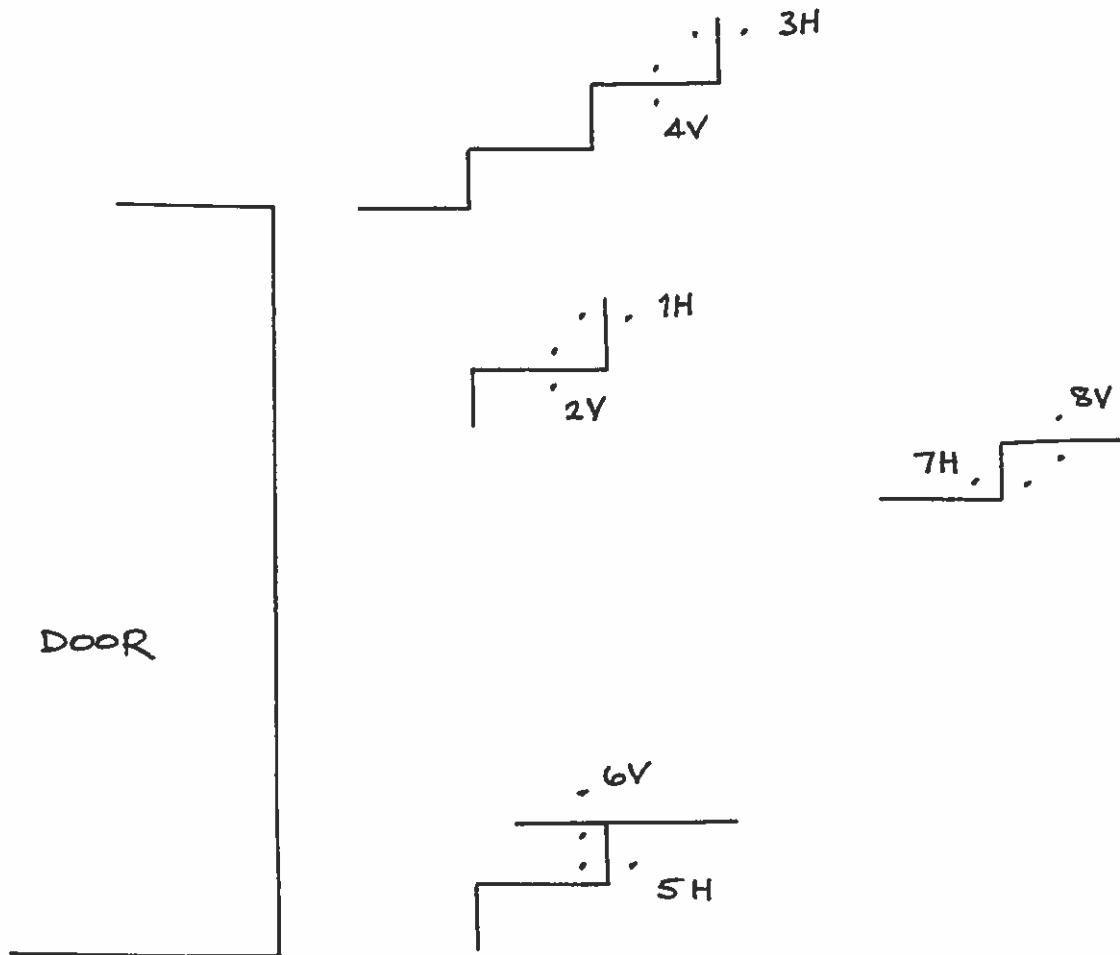
Wall 5 - Partition Wall Between Sports Hall and Corridor

Diagrammatic Representation of Cracks

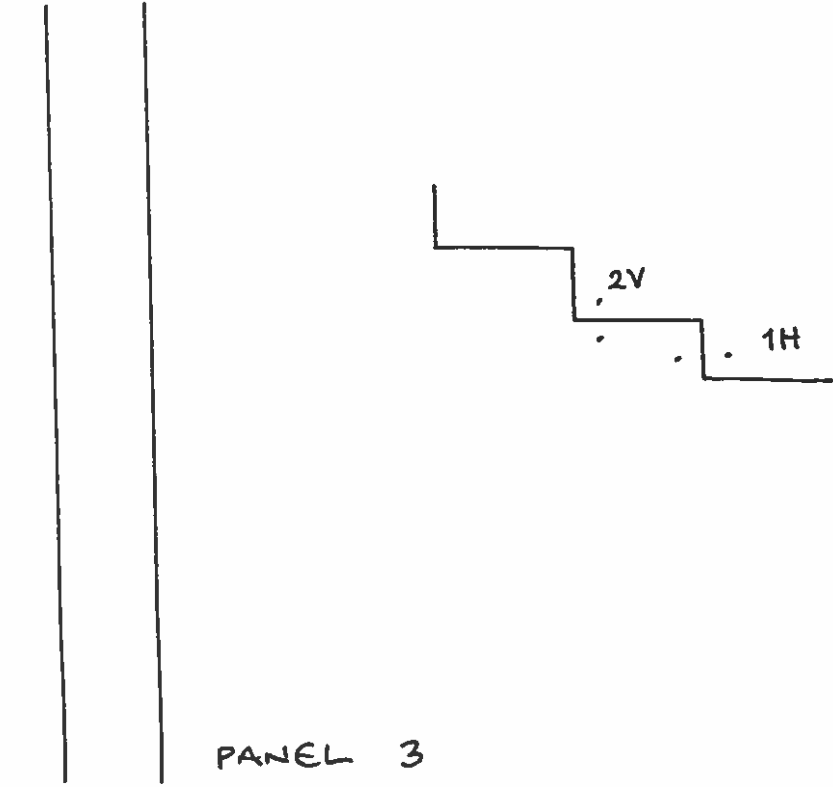
Wall 6 - Partition Wall Between Canteen / Sports Hall

Diagrammatic Representation of Cracks

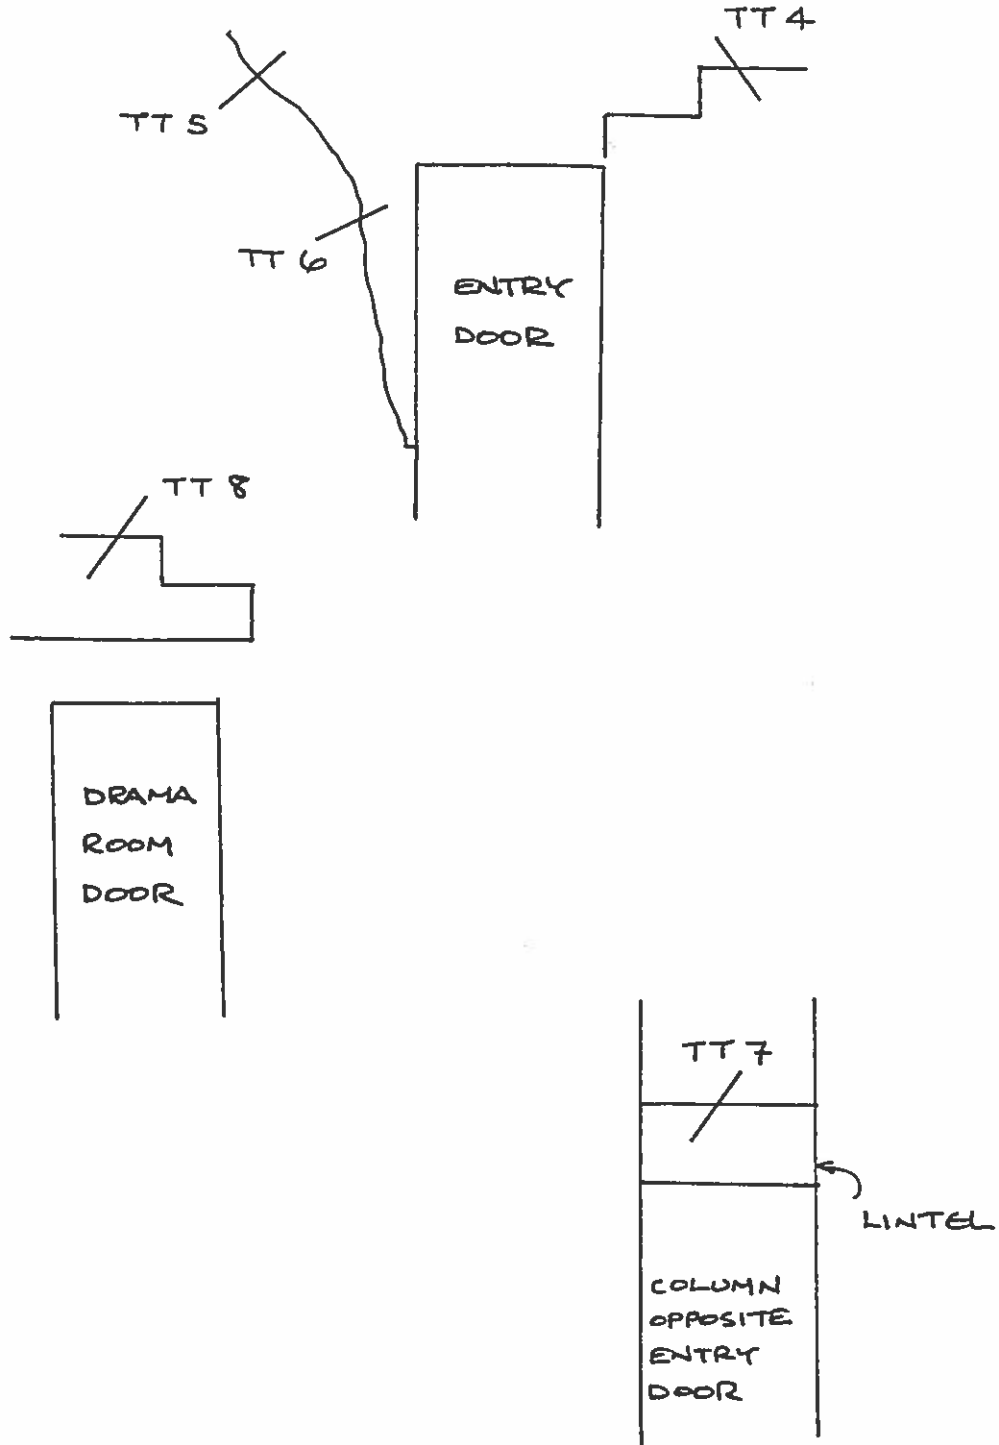
Wall 8 - Drama Store Wall

Diagrammatic Representation of Cracks
