**ROADS DEPARTMENT
ENGINEERING & DESIGN SERVICES**

Structural Survey Report

*Lochside Leisure Centre
Forfar.*

26 July 2001

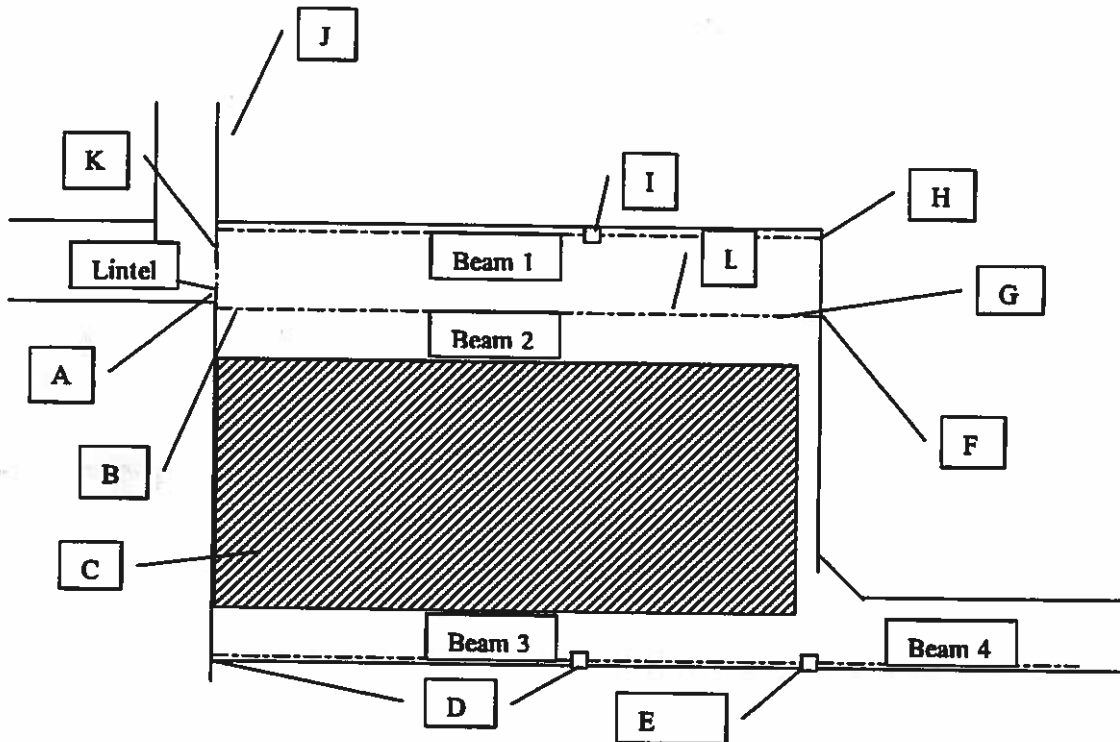
Café Ceiling Survey: 18/07/2001

- A. Beam 2 has rotated anti-clockwise by approximately 2mm.
No padstone below bearing, this has resulted in signs of crushing and mortar loss to brick.
30mm service pipe through brick immediately below beam
Lack of access prevents full inspection
(Plate 2).
- B. 2no 100mm diameter ducts with 20mm insulation.
Take design size of ducts as 135mm to allow for weakening effect of burning on steel.

In summary the main problem areas in the Café ceiling are Beam B and its bearing nearest the sports hall. This beam and bearing require analysis and strengthening solutions as per Sections 3 and 4.

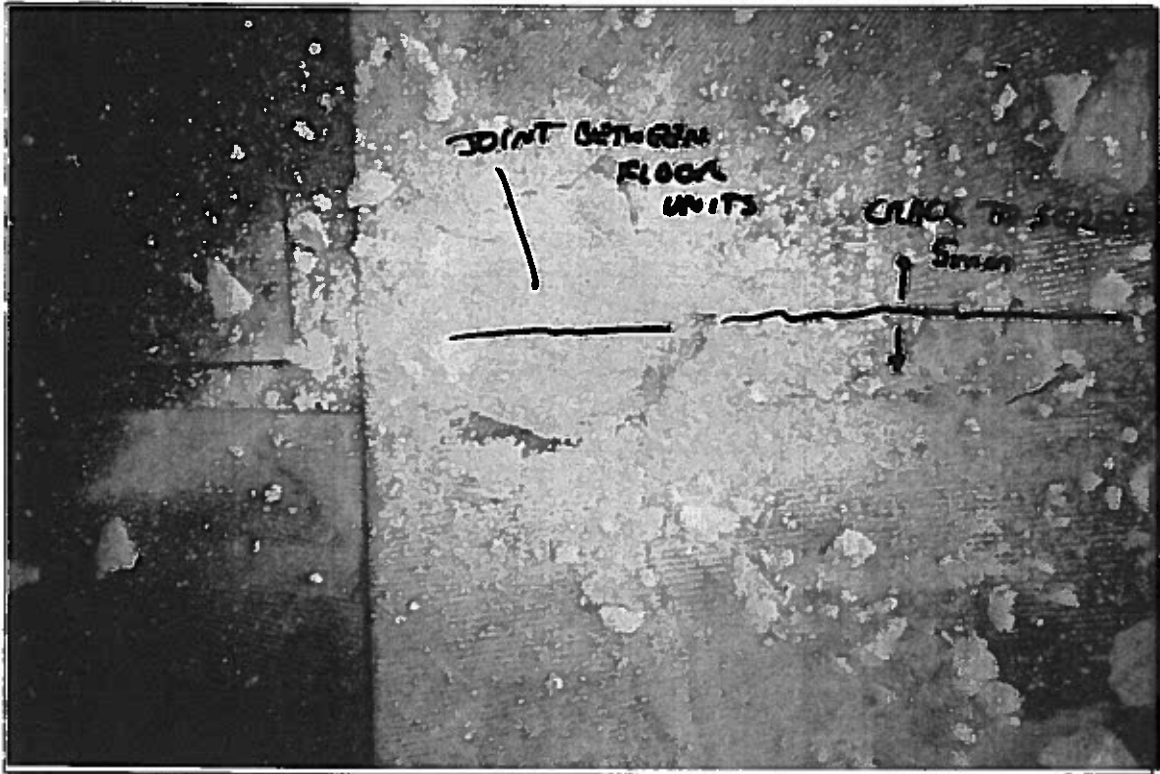
Plate No.: 1

Screed was removed in the area shown in Figure 1 and the cracking to the screed was found to be directly above the joint between two adjacent units and did not to continue through into any units and compromise their structural capacity (Plate 1).

Defects: 5mm CRACK TO SCAFFED ABOVE JOINT BETWEEN ADJACENT FLOOR UNITS

Comments: NO COMPROMISE TO STRUCTURAL CAPACITY OF FLOOR UNITS.

Location: CRECHE ROOM FLOOR

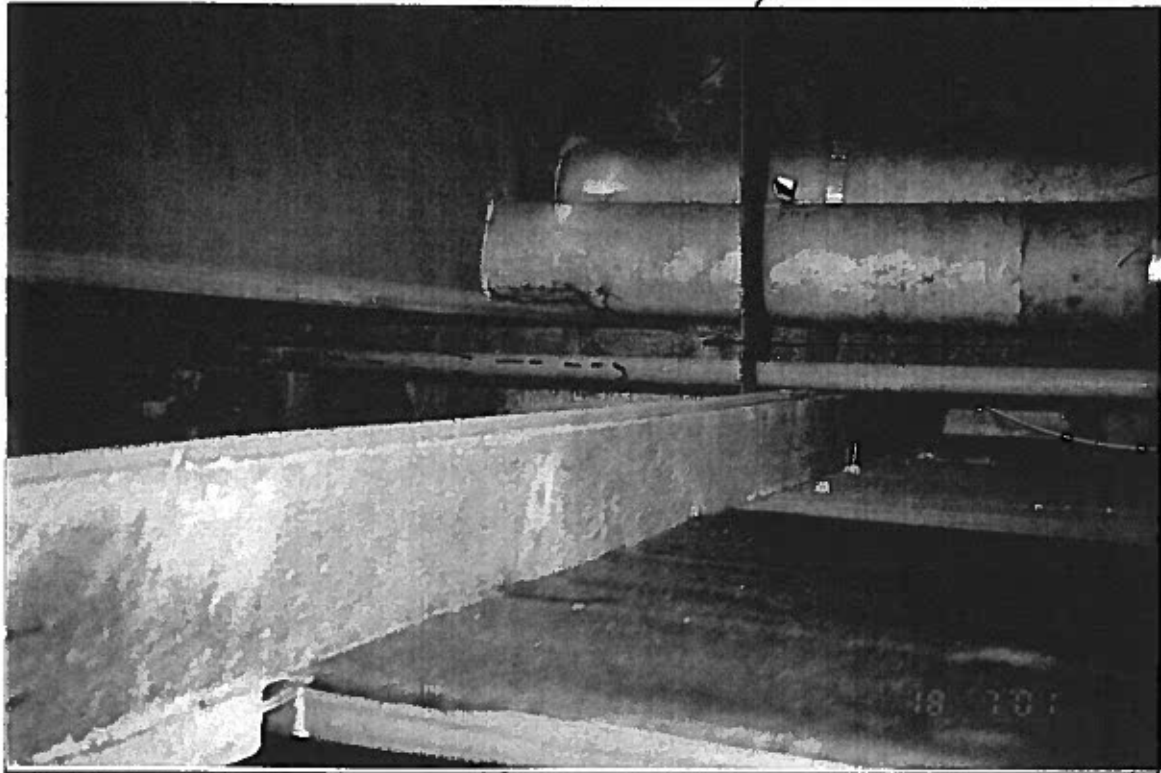
Plate No.: 2

The four no. duct holes at position G were found to be positioned so as the structural capacity of the beam was not reduced below that which is required. The two no. duct holes at B however were found to be of such size and in their location do significantly reduce the capacity of the beam below that which is required in accordance with current British Standards.

2mm GAP DUE TO ROTATION

DUCTS THROUGH WEB
NEED
SUPPORT

NO
PADS

Defects: NO PADSTONE BELOW BEAM, 2mm ANTI - CLOCKWISE ROTATION AT BEAM TOP FLANGE, 30mm DIA. SERVICE PIPE BELOW BEARING, 2 NO. 125mm DIA. DUCT HOLES GUMED IN WEBS.

Location: CAFE CEILING
BEAM 2 BEARING MUST. SPORTS HALL.

Beam 2 requires two web stiffeners to be welded as per Appendix 4.

Webs stiffeners should be installed in Beam 2 as per Appendix 4, due to the significant loss in section capacity, this is recommended to be carried out in the short term.

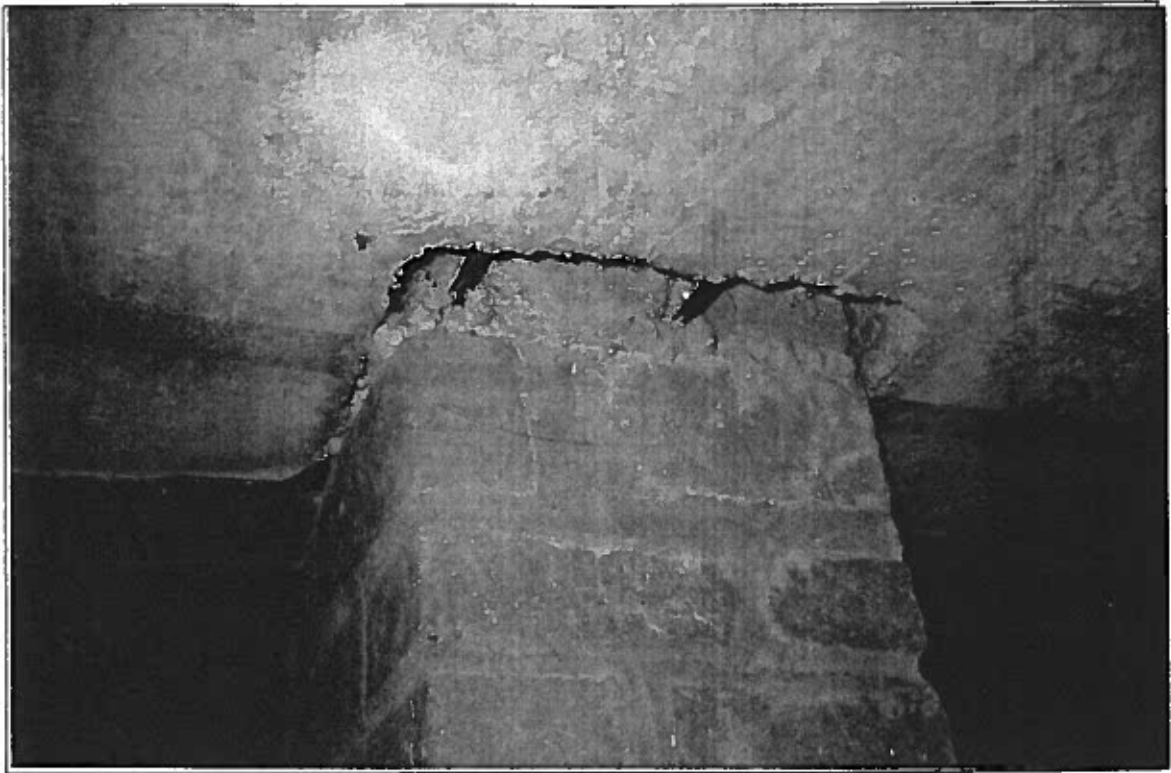
Plate No.: 3

- C. No signs of cracking to soffit or concrete units, 2 no. 300mm wide infill panels in good condition.
- D. Beam 3 good condition continuous support over brick column good, but lack of concrete infill to slab edge (Plate 3).
No sign of crushing to bearings
Lack of access prevents full inspection.
- E. *Lack of access prevents full inspection*
10-15mm gap above Beam 4 padstone – no adjacent cracking, therefore gap likely to be due to poor construction.
Chasing cut in brickwork for services
(Plate 4)
- F. Padstone and bearings in good condition.

Defects: LACK OF CONCRETE INFILL BETWEEN PRECAST UNITS AND MASONRY COLUMN.

Comments: EXPOSED RE-BARS PROBABLY USED AS A MAKESHIFT BEARING WHEN PRECAST SLABS FOUND OUT TO BE CUT TO WRONG SHAPE.

Location: CAFE CEILING - BEAM 3

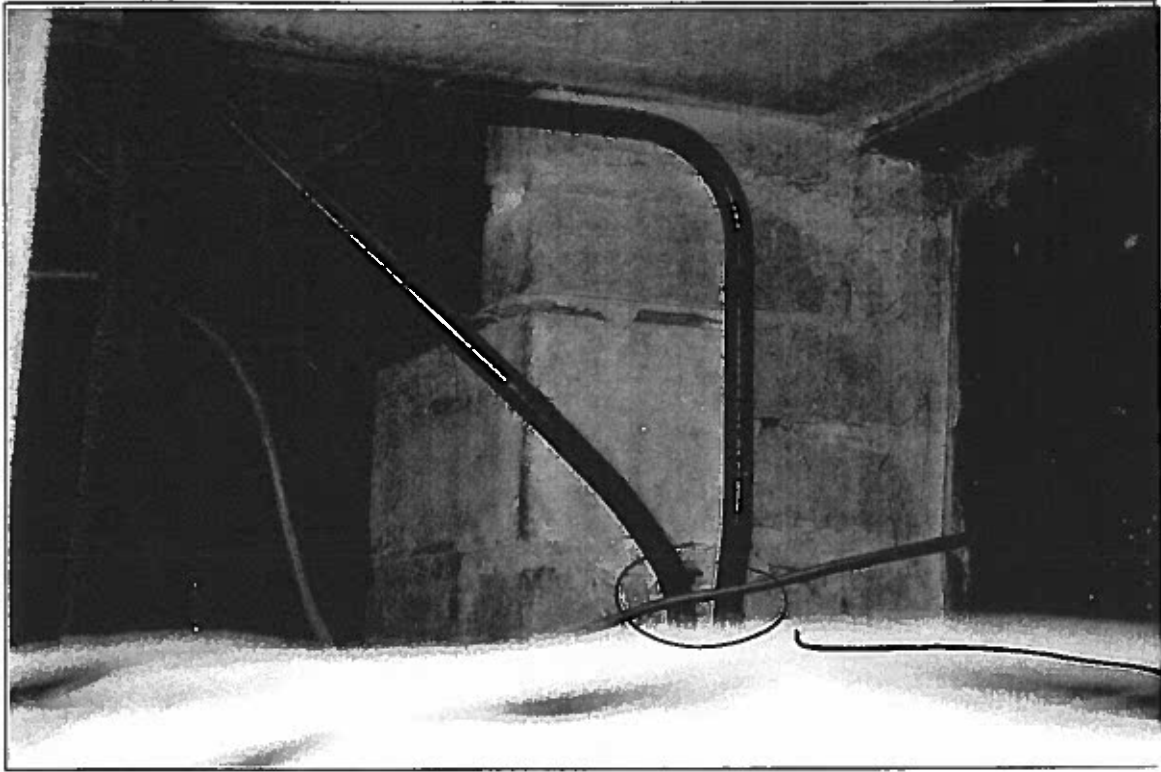
Plate No.: 4

CHASING
CUT IN
BRICKWA

Defects: 10-15mm GAP ABOVE PADSTONE, PROBABLY DUE TO POOR CONSTRUCTION.

Comments: LACK OF ACCESS TO OPPOSITE

Location: CAFE CEILING - BEAM

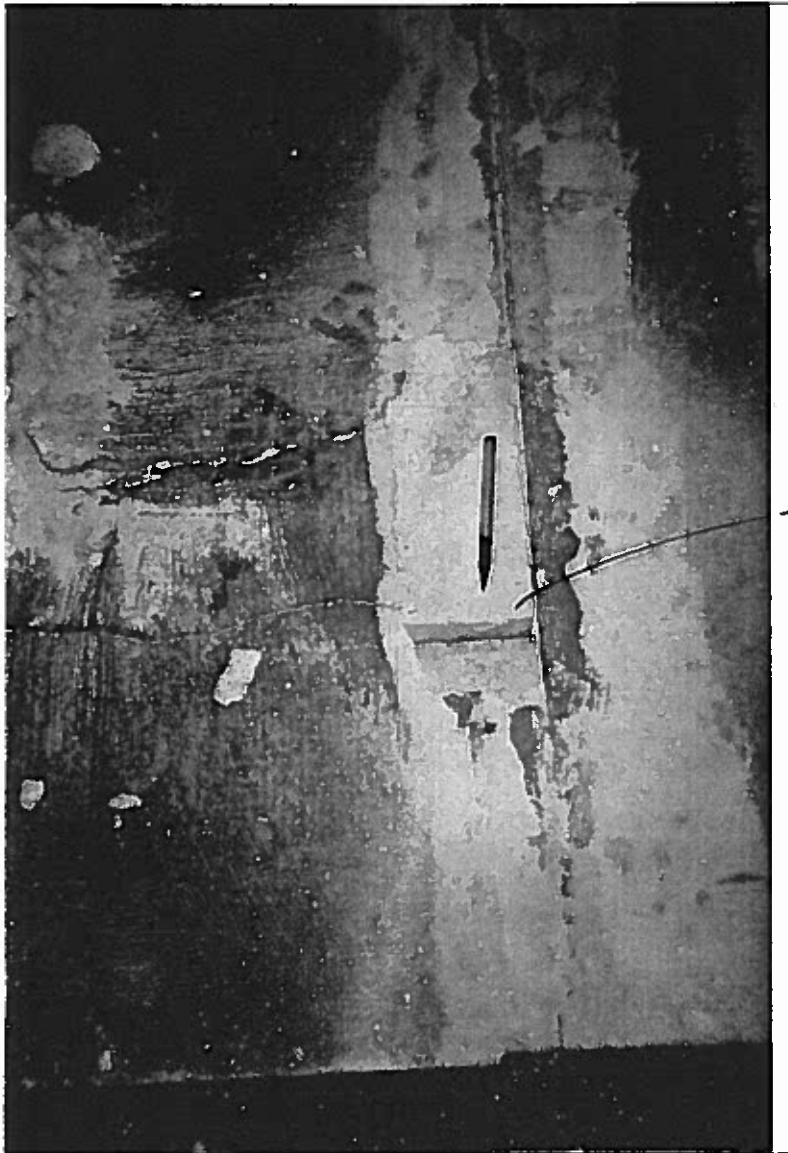
Plate No.: 9

As the floor slopes to the rear polygym door from the dummy wall, differential movements between adjacent units can be observed (Plats 8 & 9), again these movements only cause cracking in the screed and do not affect the structural capacity of the individual floor units.

END OF UNIT

Comments: CRACKS IN SCAFFOLD ONLY - UNIT UNAFFECTED.

Location: POLYGYM.

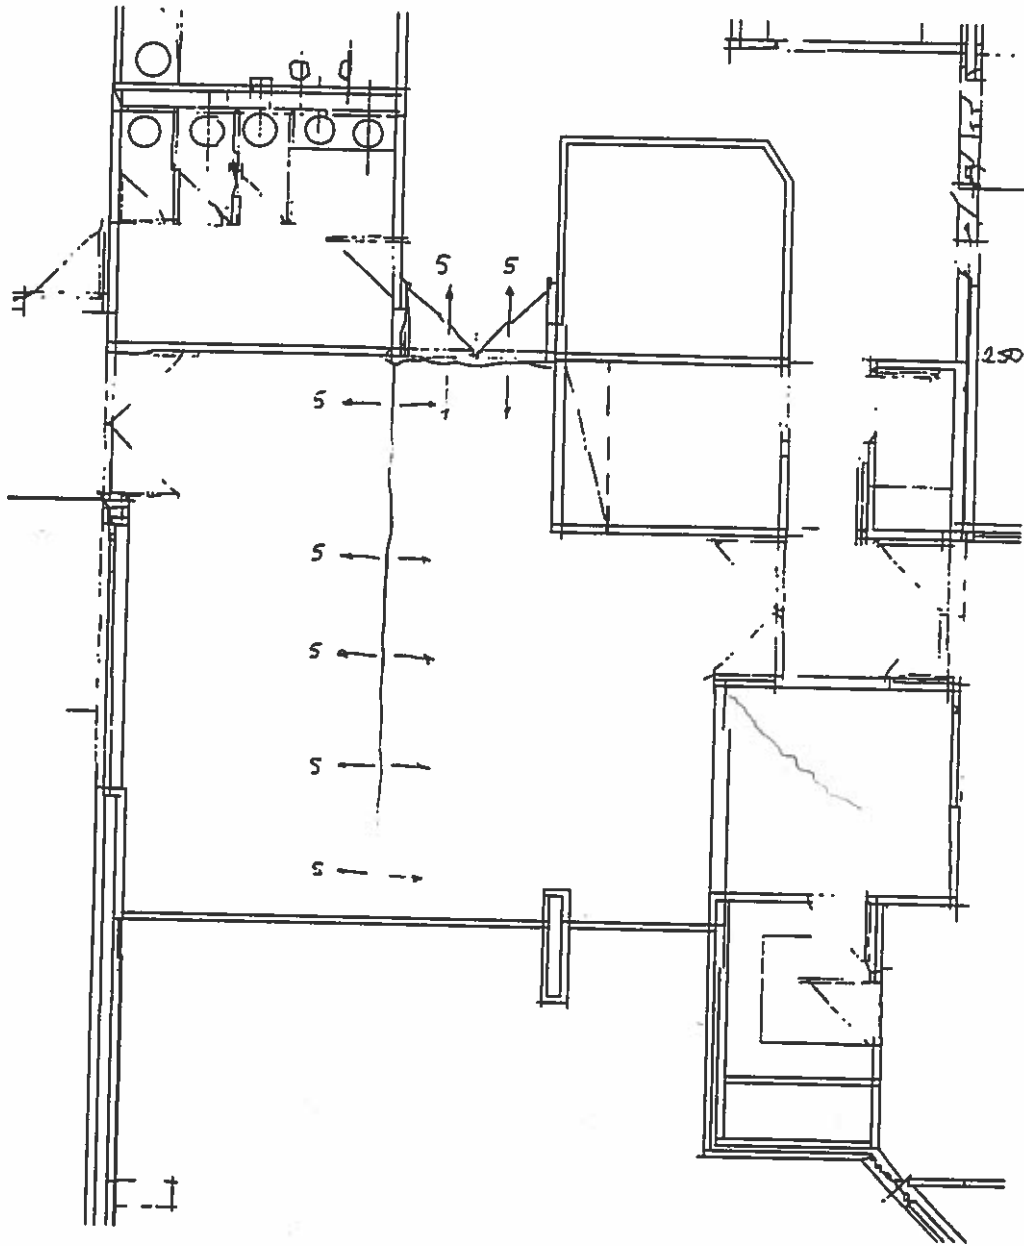
Figure 1: Creche Room: Cracking to Floor Screed

The crèche room floor has a measured slope of up to 1:100 falling towards the sports hall corner (Appendix 3), carpet tiles were removed to reveal cracking in the screed as per Figure 1.

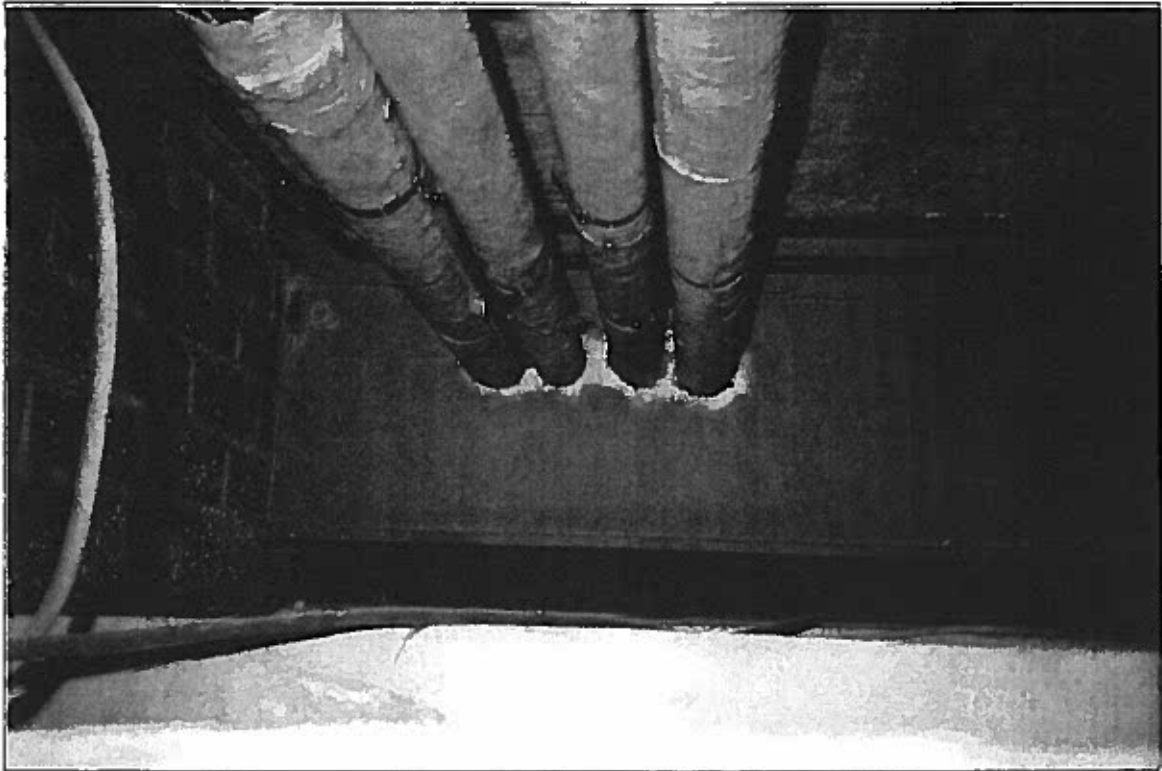
Plate No.: 5

Defects: 4 NO. SERVICE DUCTS BURST THROUGH WEB

Comments: BEARING & PADSTONE IN GOOD CONDITION.

Location: CAFE CEILING, BEAM 2 BEARING

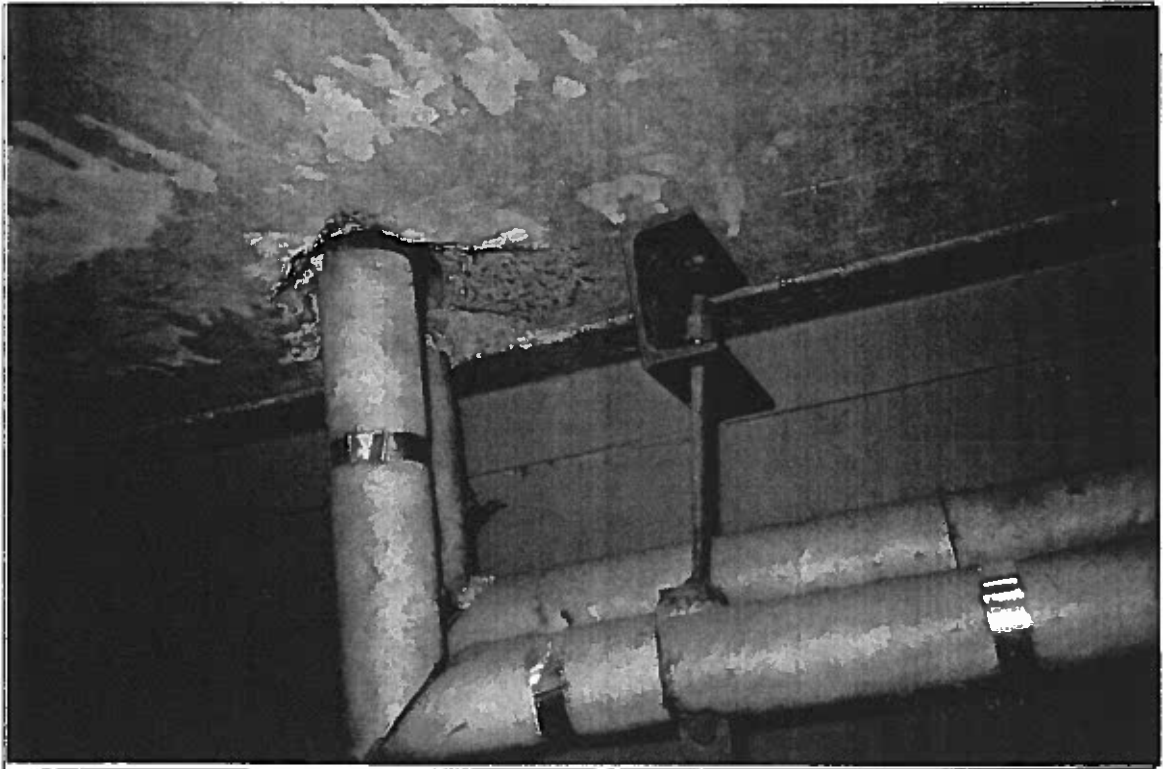
Plate No.: 6 Location: CAFE CEILING (L)

- L. Service Voids Through Pre-Cast Units (Plate 6)

The floor units above the café have been punched through to allow service access, this has not resulted in serviceability cracking in the units and has therefore not been subject to analysis and no strengthening is required.

Defects: Holes cut in precast units.

Comments: Evidence of steel beam continuing through depth of slabs can be observed.

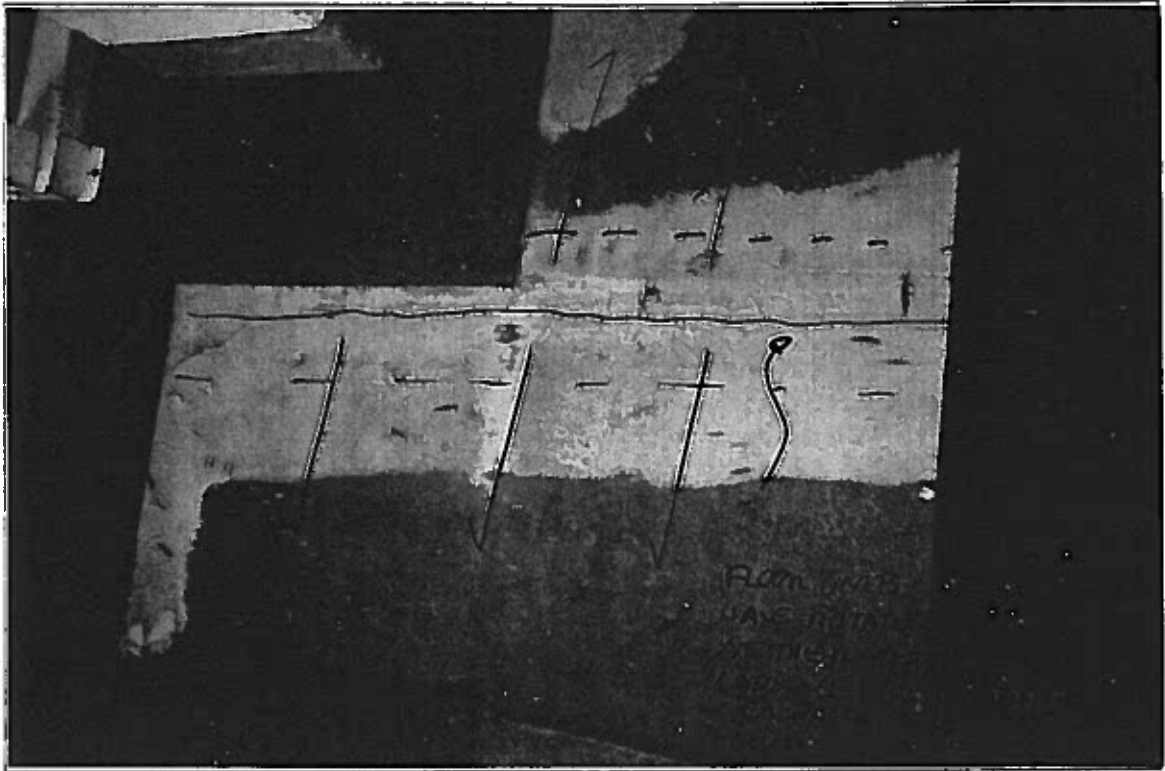
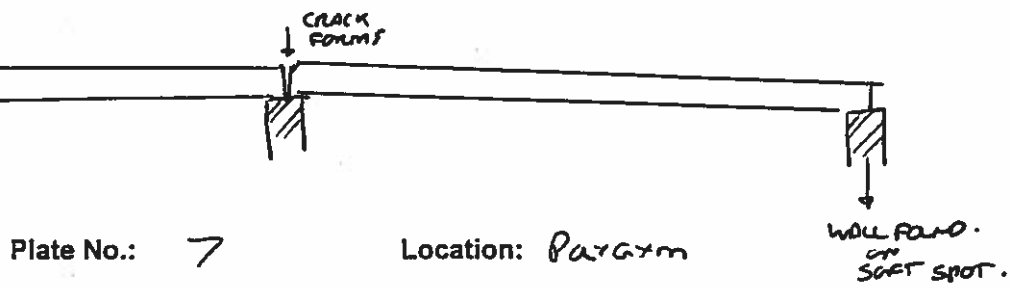
Plate No.: 7

Carpet tiles were removed in the polygym where the contour plot shows a slope of 1:75 running towards the front of the building from the middle of the floor. The floor slopes away from the centre where a dummy wall supports the floor unit bearings. The ends of the units have rotated to form a crack which has been in evidence before and been repaired (Plate 7). The capacity of the floor units has not been affected.

Defects: LONG TERM RC REPAIR MADE TO ENDS OF WALL

Comments: CRACK CAUSED BY OVERALL ROTATION OF FLOOR :

Location: PAUGYM

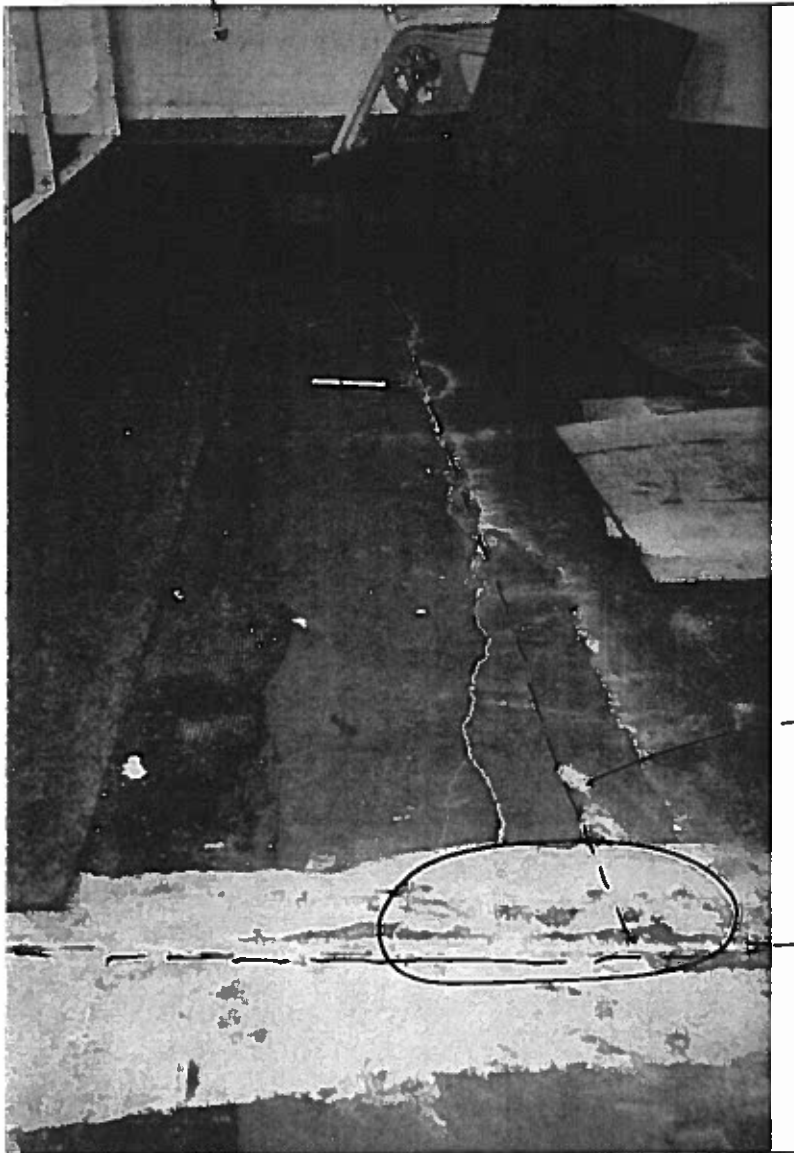
Plate No.: 8

REAR WALL

Comments: Cracks in screed caused by LHS units deflecting relative to RHS unit

Location: POLYGYM
