# Asbestos Survey Angus Council Property

## Lochside Leisure Centre Forfar

Survey No – 745712219-001

Survey Type – Refurbishment

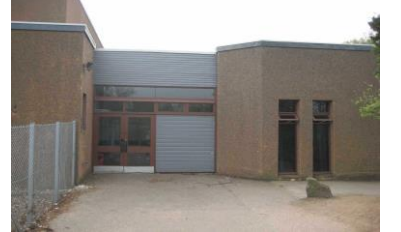
Floor	Room	Asbestos Materials	
Ground	Boiler	None Found	 
Ground	Weights Area	No Access/Steel Shutters Un-Known

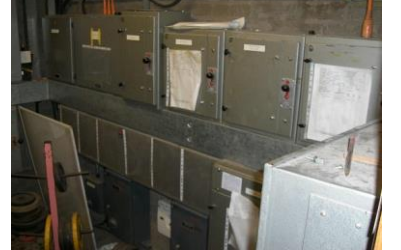
Ground	Weights Area Electric Cupboard	Flash Guards/Insulators

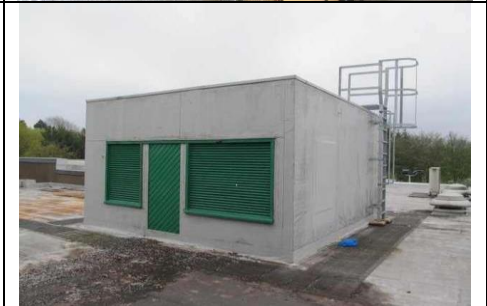
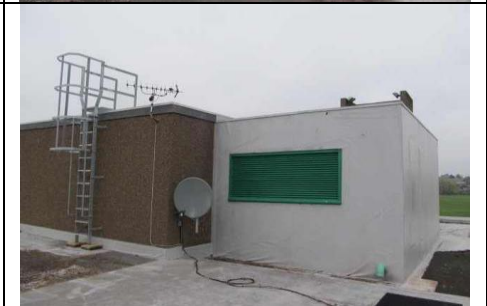
External Roof	Water Tank Housing X2	Unknown No access boarded over

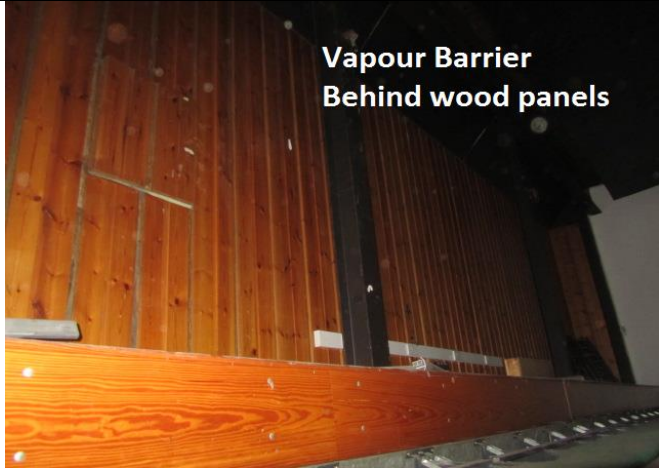
Floor	Room	Item/Area	Material	Asbestos Type	Sample Number
Ground First	External Wall	Vapour Barrier	Bitumen Paper	Non Asbestos	2022653 A
<b>Photo</b>			<b>Material Assessment</b>		<b>Priority Assessment</b>

<p>Vapour Barrier Behind wood panels</p>			<b>Product Type</b>		<b>Occupancy Activity</b>
			<b>Extent of Damage</b>		<b>Accessibility</b>
			<b>Surface Treatment</b>		<b>Exposure Potential</b>
			<b>Asbestos Type</b>		<b>Maint Disturbance</b>
			<b>Sub Total</b>		<b>Sub Total</b>
					<b>Total</b>
	<b>Recommendations:- None</b>				
	<b>Notes:-</b>

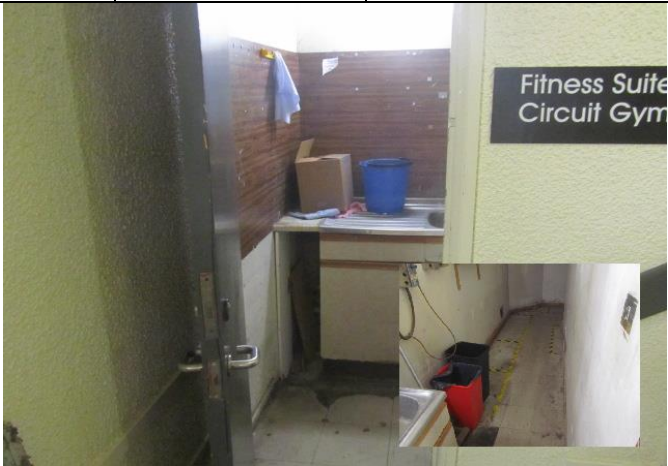
Floor	Room	Item/Area	Material	Asbestos Type	Sample Number			
Ground	Store Under stairs at reception	Floor Tiles/ 6 m2	Thermoplastic	Chrysotile (white)	2022653 B			
<b>Photo</b>

<b>Material Assessment</b>		<b>Priority Assessment</b>			
			<b>Product Type</b>	1	<b>Occupancy Activity</b>	0		
			<b>Extent of Damage</b>	1	<b>Accessibility</b>	0		
			<b>Surface Treatment</b>	0	<b>Exposure Potential</b>	0		
			<b>Asbestos Type</b>	1	<b>Maint Disturbance</b>	0		
			<b>Sub Total</b>	3	<b>Sub Total</b>	0		
						<b>Total</b>	<b>3</b>	
			<b>Recommendations:- Remove tiles prior to any works commencing</b>					
			<b>Notes:- Dispose of as contaminated waste</b>

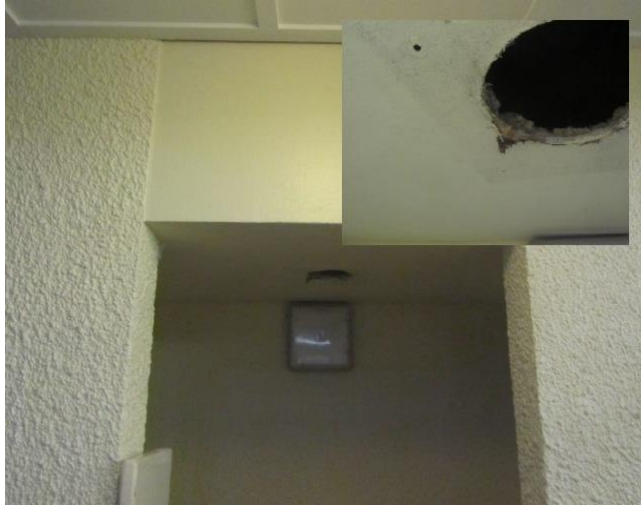
Floor	Room	Item/Area	Material	Asbestos Type	Sample Number
Ground	Reception Area	Ceiling Coating	Hessian	Non Asbestos	2022653 C
<b>Photo</b>			<b>Material Assessment</b>		<b>Priority Assessment</b>

<b>Product Type</b>		<b>Occupancy Activity</b>
			<b>Extent of Damage</b>		<b>Accessibility</b>
			<b>Surface Treatment</b>		<b>Exposure Potential</b>
			<b>Asbestos Type</b>		<b>Maint Disturbance</b>
			<b>Sub Total</b>		<b>Sub Total</b>
					<b>Total</b>
				<b>Recommendations:- None</b>	
			<b>Notes:- Same coating found to heater panel on first floor</b>

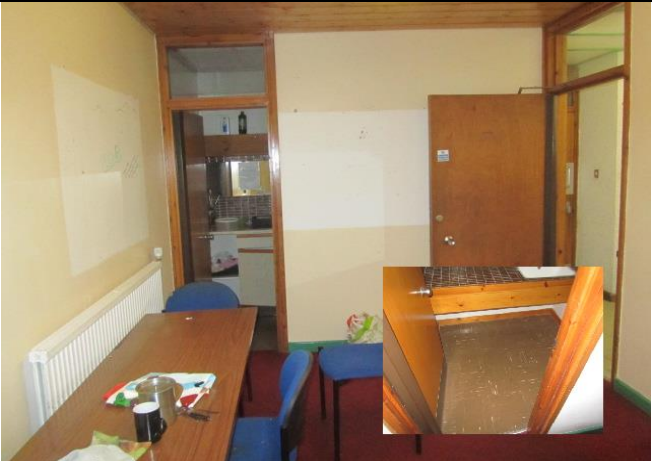
Floor	Room	Item/Area	Material	Asbestos Type	Sample Number		
Ground	Staff rooms X2	Floor Tiles (Brown)	Thermoplastic	None Asbestos	2022653 D		
<b>Photo</b>

<b>Material Assessment</b>		<b>Priority Assessment</b>		
			<b>Product Type</b>		<b>Occupancy Activity</b>		
			<b>Extent of Damage</b>		<b>Accessibility</b>		
			<b>Surface Treatment</b>		<b>Exposure Potential</b>		
			<b>Asbestos Type</b>		<b>Maint Disturbance</b>		
			<b>Sub Total</b>		<b>Sub Total</b>		
					<b>Total</b>		
<b>Recommendations:- None</b>							
<b>Notes:-</b>

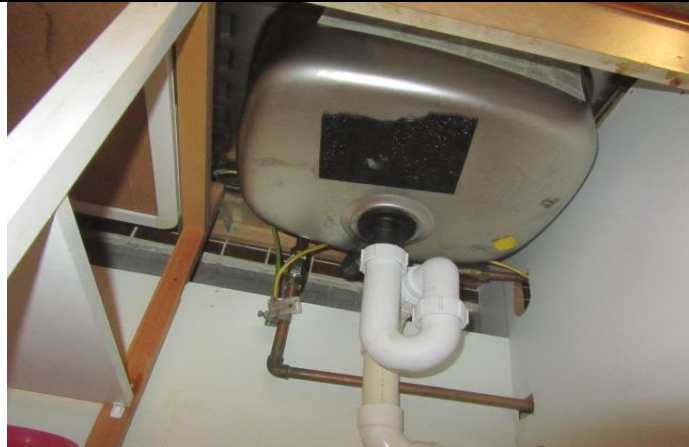
Floor	Room	Item/Area	Material	Asbestos Type	Sample Number
Ground	Staff rooms X2	Sink Pad	Bitumen	Non Asbestos	2022653 E
<b>Photo</b>			<b>Material Assessment</b>		<b>Priority Assessment</b>

<b>Product Type</b>		<b>Occupancy Activity</b>
			<b>Extent of Damage</b>		<b>Accessibility</b>
			<b>Surface Treatment</b>		<b>Exposure Potential</b>
			<b>Asbestos Type</b>		<b>Maint Disturbance</b>
			<b>Sub Total</b>		<b>Sub Total</b>
					<b>Total</b>
				<b>Recommendations:- None</b>	
			<b>Notes:-</b>

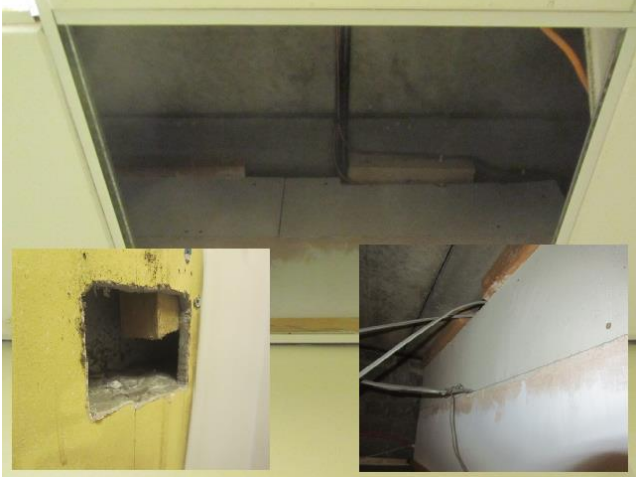
Floor	Room	Item/Area	Material	Asbestos Type	Sample Number
Ground	Toilets at reception	Wall Sheeting	Boarding	Non Asbestos	2022653 F
<b>Photo</b>			<b>Material Assessment</b>		<b>Priority Assessment</b>

<b>Product Type</b>		<b>Occupancy Activity</b>
			<b>Extent of Damage</b>		<b>Accessibility</b>
			<b>Surface Treatment</b>		<b>Exposure Potential</b>
			<b>Asbestos Type</b>		<b>Maint Disturbance</b>
			<b>Sub Total</b>		<b>Sub Total</b>
					<b>Total</b>
			<b>Recommendations:- None</b>		
<b>Notes:-</b>

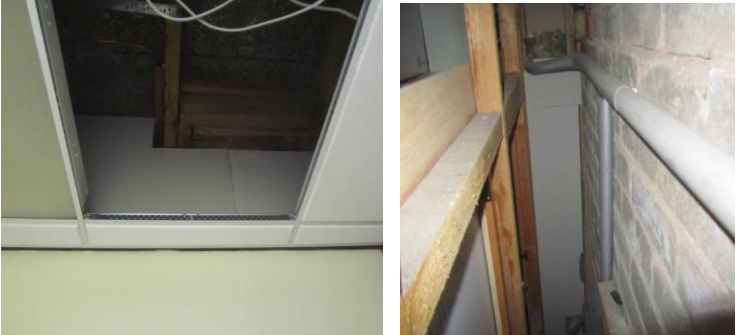
Floor	Room	Item/Area	Material	Asbestos Type	Sample Number	
Ground	Staff toilets/ Disabled toilet At changing rooms	Wall Sheeting	Boarding	Non Asbestos	2022653 G	
<b>Photo</b>

<b>Material Assessment</b>		<b>Priority Assessment</b>	
			<b>Product Type</b>		<b>Occupancy Activity</b>	
			<b>Extent of Damage</b>		<b>Accessibility</b>	
			<b>Surface Treatment</b>		<b>Exposure Potential</b>	
			<b>Asbestos Type</b>		<b>Maint Disturbance</b>	
			<b>Sub Total</b>		<b>Sub Total</b>	
					<b>Total</b>	
			<b>Recommendations:- None</b>			
<b>Notes:-</b>

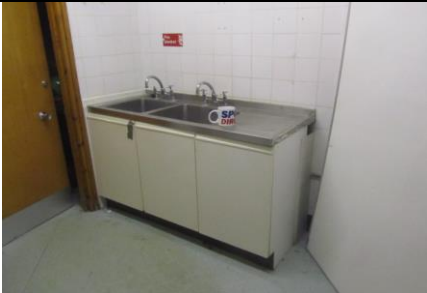
Floor	Room	Item/Area	Material	Asbestos Type	Sample Number
Ground	Canteen Kitchen	Sink Pad	Bitumen	Non Asbestos	2022653 H
<b>Photo</b>			<b>Material Assessment</b>		<b>Priority Assessment</b>

<b>Product Type</b>		<b>Occupancy Activity</b>
			<b>Extent of Damage</b>		<b>Accessibility</b>
			<b>Surface Treatment</b>		<b>Exposure Potential</b>
			<b>Asbestos Type</b>		<b>Maint Disturbance</b>
			<b>Sub Total</b>		<b>Sub Total</b>
					<b>Total</b>
				<b>Recommendations:- None</b>	
			<b>Notes:-</b>

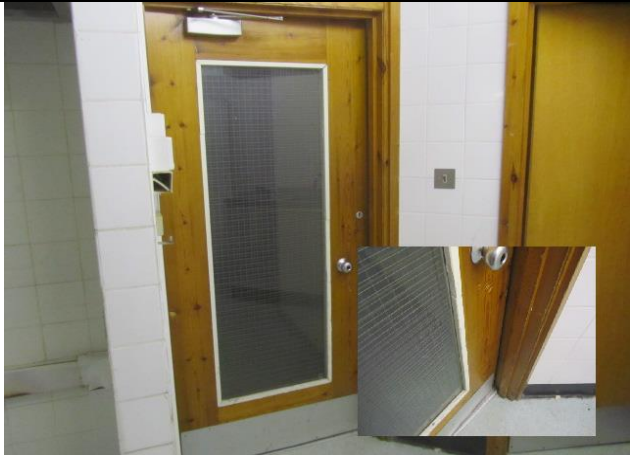
Floor	Room	Item/Area	Material	Asbestos Type	Sample Number	
Ground	Canteen Kitchen	Glazing Beads to Rear corridor door	AIB	Amosite(Brown)	2022653 I	
<b>Photo</b>			<b>Material Assessment</b>		<b>Priority Assessment</b>

<b>Product Type</b>	2	<b>Occupancy Activity</b>	0
			<b>Extent of Damage</b>	1	<b>Accessibility</b>	0
			<b>Surface Treatment</b>	1	<b>Exposure Potential</b>	0
			<b>Asbestos Type</b>	2	<b>Maint Disturbance</b>	0
			<b>Sub Total</b>	6	<b>Sub Total</b>	0
					<b>Total</b>	<b>6</b>
				<b>Recommendations:- Remove and dispose of door as contaminated waste</b>		
			<b>Notes:- AIB- Asbestos Insulation Board</b>

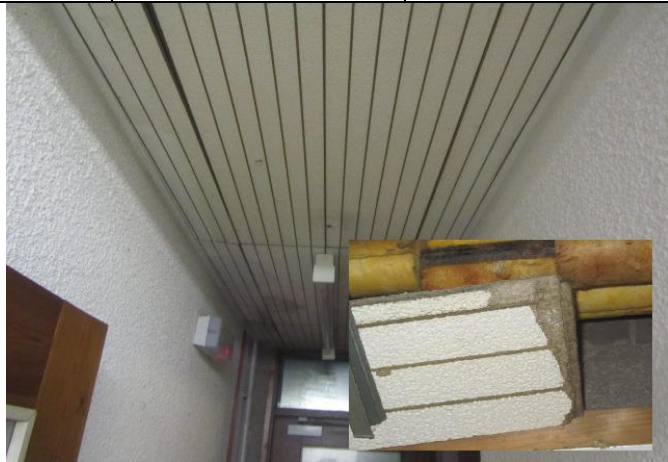
Floor	Room	Item/Area	Material	Asbestos Type	Sample Number
Ground	Corridor/Stairwell	Ceiling Tiles	Fibre board	Non Asbestos	2022653 J
<b>Photo</b>			<b>Material Assessment</b>		<b>Priority Assessment</b>

<b>Product Type</b>		<b>Occupancy Activity</b>
			<b>Extent of Damage</b>		<b>Accessibility</b>
			<b>Surface Treatment</b>		<b>Exposure Potential</b>
			<b>Asbestos Type</b>		<b>Maint Disturbance</b>
			<b>Sub Total</b>		<b>Sub Total</b>
					<b>Total</b>
				<b>Recommendations:- None</b>	
			<b>Notes:-</b>

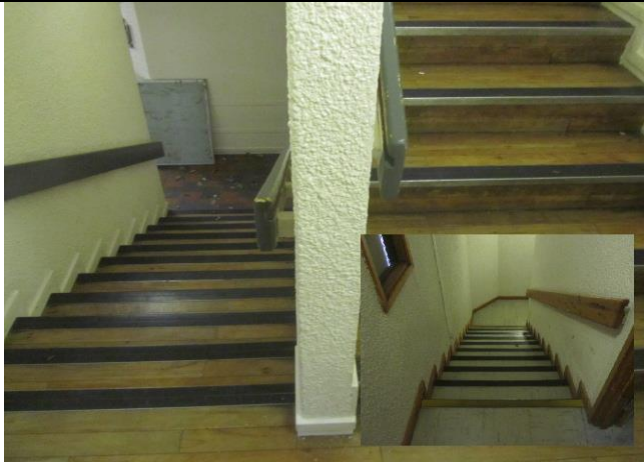
Floor	Room	Item/Area	Material	Asbestos Type	Sample Number	
Ground/ First	Stairwells	Stair Nosing	Thermoplastic	Non Asbestos	2022653 K	
<b>Photo</b>			<b>Material Assessment</b>		<b>Priority Assessment</b>

<b>Product Type</b>		<b>Occupancy Activity</b>	
			<b>Extent of Damage</b>		<b>Accessibility</b>	
			<b>Surface Treatment</b>		<b>Exposure Potential</b>	
			<b>Asbestos Type</b>		<b>Maint Disturbance</b>	
			<b>Sub Total</b>		<b>Sub Total</b>	
					<b>Total</b>	
			<b>Recommendations:- None</b>			
<b>Notes:-</b>

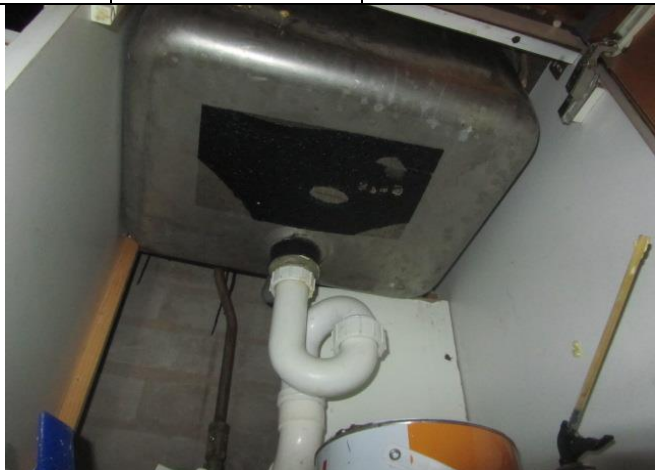
Floor	Room	Item/Area	Material	Asbestos Type	Sample Number		
First	Cleaners Store Top stairs	Sink Pad	Bitumen	Chrysotile(white)	2022653 L		
<b>Photo</b>			<b>Material Assessment</b>		<b>Priority Assessment</b>

<b>Product Type</b>	1	<b>Occupancy Activity</b>	0		
		<b>Extent of Damage</b>	1	<b>Accessibility</b>	0		
		<b>Surface Treatment</b>	0	<b>Exposure Potential</b>	0		
		<b>Asbestos Type</b>	1	<b>Maint Disturbance</b>	0		
		<b>Sub Total</b>	3	<b>Sub Total</b>	0		
						<b>Total</b>	<b>3</b>
		<b>Recommendations:- Remove sink and dispose of as contaminated waste</b>					
<b>Notes:-</b>

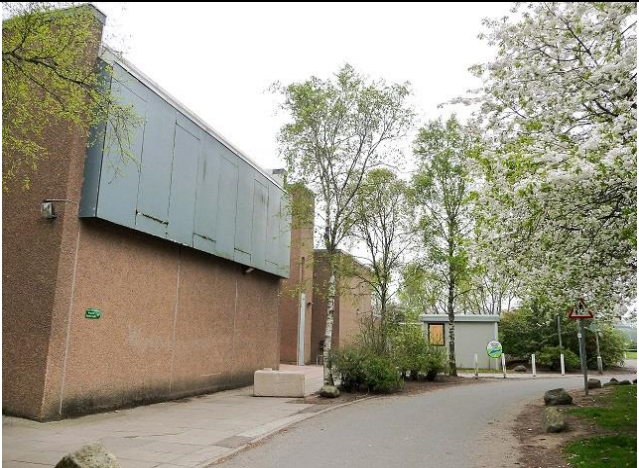
Floor	Room	Item/Area	Material	Asbestos Type	Sample Number	
External	Front Elevation	Blue Panels	Cement/Eternit	None Asbestos	2022653 M	
<b>Photo</b>

<b>Material Assessment</b>		<b>Priority Assessment</b>	
			<b>Product Type</b>		<b>Occupancy Activity</b>	
			<b>Extent of Damage</b>		<b>Accessibility</b>	
			<b>Surface Treatment</b>		<b>Exposure Potential</b>	
			<b>Asbestos Type</b>		<b>Maint Disturbance</b>	
			<b>Sub Total</b>		<b>Sub Total</b>	
					<b>Total</b>	
<b>Recommendations:- None</b>						
<b>Notes:-</b>

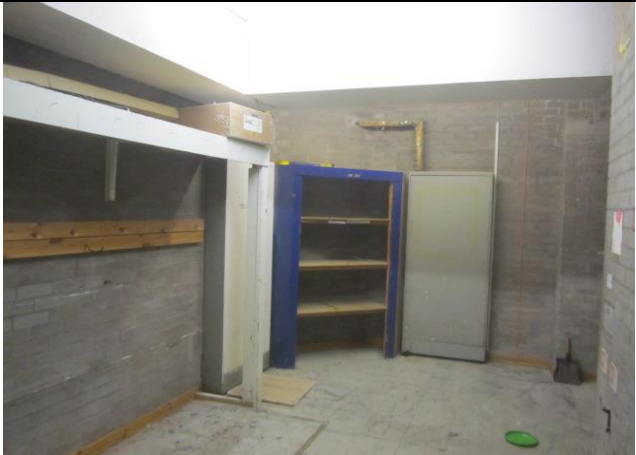
Floor	Room	Item/Area	Material	Asbestos Type	Sample Number	
Ground	Store Small Hall	Floor Tiles (Grey)/ 22 m2	Thermoplastic	SP- Chrysotile (white)	As per 2022653 B	
<b>Photo</b>			<b>Material Assessment</b>		<b>Priority Assessment</b>

<b>Product Type</b>	1	<b>Occupancy Activity</b>	0
			<b>Extent of Damage</b>	1	<b>Accessibility</b>	0
			<b>Surface Treatment</b>	0	<b>Exposure Potential</b>	0
			<b>Asbestos Type</b>	1	<b>Maint Disturbance</b>	0
			<b>Sub Total</b>	3	<b>Sub Total</b>	0
					<b>Total</b>	<b>3</b>
				<b>Recommendations:- Remove tiles prior to any works commencing</b>		
			<b>Notes:- Dispose of as contaminated waste</b> SP- Strongly Presumed

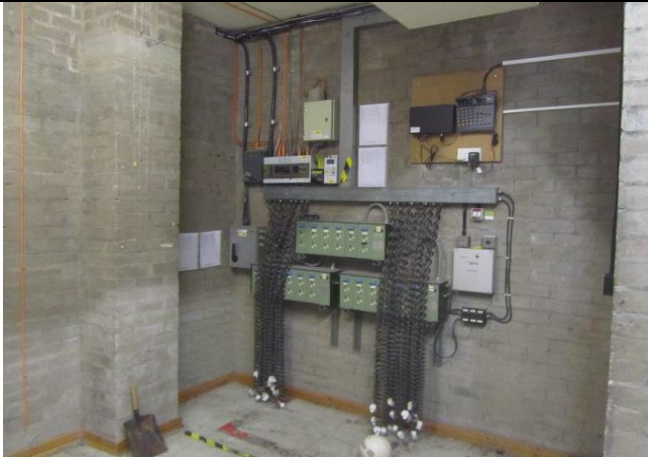
Floor	Room	Item/Area	Material	Asbestos Type	Sample Number		
Ground	Store Small Hall	Electrical switch gear, Flash guards	Cloth/cement	SP- Chrysotile (white)	None		
<b>Photo</b>					<b>Material Assessment</b>	<b>Priority Assessment</b>

<b>Product Type</b>	2	<b>Occupancy Activity</b>	0		
		<b>Extent of Damage</b>	0	<b>Accessibility</b>	0		
		<b>Surface Treatment</b>	0	<b>Exposure Potential</b>	0		
		<b>Asbestos Type</b>	1	<b>Maint Disturbance</b>	0		
		<b>Sub Total</b>	3	<b>Sub Total</b>	0		
						<b>Total</b>	<b>3</b>
		<p><b>Recommendations:-</b> Items to be checked once power supply isolated.</p> <p><b>Notes:-</b> Identified items to be removed and disposed of as contaminated waste. Old electrical switches know to contain items containing Asbestos</p>

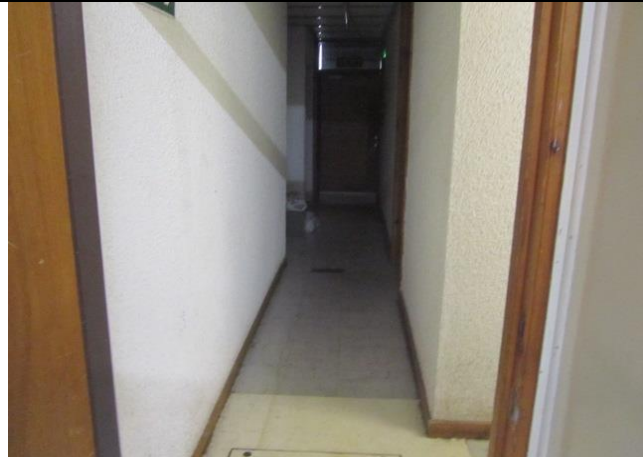
Floor	Room	Item/Area	Material	Asbestos Type	Sample Number	
Ground	Corridor to Rear small hall	Floor Tiles/13 m2	Thermoplastic	SP- Chrysotile (white)	As per 2022653 B	
<b>Photo</b>			<b>Material Assessment</b>		<b>Priority Assessment</b>

<b>Product Type</b>	1	<b>Occupancy Activity</b>	0
			<b>Extent of Damage</b>	1	<b>Accessibility</b>	0
			<b>Surface Treatment</b>	0	<b>Exposure Potential</b>	0
			<b>Asbestos Type</b>	1	<b>Maint Disturbance</b>	0
			<b>Sub Total</b>	3	<b>Sub Total</b>	0
					<b>Total</b>	<b>3</b>
			<b>Recommendations:- Remove tiles prior to any works commencing</b>			
<b>Notes:- Dispose of as contaminated waste</b> SP- Strongly Presumed

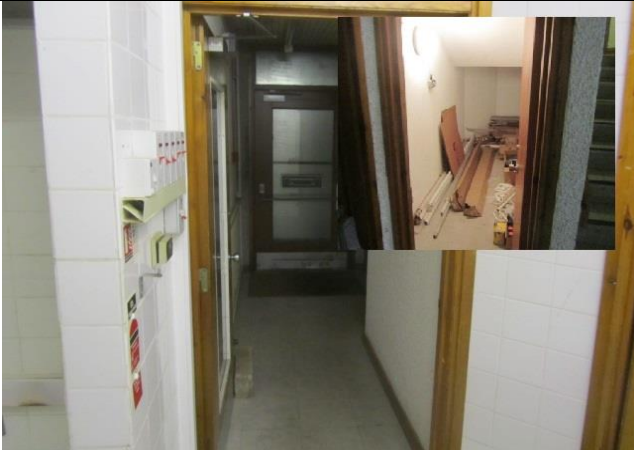
Floor	Room	Item/Area	Material	Asbestos Type	Sample Number	
Ground	Corridor/store From kitchen	Floor Tiles/ 7 m2	Thermoplastic	SP- Chrysotile (white)	As per 2022653 B	
<b>Photo</b>						<b>Material Assessment</b>

<b>Product Type</b>	1	<b>Occupancy Activity</b>	0	
		<b>Extent of Damage</b>	1	<b>Accessibility</b>	0	
		<b>Surface Treatment</b>	0	<b>Exposure Potential</b>	0	
		<b>Asbestos Type</b>	1	<b>Maint Disturbance</b>	0	
		<b>Sub Total</b>	3	<b>Sub Total</b>	0	
					<b>Total</b>	<b>3</b>
		<b>Recommendations:- Remove tiles prior to any works commencing</b>				
<b>Notes:- Dispose of as contaminated waste</b> SP- Strongly Presumed

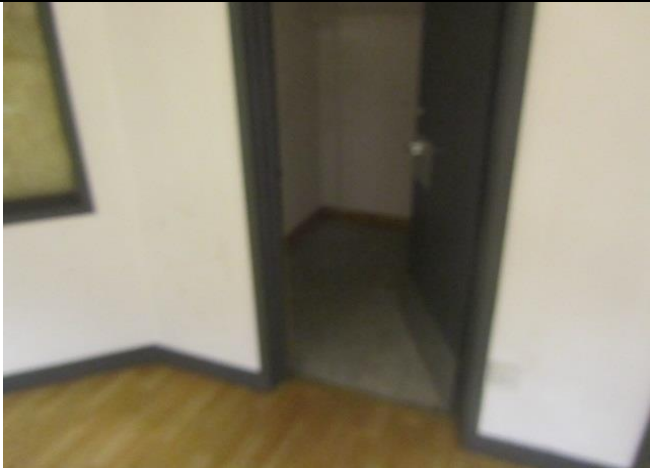
Floor	Room	Item/Area	Material	Asbestos Type	Sample Number	
First	Store	Floor Tiles/ 2 m2	Thermoplastic	SP- Chrysotile (white)	As per 2022653 B	
<b>Photo</b>			<b>Material Assessment</b>		<b>Priority Assessment</b>

<b>Product Type</b>	1	<b>Occupancy Activity</b>	0
			<b>Extent of Damage</b>	1	<b>Accessibility</b>	0
			<b>Surface Treatment</b>	0	<b>Exposure Potential</b>	0
			<b>Asbestos Type</b>	1	<b>Maint Disturbance</b>	0
			<b>Sub Total</b>	3	<b>Sub Total</b>	0
					<b>Total</b>	<b>3</b>
				<b>Recommendations:- Remove files prior to any works commencing</b>		
			<b>Notes:- Dispose of as contaminated waste</b> SP- Strongly Presumed

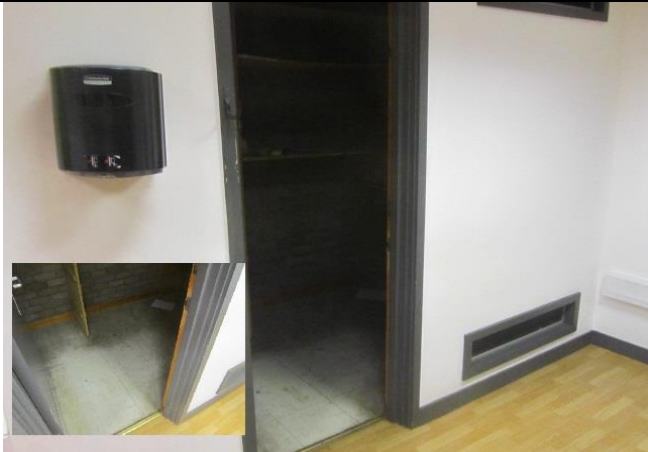
Floor	Room	Item/Area	Material	Asbestos Type	Sample Number		
First	Studio Store	Floor Tiles/ 4 m2	Thermoplastic	SP- Chrysotile (white)	As per 2022653 B		
<b>Photo</b>			<b>Material Assessment</b>		<b>Priority Assessment</b>

<b>Product Type</b>	1	<b>Occupancy Activity</b>	0		
		<b>Extent of Damage</b>	1	<b>Accessibility</b>	0		
		<b>Surface Treatment</b>	0	<b>Exposure Potential</b>	0		
		<b>Asbestos Type</b>	1	<b>Maint Disturbance</b>	0		
		<b>Sub Total</b>	3	<b>Sub Total</b>	0		
						<b>Total</b>	<b>3</b>
		<b>Recommendations:- Remove files prior to any works commencing</b>					
<b>Notes:- Dispose of as contaminated waste</b> SP- Strongly Presumed

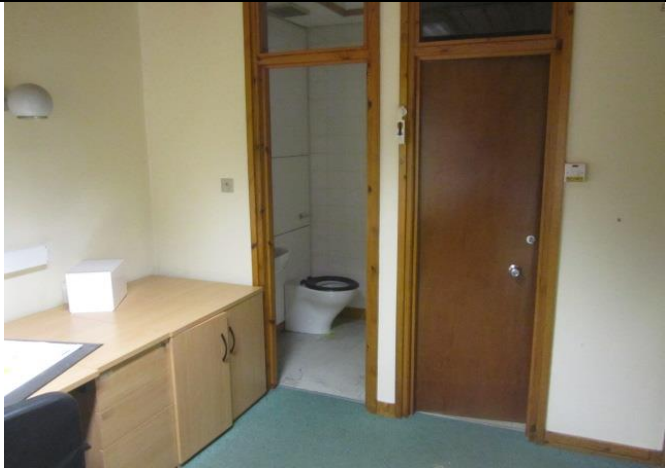
Floor	Room	Item/Area	Material	Asbestos Type	Sample Number
First	Studio office/ Store, WC	Floor Tiles/4 m2 Store, WC	Thermoplastic	SP- Chrysotile (white)	As per 2022653 B
<b>Photo</b>			<b>Material Assessment</b>		<b>Priority Assessment</b>

<b>Product Type</b>	1	<b>Occupancy Activity</b>	0
		<b>Extent of Damage</b>	1	<b>Accessibility</b>	0
		<b>Surface Treatment</b>	0	<b>Exposure Potential</b>	0
		<b>Asbestos Type</b>	1	<b>Maint Disturbance</b>	0
		<b>Sub Total</b>	3	<b>Sub Total</b>	0
				<b>Total</b>	<b>3</b>
		<b>Recommendations:- Remove files prior to any works commencing</b>			
<b>Notes:- Dispose of as contaminated waste</b> SP- Strongly Presumed

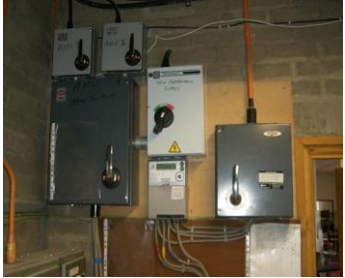
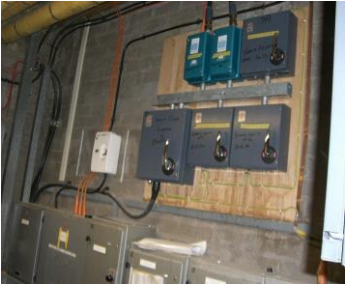
Floor	Room	Item/Area	Material	Asbestos Type	Sample Number		
External	Weight room Electrical switch room	Electrical switch gear, Flash guards	Cloth/Cement	SP- Chrysotile (white)	None		
<b>Photo</b>			<b>Material Assessment</b>		<b>Priority Assessment</b>

<b>Product Type</b>		2	<b>Occupancy Activity</b>	0	
		<b>Extent of Damage</b>		0	<b>Accessibility</b>	0

<b>Surface Treatment</b>		0	<b>Exposure Potential</b>	0	
		<b>Asbestos Type</b>		1	<b>Maint Disturbance</b>	0	
		<b>Sub Total</b>		3	<b>Sub Total</b>	0	
						<b>Total</b>	<b>3</b>
<p><b>Recommendations:-</b> Items to be checked once power supply isolated.</p>							
<p><b>Notes:-</b> Identified items to be removed and disposed of as contaminated waste.</p> <p>Old electrical switches know to contain items containing Asbestos</p>
