**Summary of Primary Defects Report
of**

**Panmure Centre
141 Kinloch Street
Carnoustie
DD7 7JP**

Angus Council

February 2021

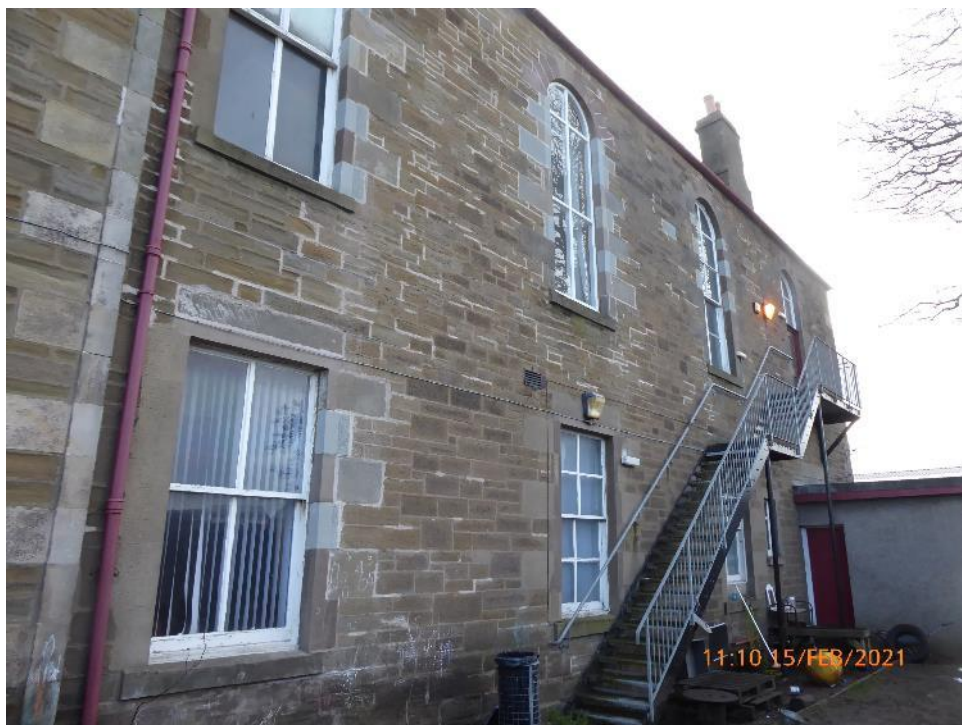
6. Evidence of previous repointing

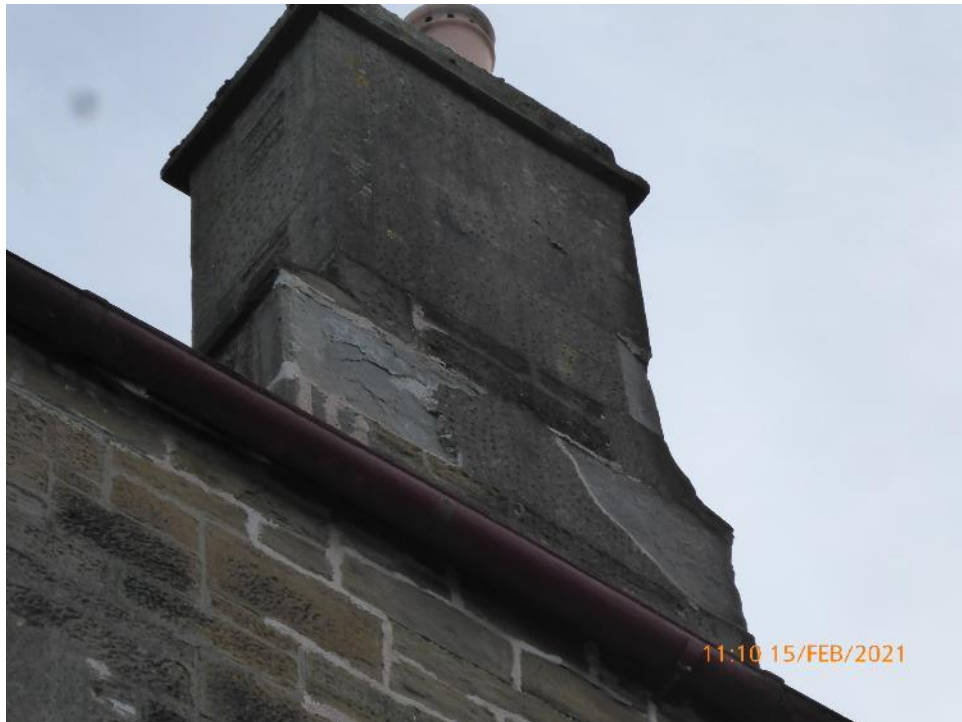
- h) The masonry walls are generally in fair condition, with scaling and erosion that is consistent with its age. Isolated stone is heavily eroded and would benefit from repair and/or replacement. Isolated cracking of lintols/sills and stone work was identified. All loose stone should be removed in the short term. Where traditionally mortar pointing has been utilised, it is strongly recommended that it is replaced with similar mortar when repointing. Modern mortar is not recommended due to its impervious characteristics which may accelerate deterioration of the adjacent masonry/brickwork.

7. Dislodged stone

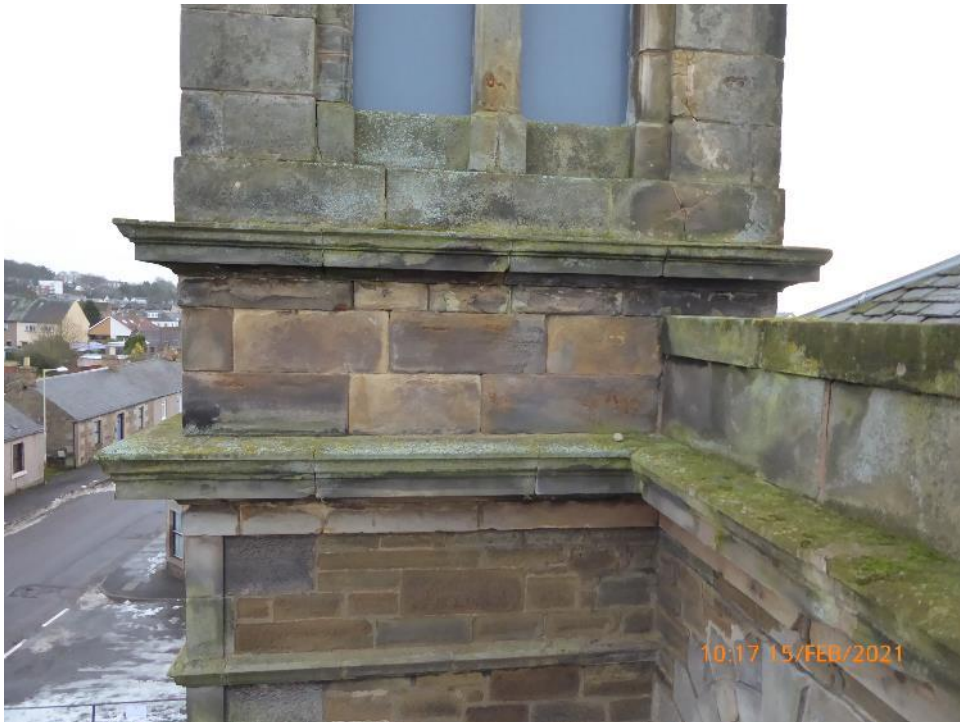
9. Erosion and missing pointing

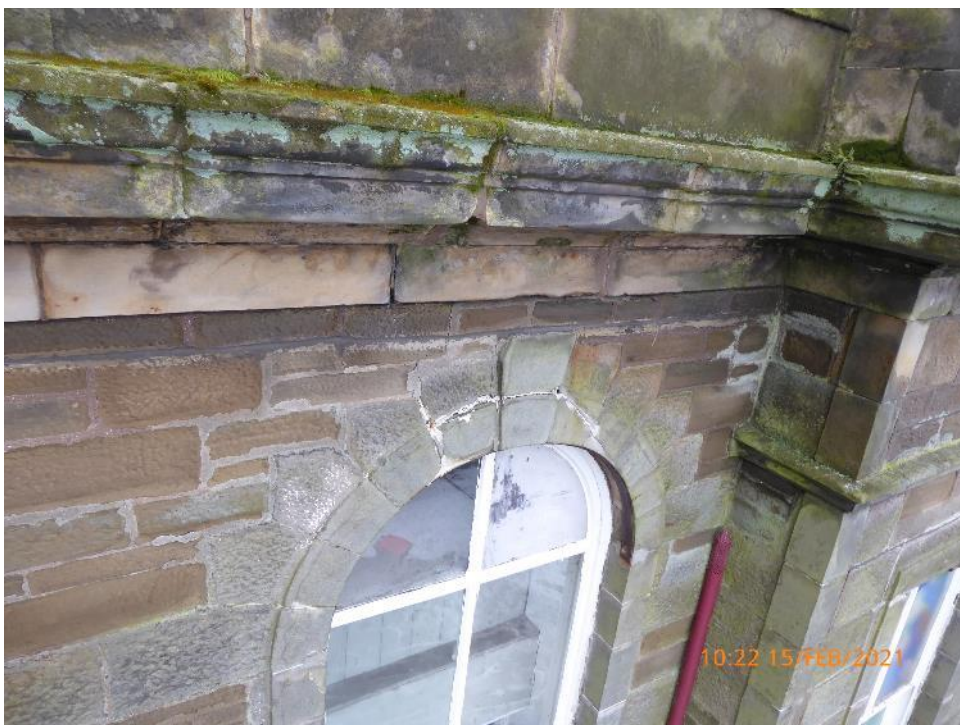
10. Erosion and missing pointing

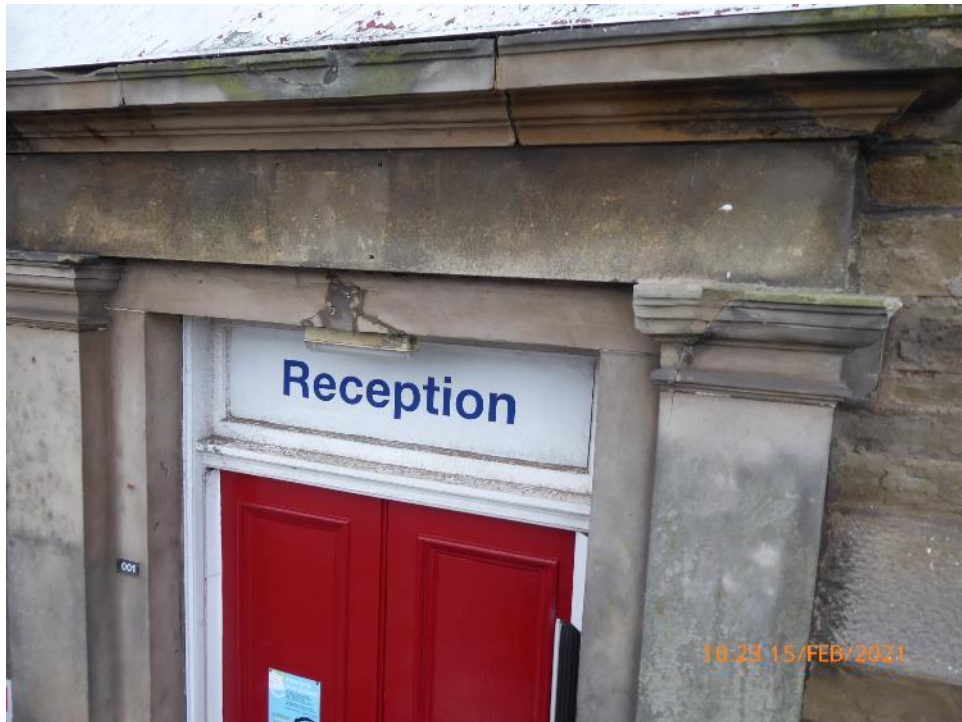
- i) We identified localised cracking of lintols/sills and stone work. We consider the cracking to be longstanding, and does not appear to affect the structural integrity of the subjects, however, we are not engineers and consideration should be given to appointing an engineer to undertake a detailed inspection prior to undertaking any necessary remedial works.
- j) There is an external metal framed fire escape stair. The stair is soiled with minor vegetation accumulation, and would benefit from regular routine maintenance/cleaning.
- k) Windows generally comprise timber single glazed units. 4 Nr. first floor windows have been partly repaired, however, we recommend all windows are thoroughly overhauled and repaired (but we recommend you budget for removal and replacement with modern double glazing units).

11. Cracked pillar

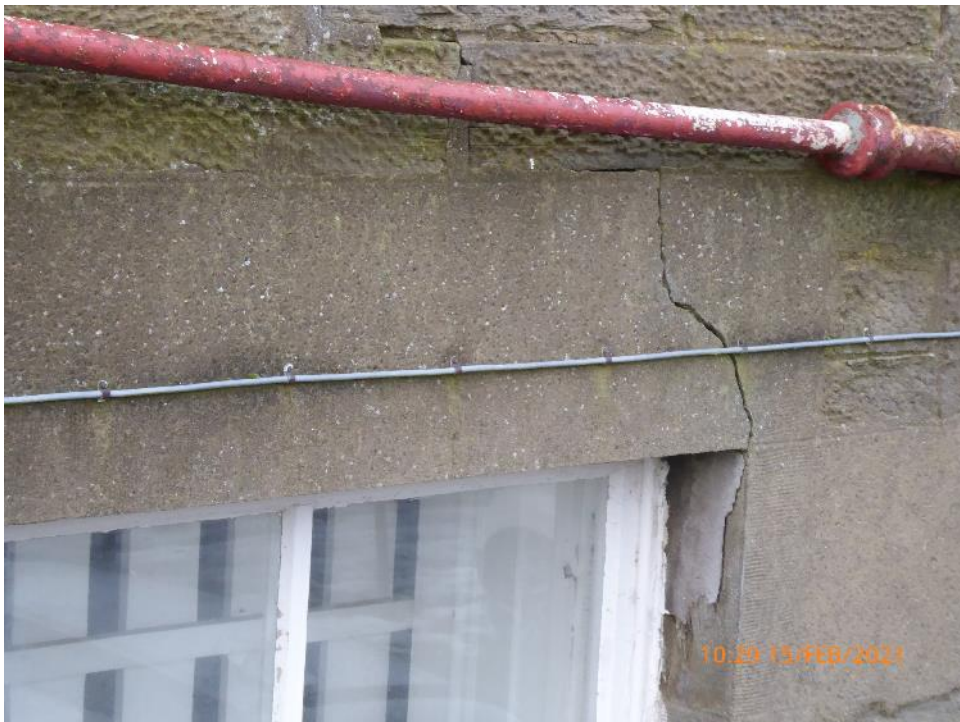
12. Cracking to head of window

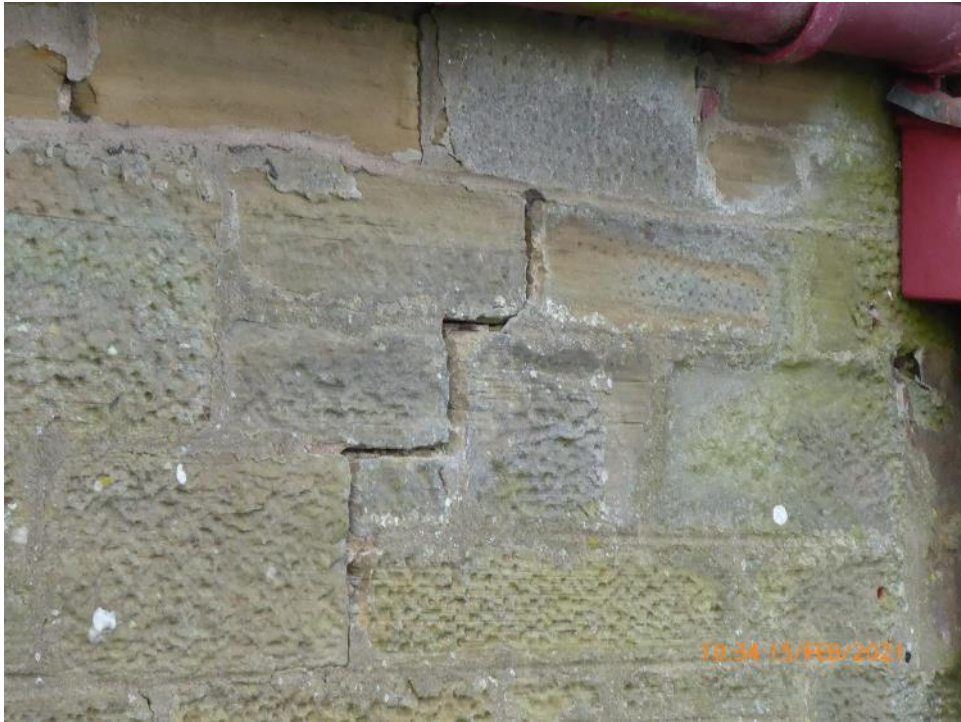
13. Cracking to east elevation

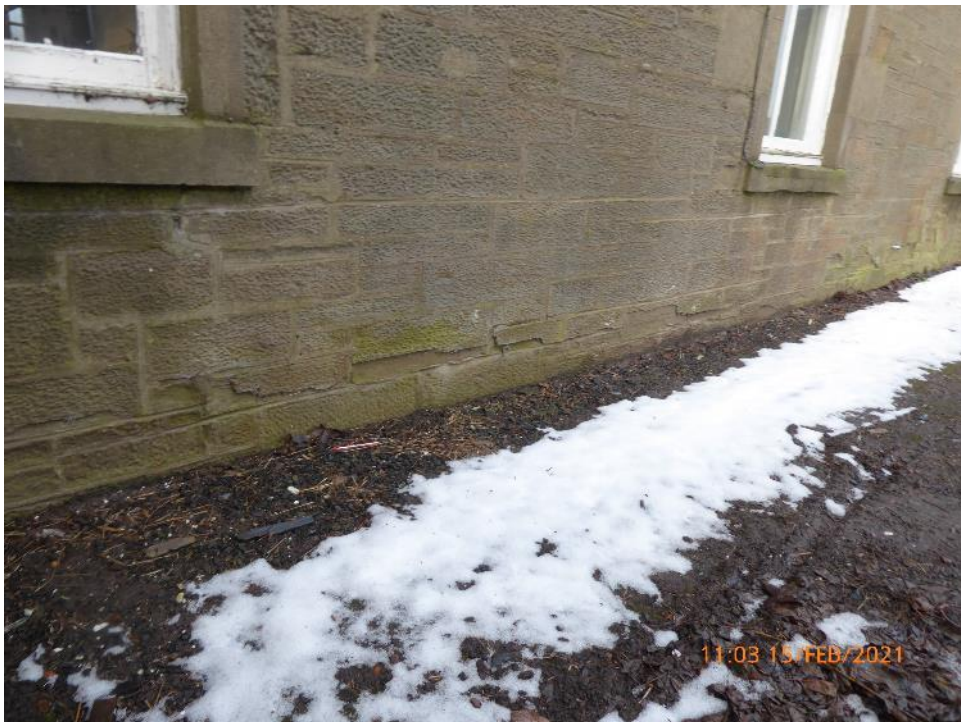
14. Typical low level erosion

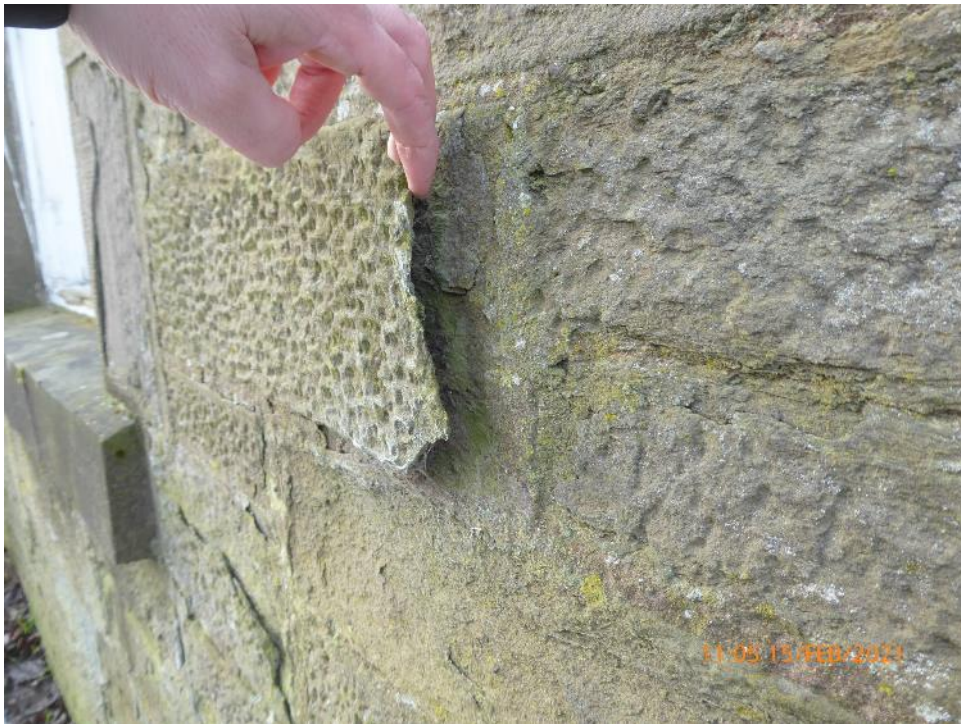
15. Typical scaling of stone

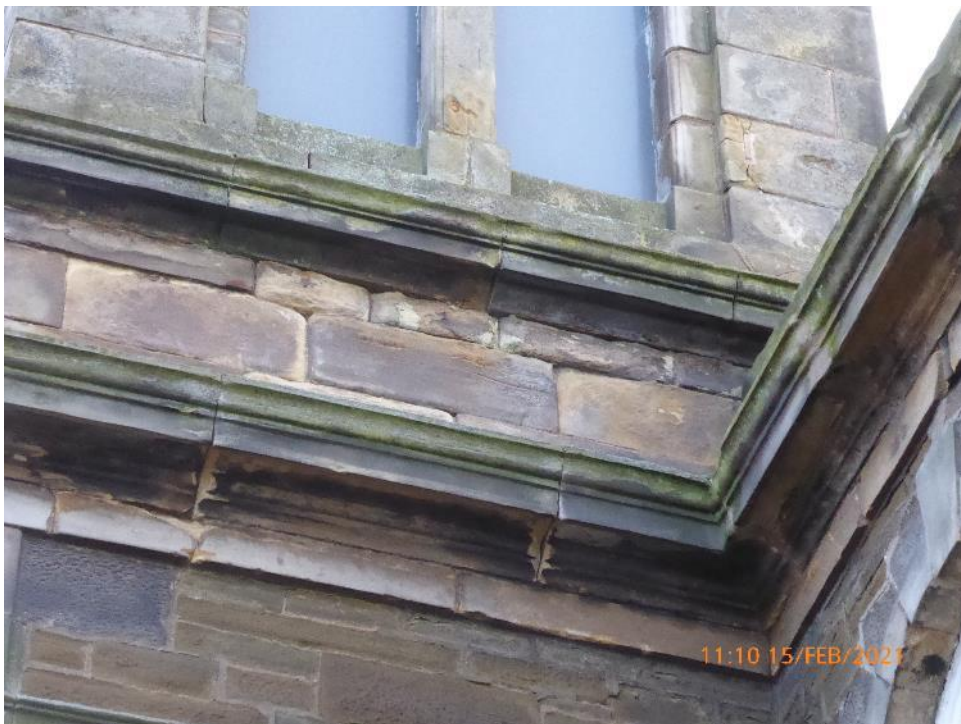
16. Erosion and missing pointing

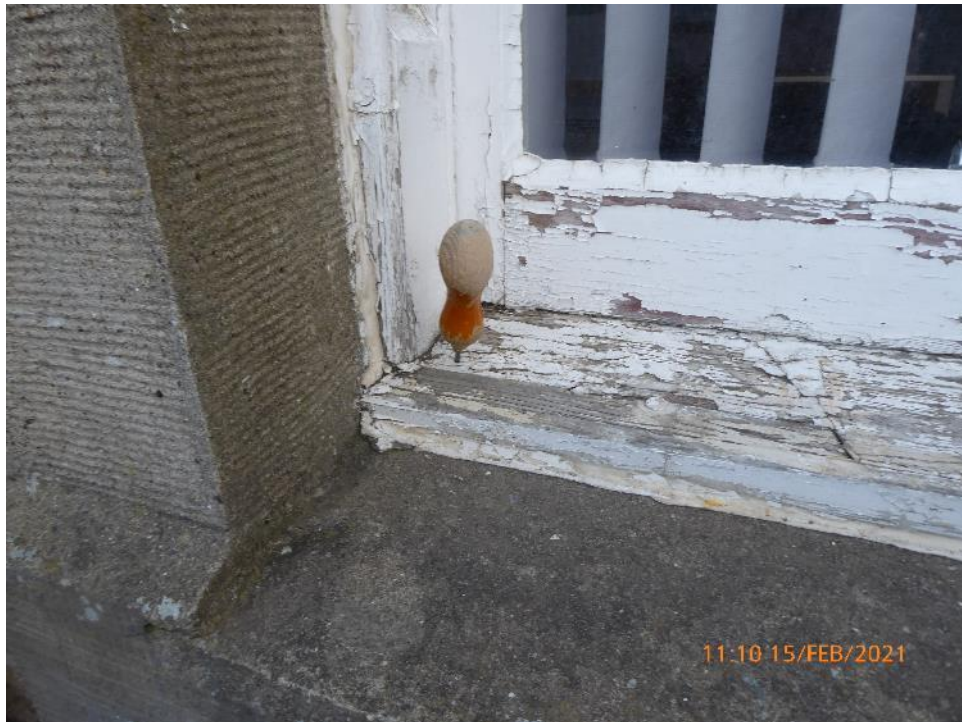
17. Typical softening of timbers

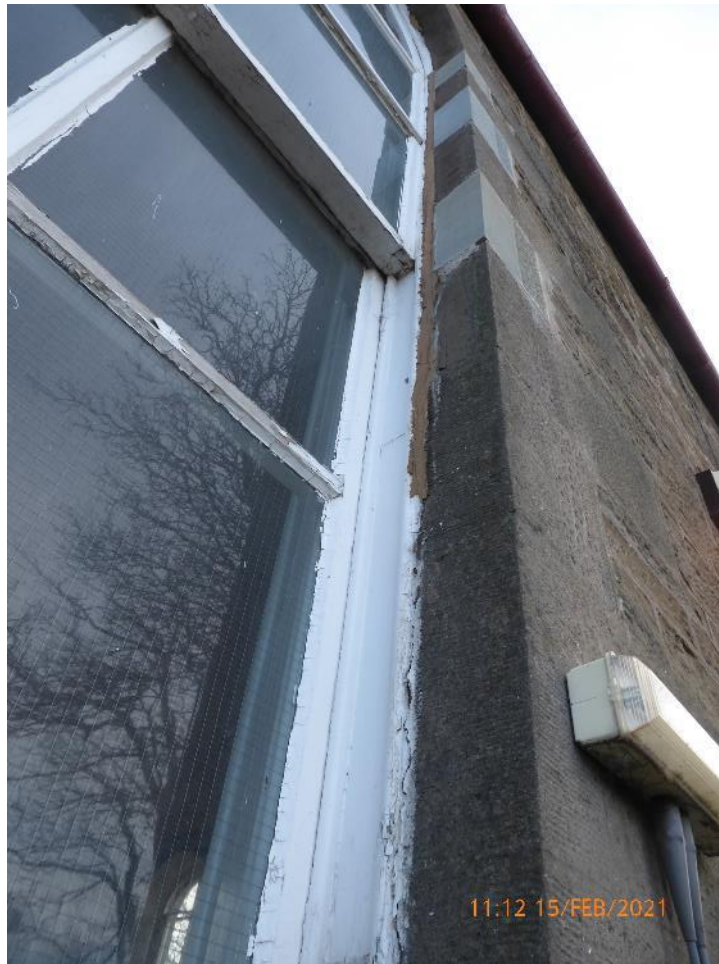
18. Loose/missing and dislodged pointing around window

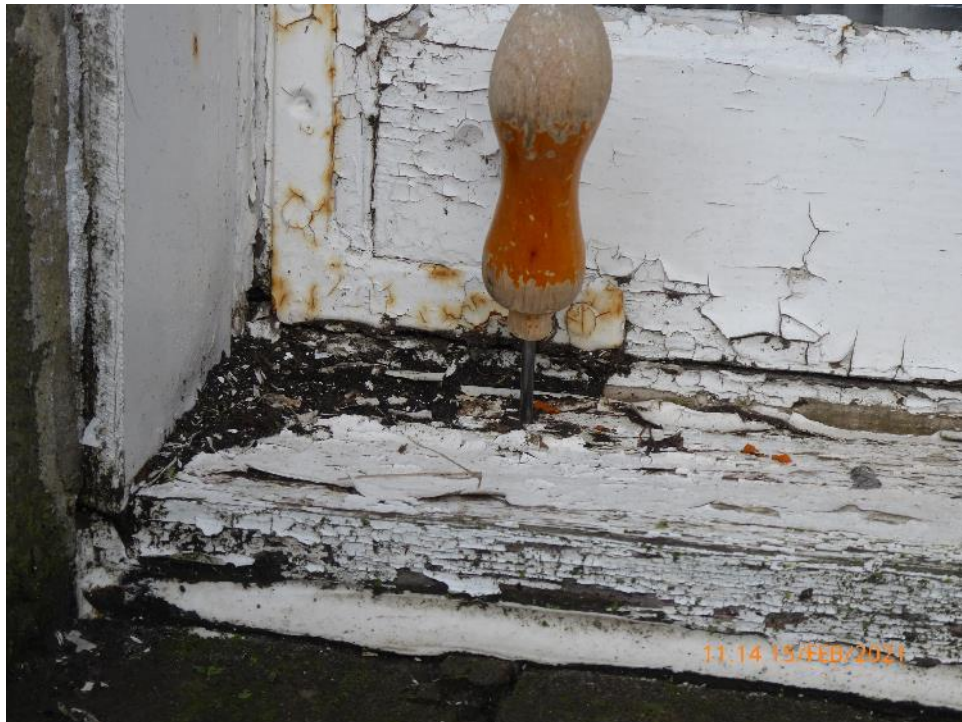
19. Decay (and previous patch repair)

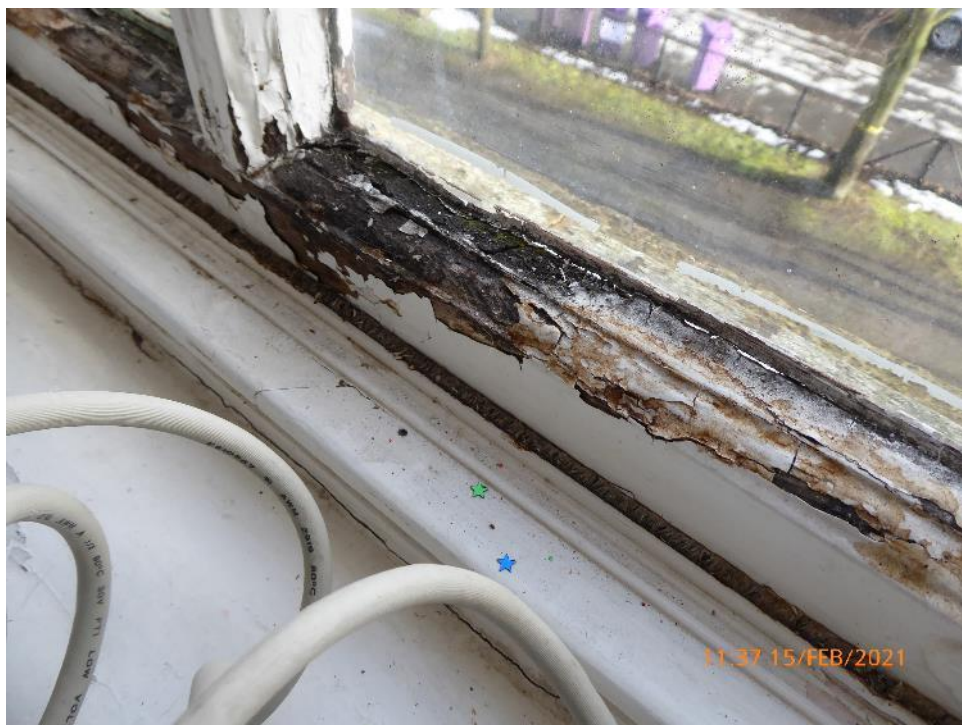
20. Decay and missing putties

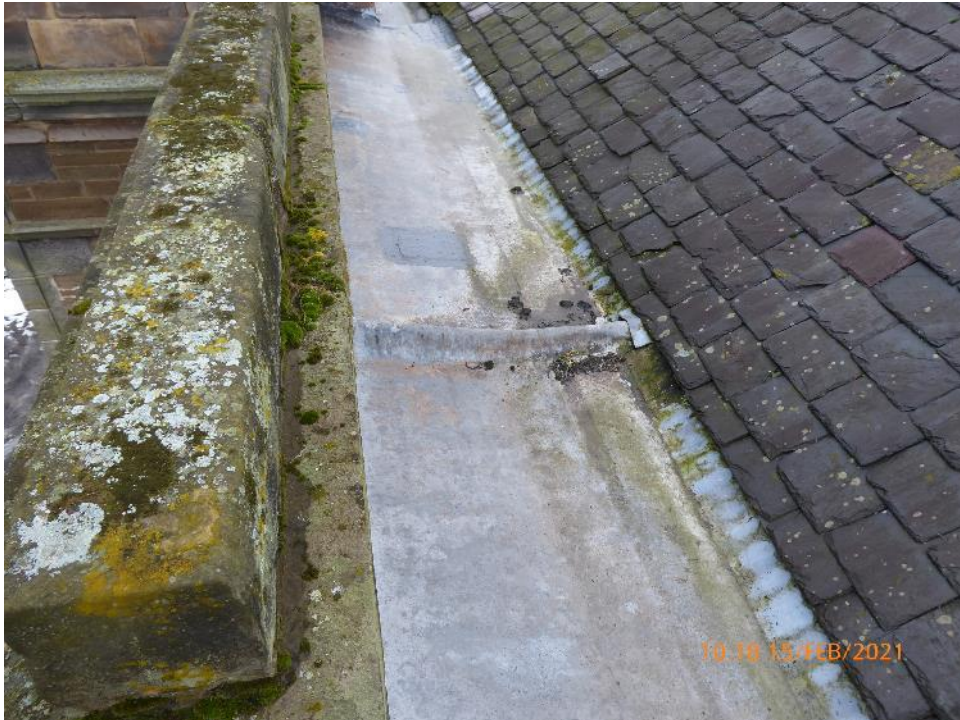
- c) We identified a number of patch repairs to the lead roof coverings, flashings and parapets/parapet upstands. Mineral felt makeshift repairs were identified to the rear of certain chimney heads. It is apparent that certain detailing is suspect, and therefore we recommend that all lead works be replaced when the roof is stripped and renewed.

21. Patch repairs to lead

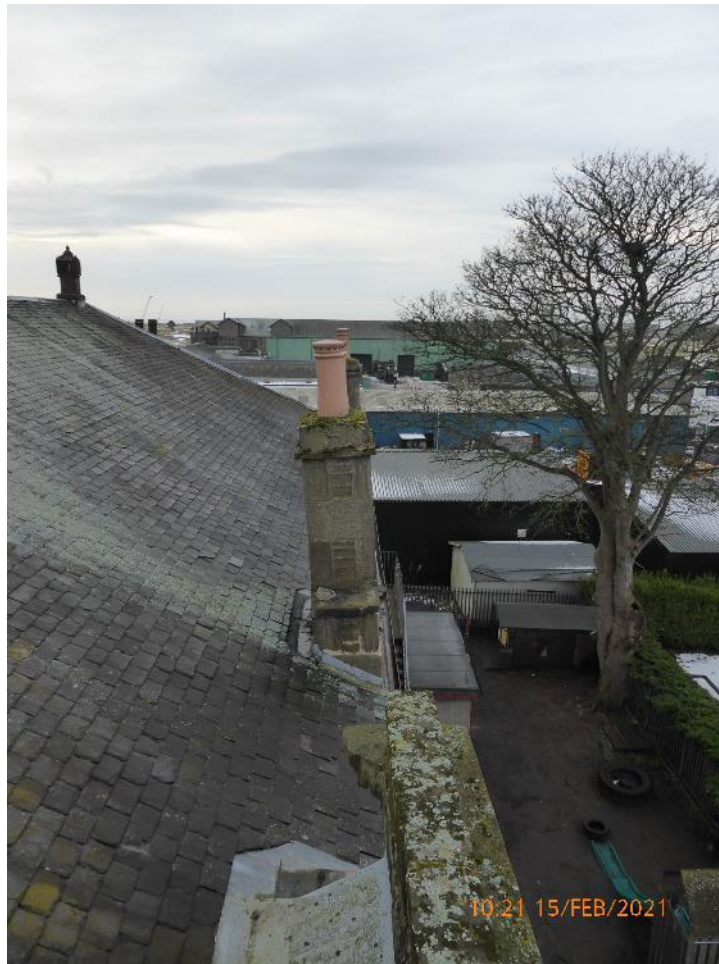
23. Typical leaning chimneyhead

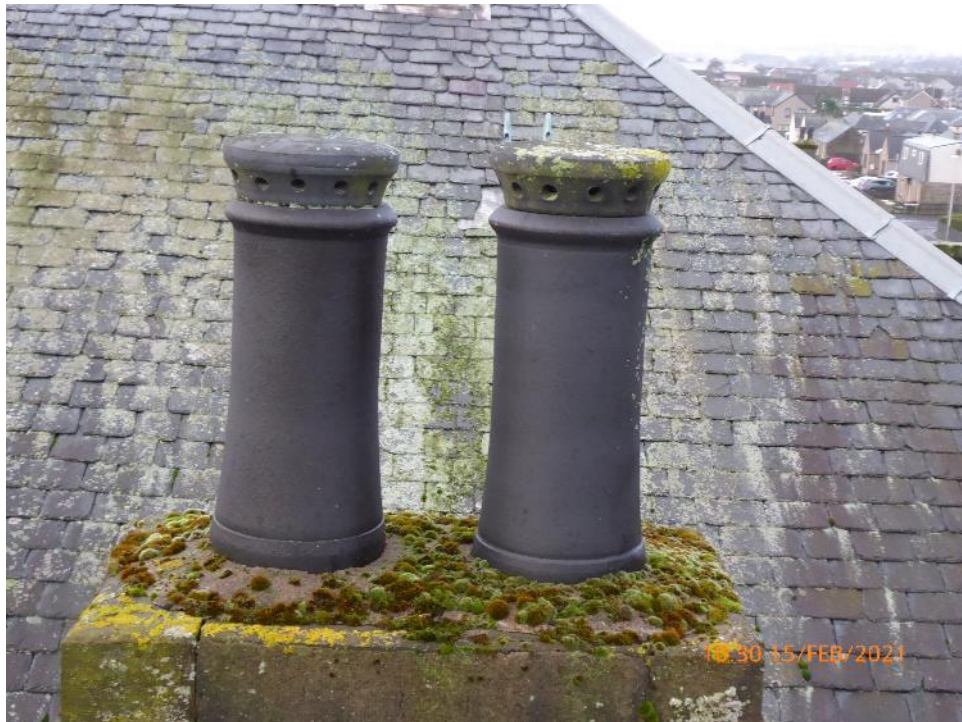
Cement flashing to base of chimneypots are cracked and would benefit from being hacked off and replaced.

24. Cracking of flaunching

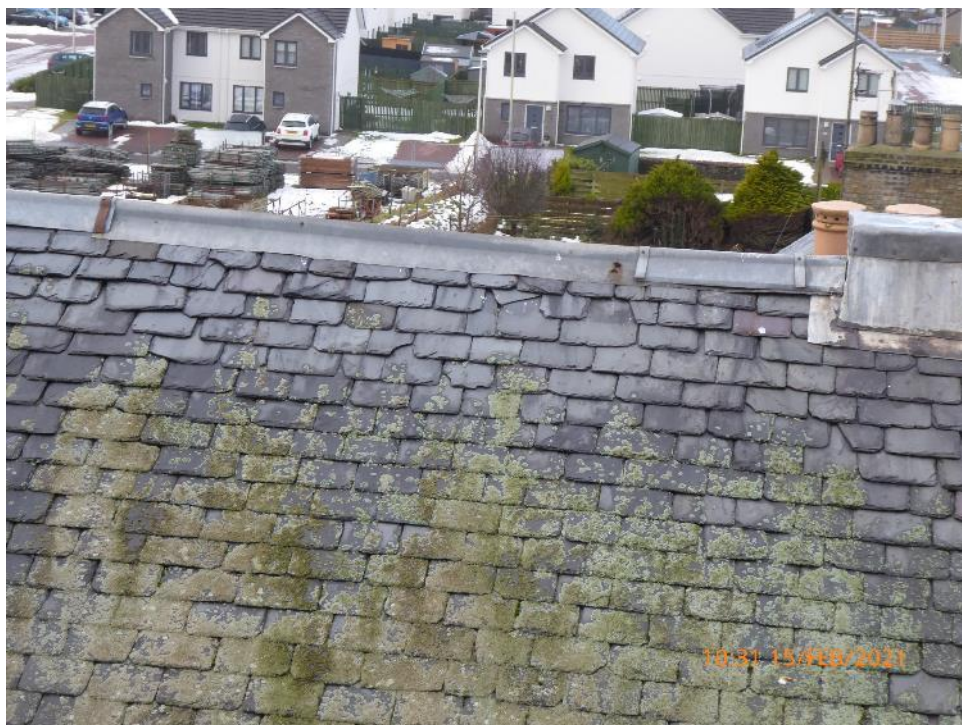
- a) Inspection of the slate roof coverings from cherry picker revealed slating to be generally intact, but with isolated loose, missing, chipped and dislodged slates. We suspect that the nail fixings are nearing the end of their life expectancy (and we did not identify under slating felt, when viewed from within the roof void– indicating the roof has unlikely to have been recovered during its life). Whilst regular ongoing maintenance should ensure that the slate covering lasts for a further number of years you should budget for its stripping and renewal as part of any modernisation and refurbishment.

25. Loose, missing and dislodged slates

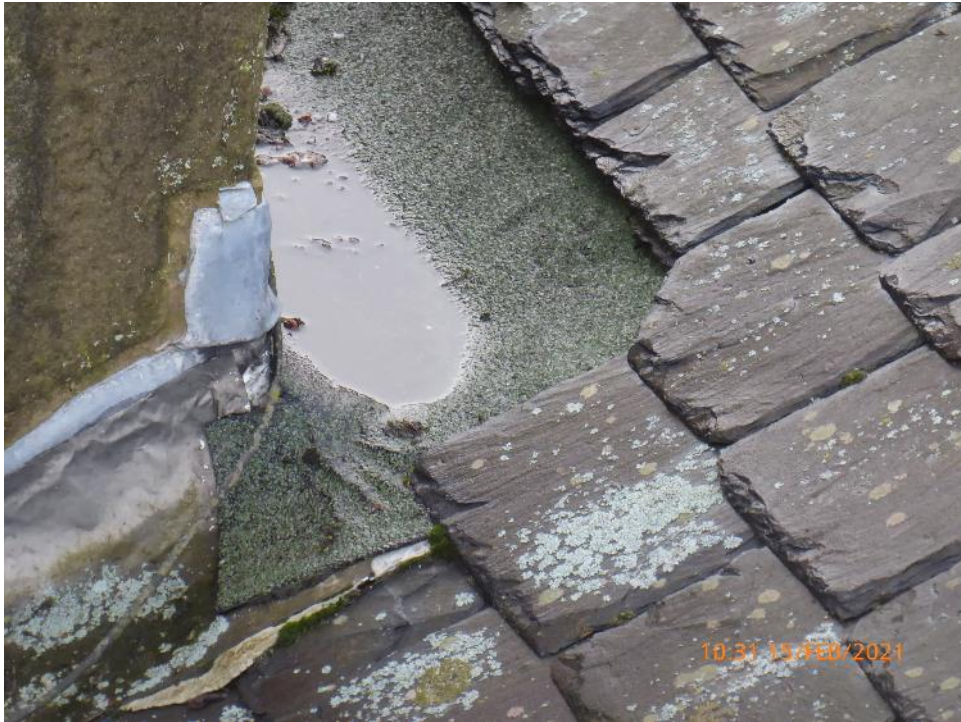
26. Temporary felt repair to rear of chimneyhead

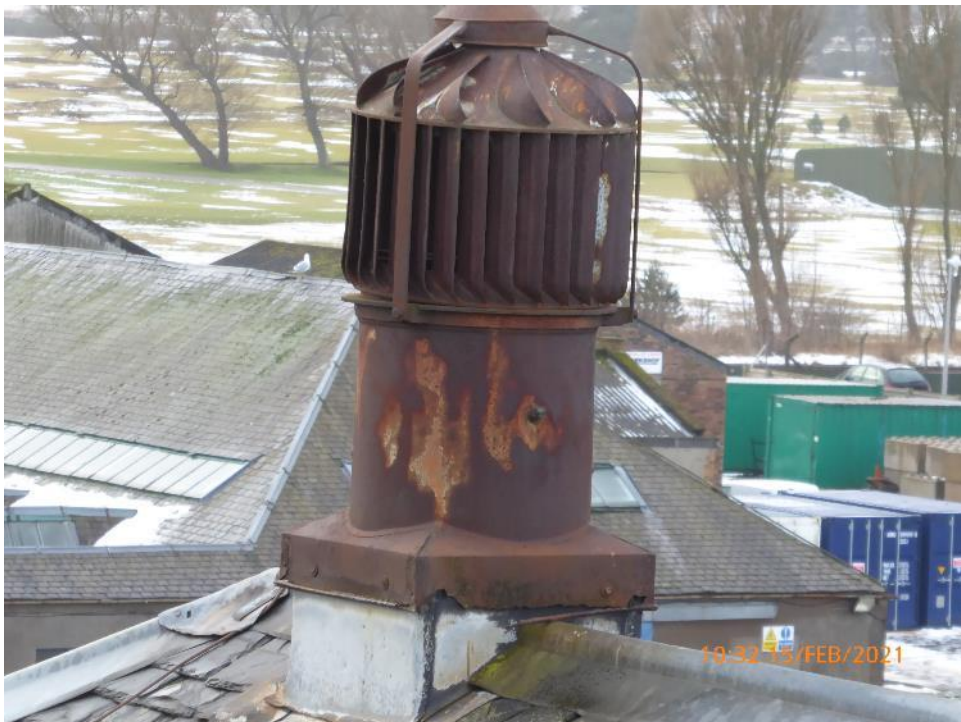
- e) The metal ridge vent to the south side of the roof is heavily corroded and would benefit from renewal in the short term.

27. Heavily corroded roof vent

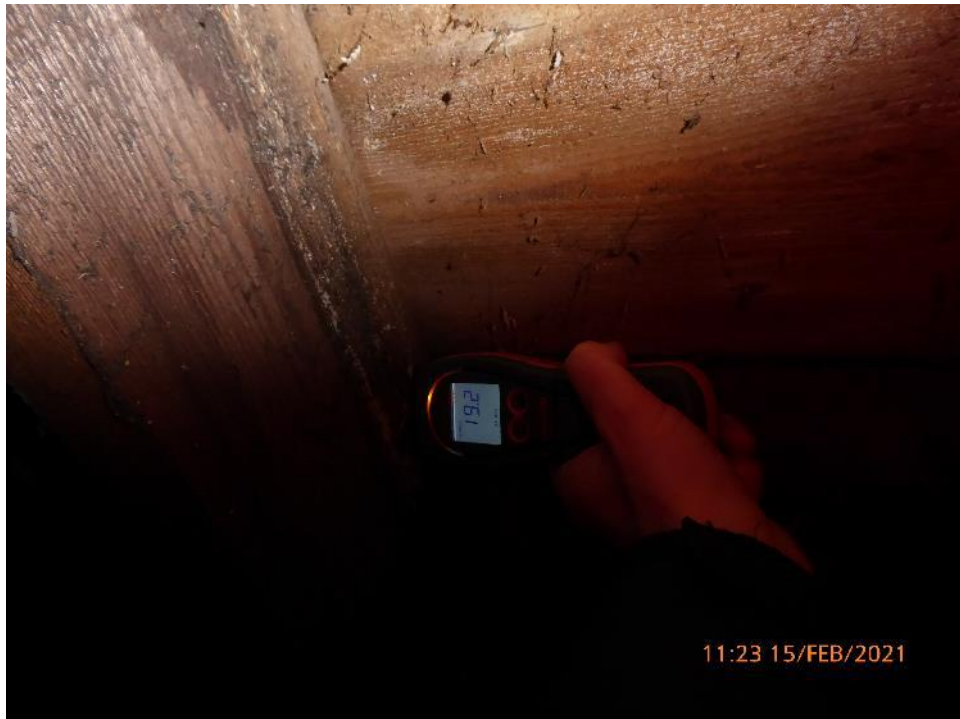
- g) Isolated high moisture meter readings/water staining was identified in a number of locations throughout, including but not restricted to the underside of the roof structure, and areas directly below. The roofline undulates in areas and isolated floors are lively under foot traffic, and it is possible that corresponding concealed timbers may be decaying. In view of the aforementioned, we recommend you instruct a timber specialist to undertake an inspection of the property, provide a costed report and undertake all recommendations contained therein.

28. High moisture meter readings to roof timbers

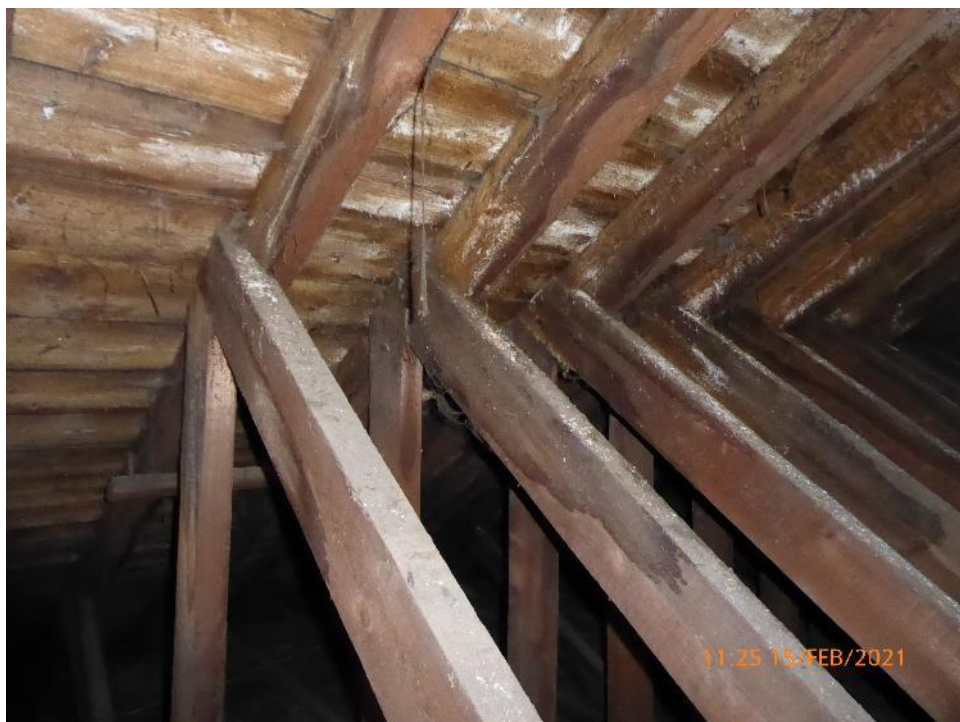
29. Water staining of roof timbers

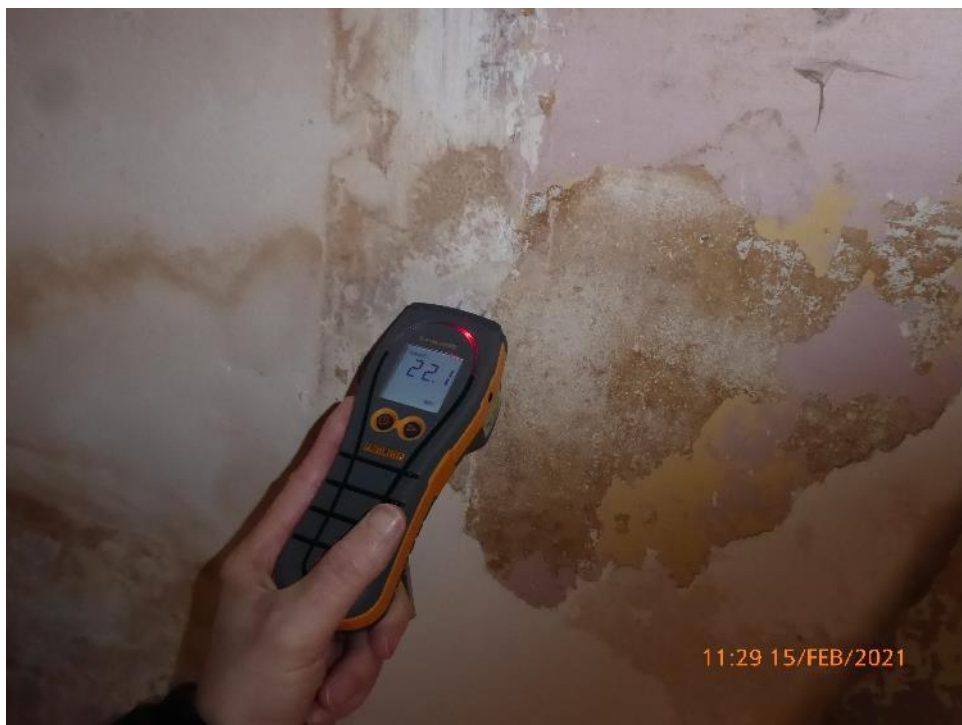
31. High moisture meter readings within attic

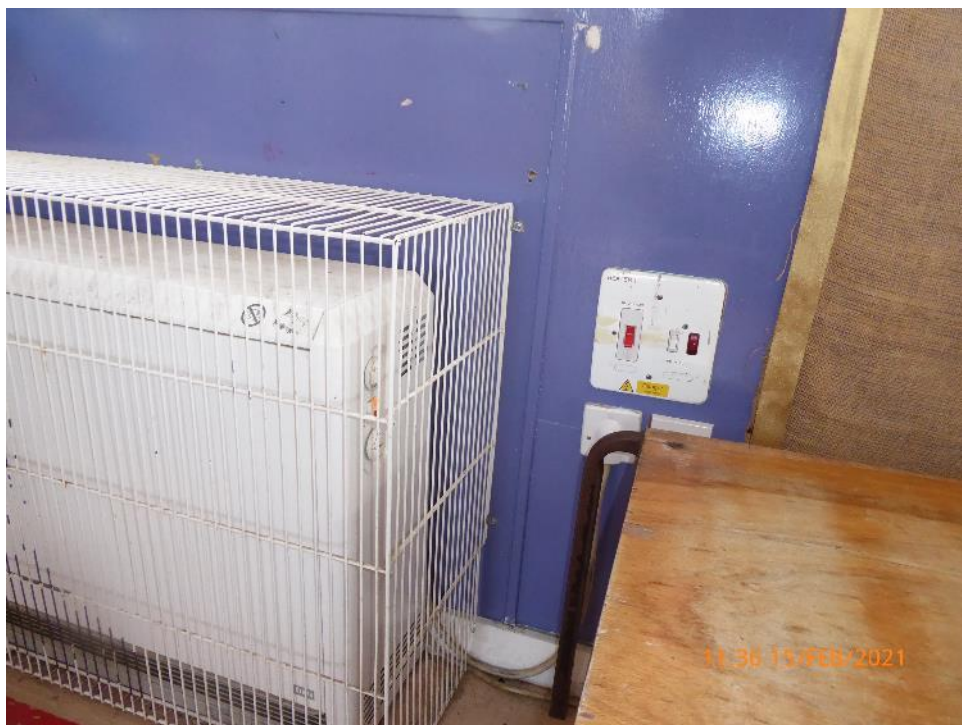
35. Aged electrical heating

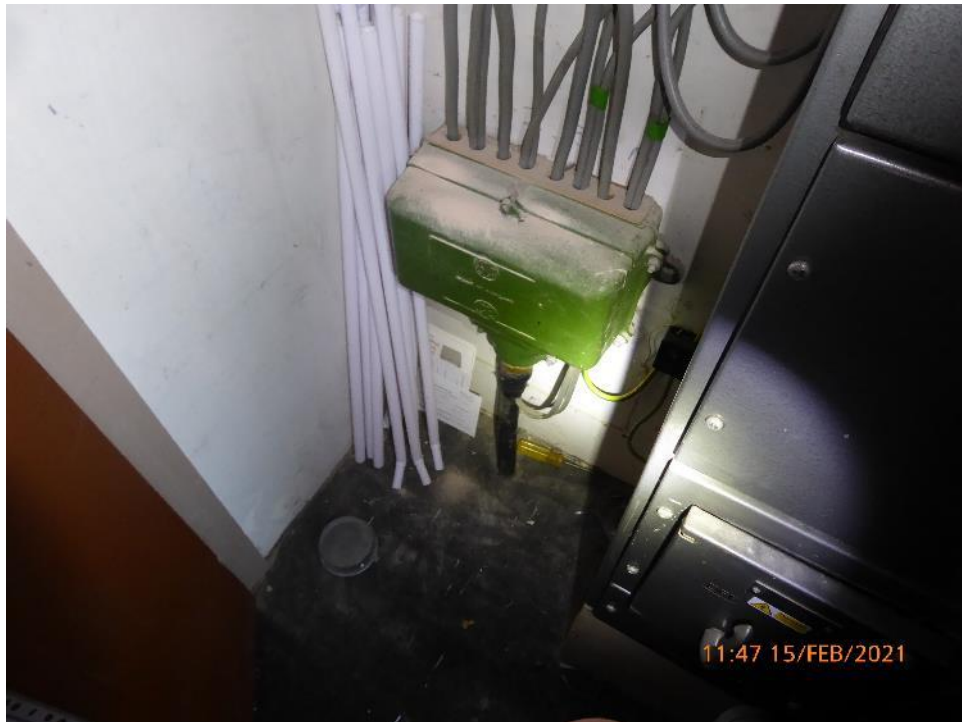
38. Aged electrical supply

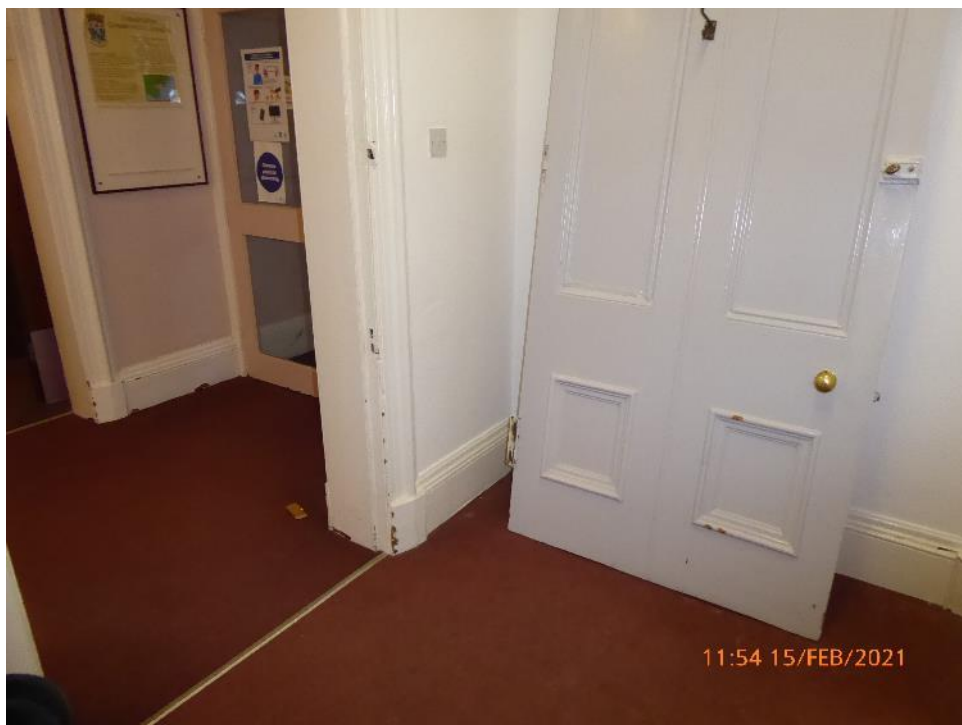
41. Previously removed door
