Appendix 2

Further details of the route

Description of the route

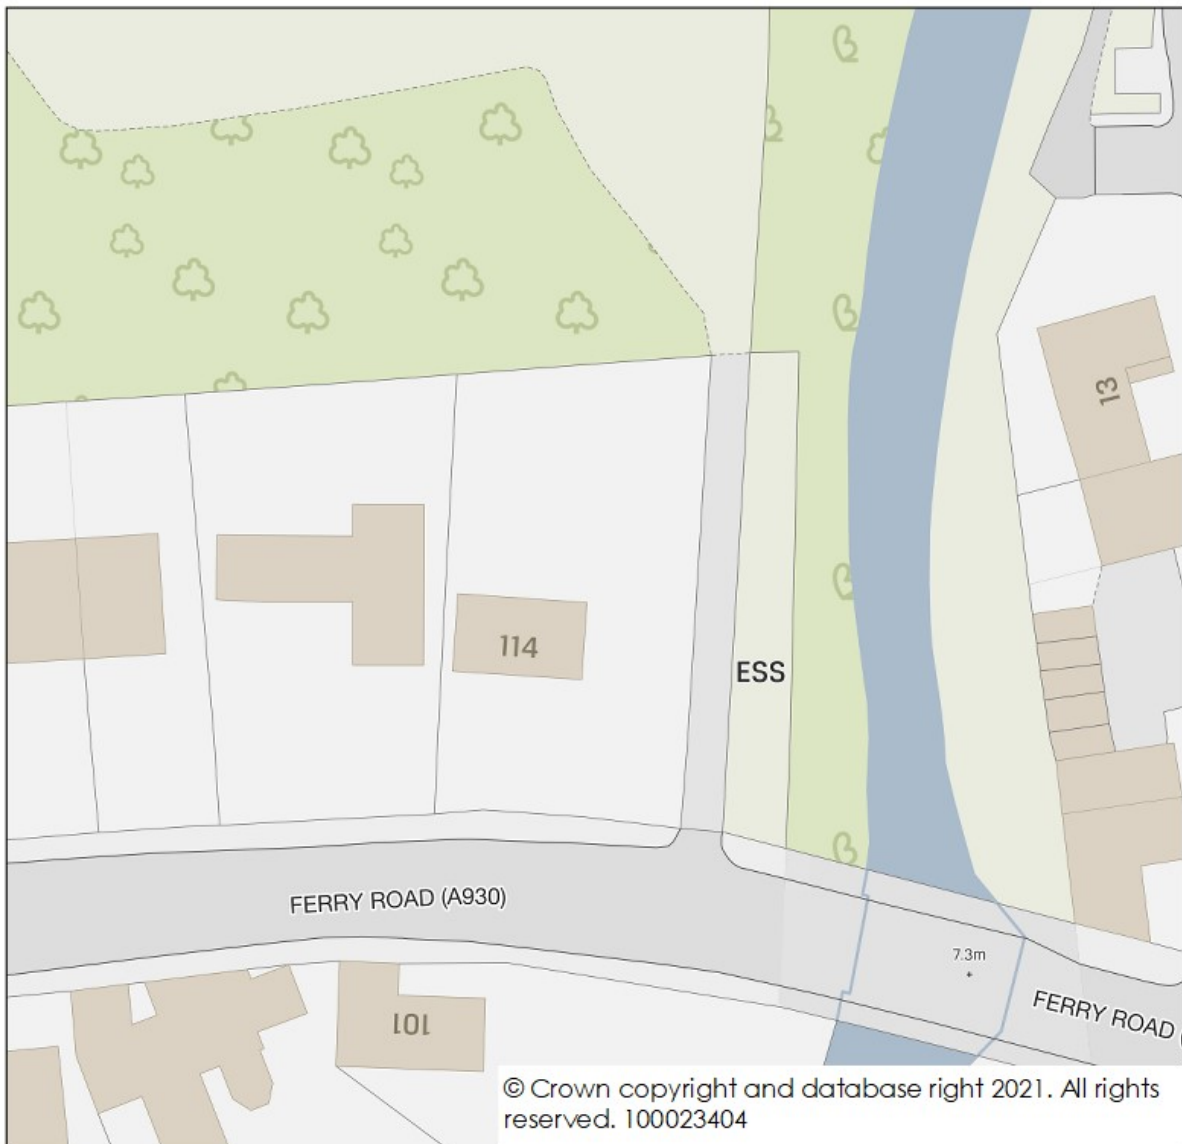
Current detailed Ordnance Survey map

The tracked is mapped as a defined narrow rectangular area running from north to south. The garden of 114 Ferry Road to the west and the electricity sub-station (labelled ESS) to the east are mapped as having a different surface type to the track (represented by different coloured shading). The eastern

and western sides of the track, and its southern extend, are mapped with solid boundary lines. The northern end is mapped with a dashed line.

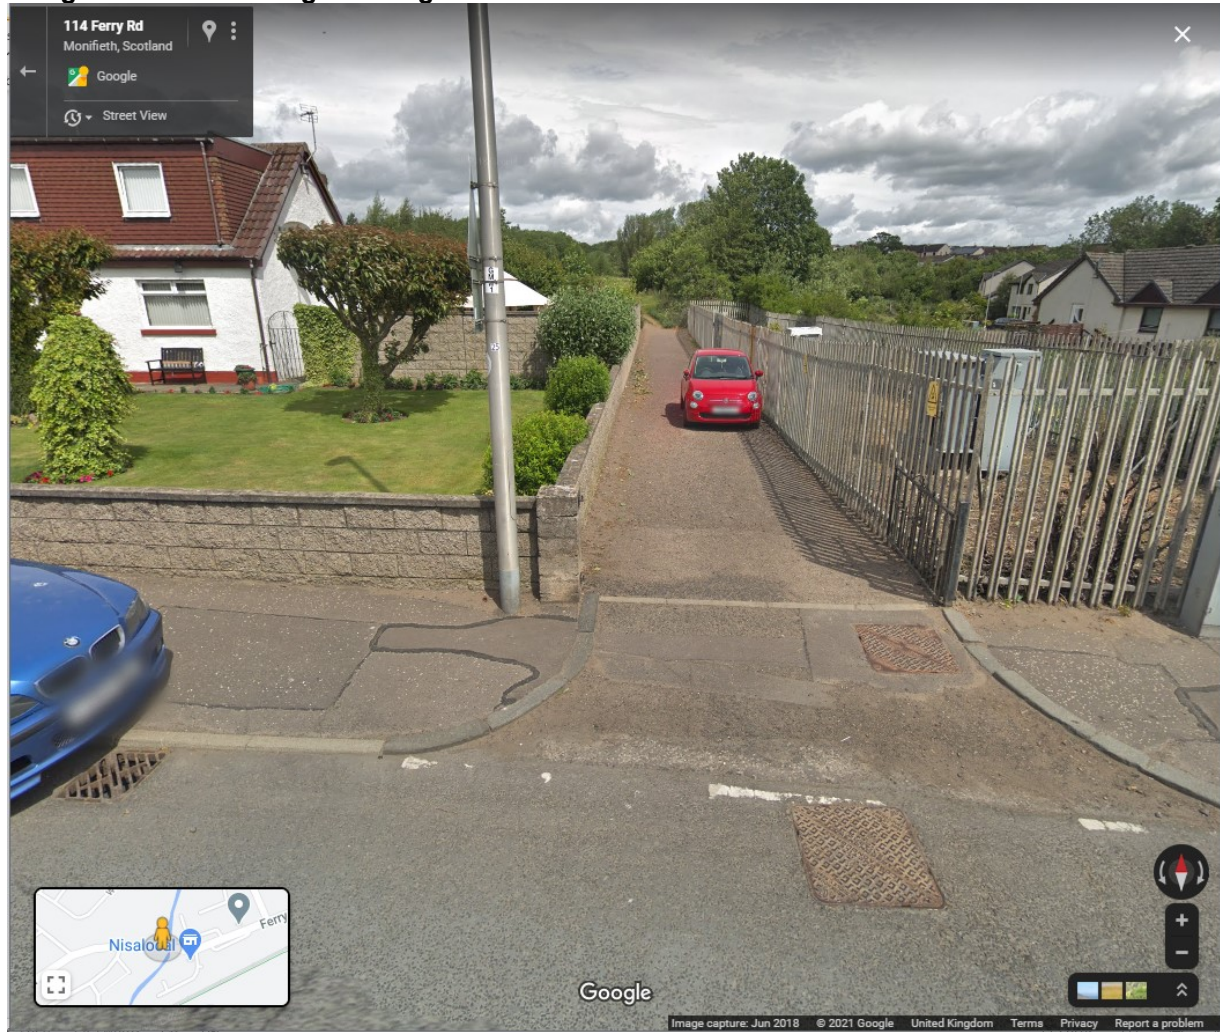
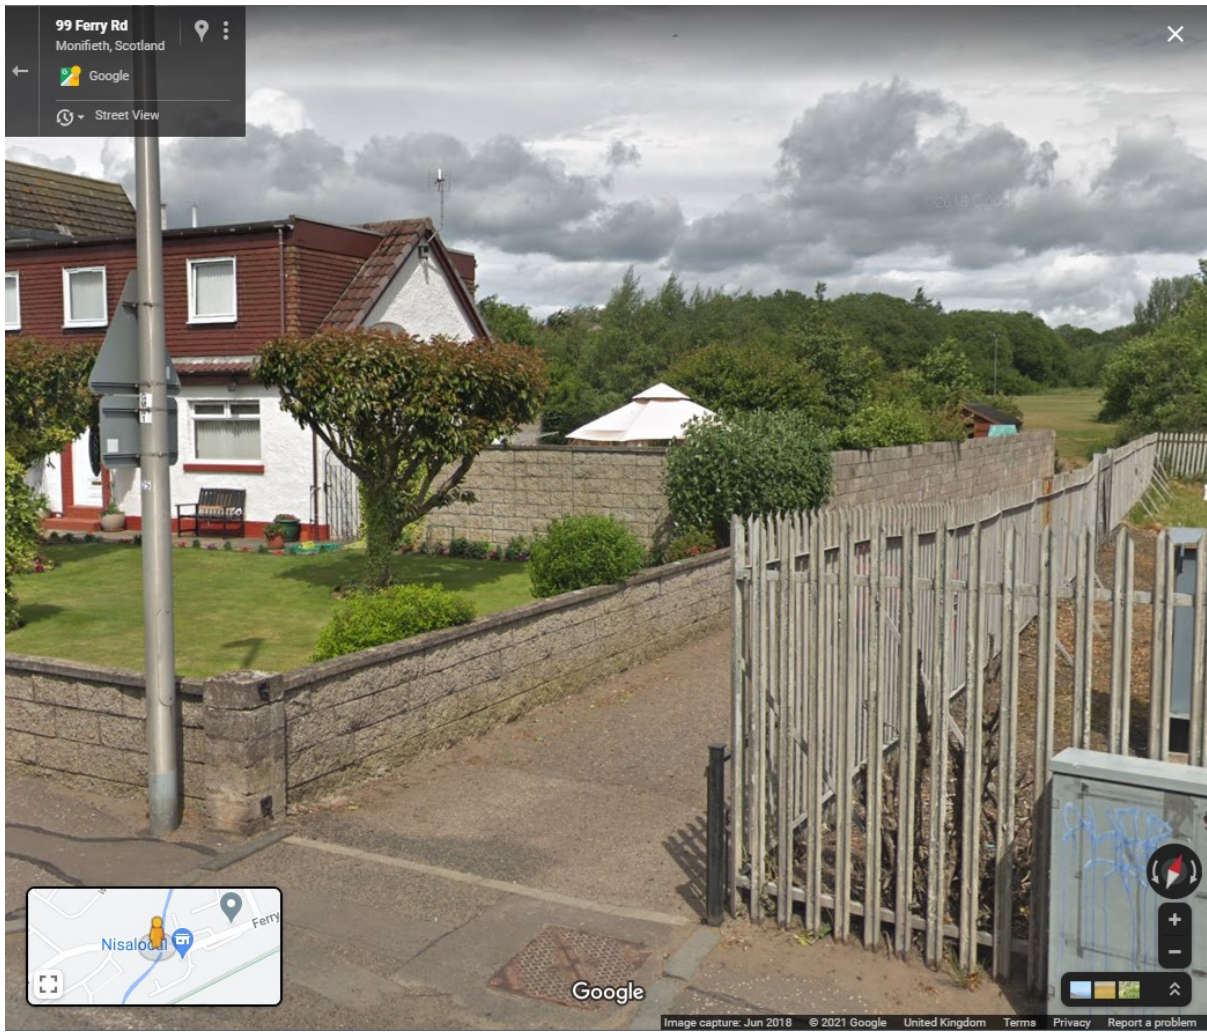
Google Street view Images dating from June 2018

The images are taken from Ferry Road. The first is looking northwards along the track. The second is from a position slightly further east, looking north west towards the track and house. The roadside kerb line curves inwards to the track entrance on both sides. The surface of the track entrance is level with the public road, with a slight step up to the roadside footway at the kerb line. There is an open gate on the right-hand side of the entrance, level with the rear of the public footway. There are gate hinges on the left-hand side, but no gate. The track appears to have a hard surface consisting of either compacted crushed stone or a rough tarred surface. There is a small red car parked on the right-hand side of the track, leaving sufficient space for somebody to walk or cycle past it on the left-hand side. There is low wall between the track and the front garden of 114 Ferry Road on the left-hand side. It is constructed of stone or stone-effect blocks. The front garden wall, facing the public road and footway, is of the same height and construction. Further north, there is a high blockwork wall between the track and the rear garden. There is a high metal palisade fence between the track and the electricity sub-station to the right. The northern end of the track is open to the playing fields beyond. A worn earth path is just visible on the playing fields.

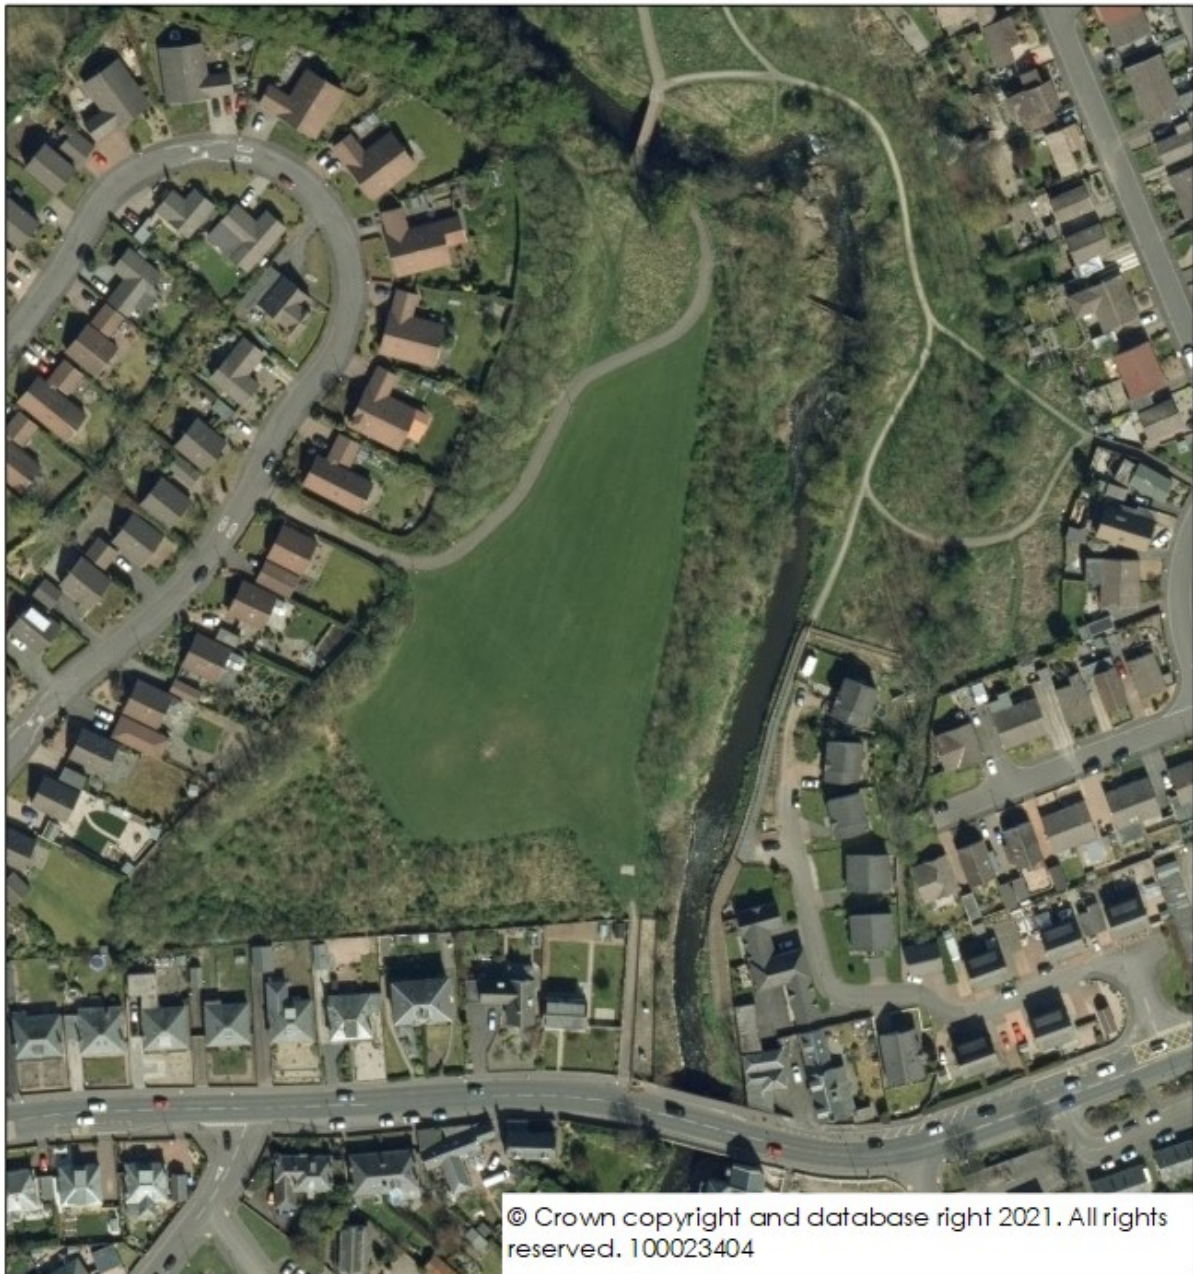
Aerial photograph taken in 2014

Ferry Road is at the bottom of the image running from left to right and the Dighty Burn is just right of centre running from top to bottom. The electricity sub-station is visible as an area of bare ground to the left of the Dighty Burn and north of Ferry Road, with the track being visible as a separate area of bare ground immediately to its left. The bare ground of the track can be seen extending onto the grass playing fields to the north. The playing fields can be seen as a large, grassed area, with woodland around their perimeter. At the northern edge of the playing fields, towards the top of the photograph, a surfaced path can be seen linking Wemyss Crescent (on the upper left hand side of the photograph) to a bridge over the Dighty Burn (top of the photograph, right of centre).

The track and boundaries on either side of it are visible on aerial photography from 1988, although the quality of the available imagery is poor. They can be more clearly seen on aerial photography from 2000, by which time the playing fields and Wemyss Crescent had been developed. The 2000 photograph shows an obvious 'desire line' path between the track and Wemyss Crescent.

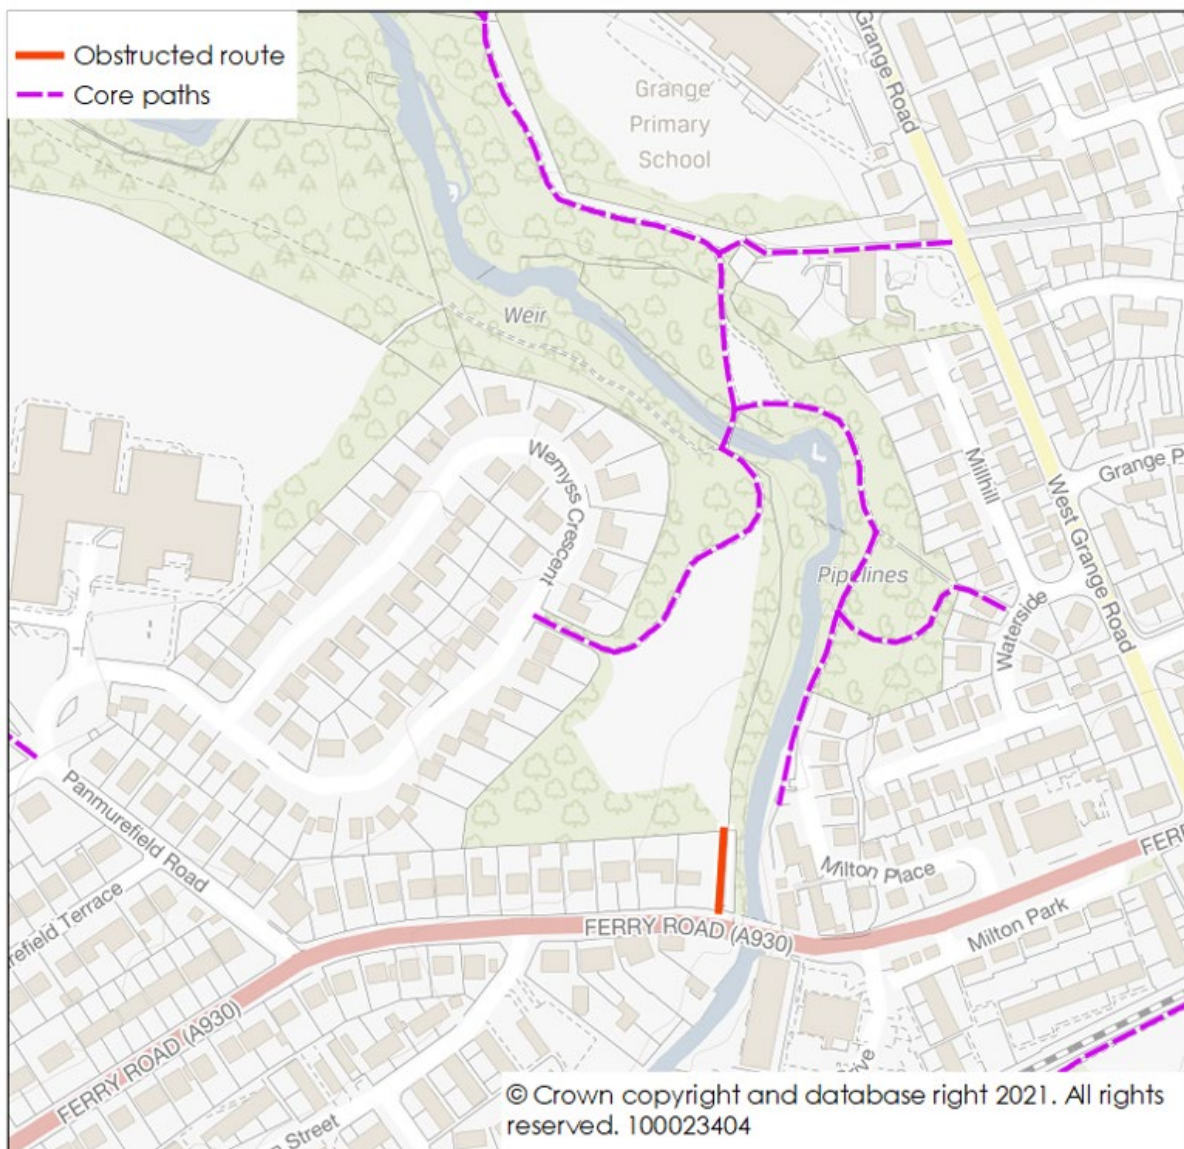
The map below shows the path (marked in red) in the context of the public road network and the designated core path network (shown in purple). Potential alternative routes include Wemyss Crescent/Panmurefield Road/Ferry Road to the west, or the Dighty Den core path network and either Milton Place/Ferry Road or Waterside/West Grange Road/Ferry Road to the east. These routes all involve a moderate or significant detour, depending on the intended destination. The route via Milton Place currently necessitates negotiating steps over flood defences, and the route via Waterside involves moderately steep gradients.
