Structural Survey Report

Lochside Leisure Centre, Forfar

09 July 1998

ANGUS COUNCIL ROADS DEPARTMENT CONSULTANCY UNIT
STRUCTURAL SURVEY REPORT
LOCHSIDE LEISURE CENTRE, FORFAR
09 JULY 1998

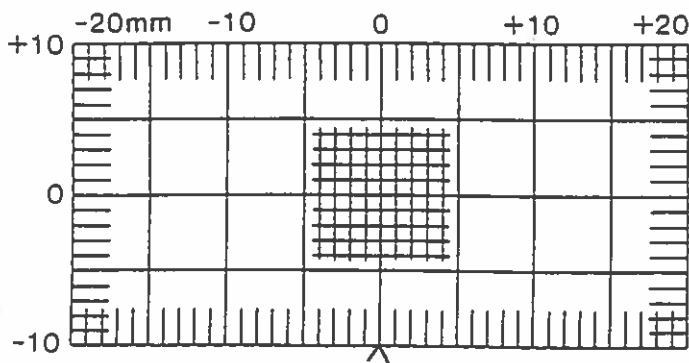
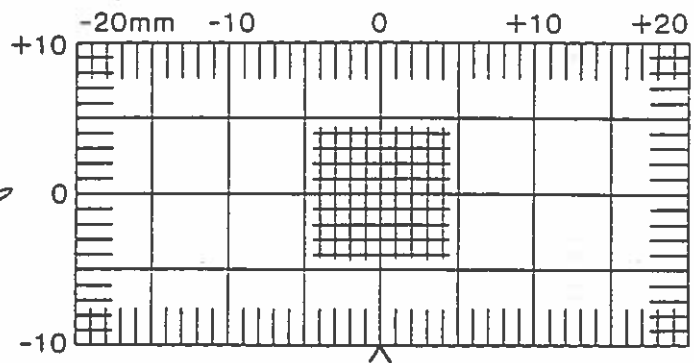
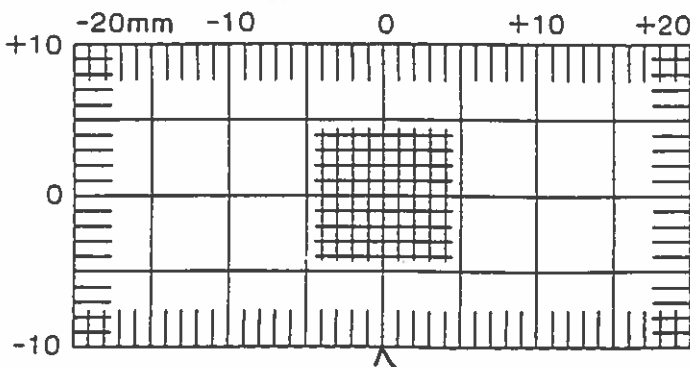
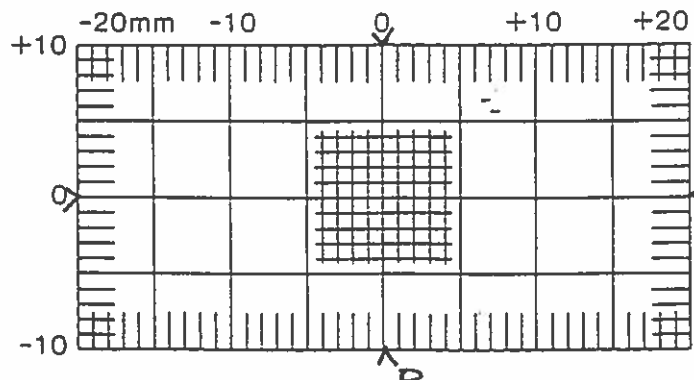
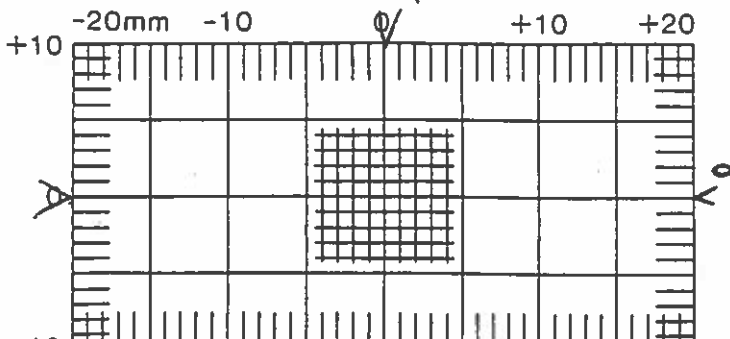
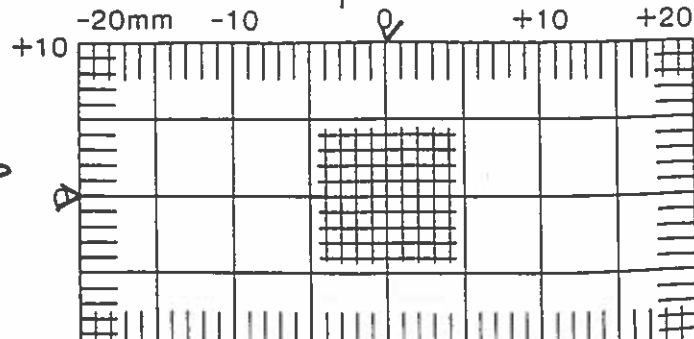
Indicate on the diagrams below the TELL-TALE movement at each reading
+ represents crack opening - represents crack closing

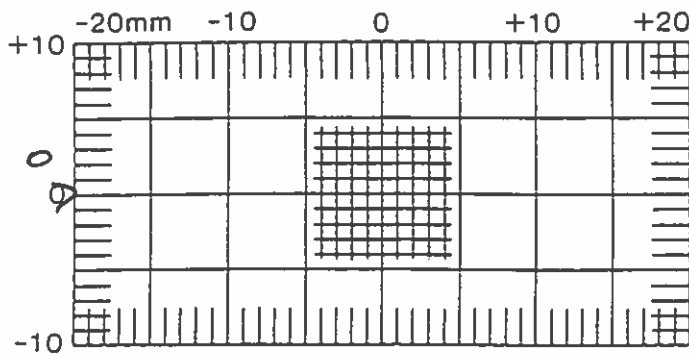
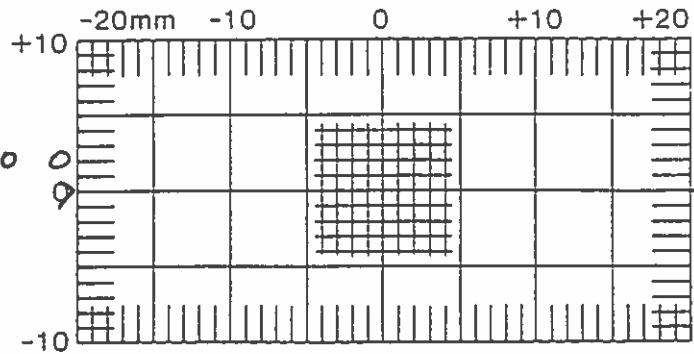
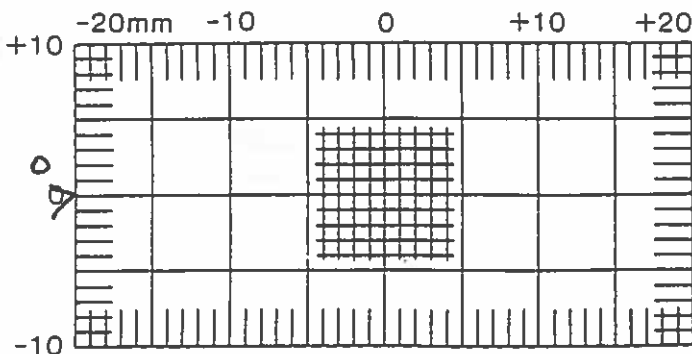
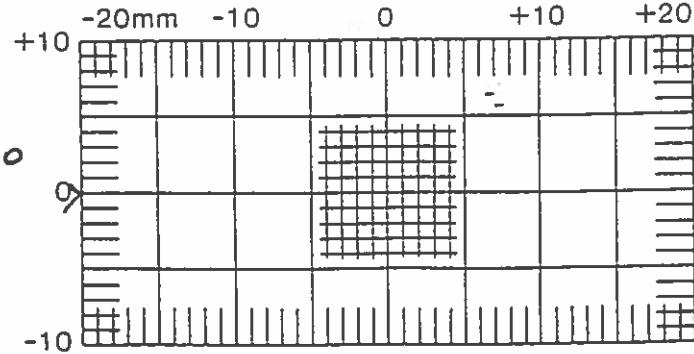
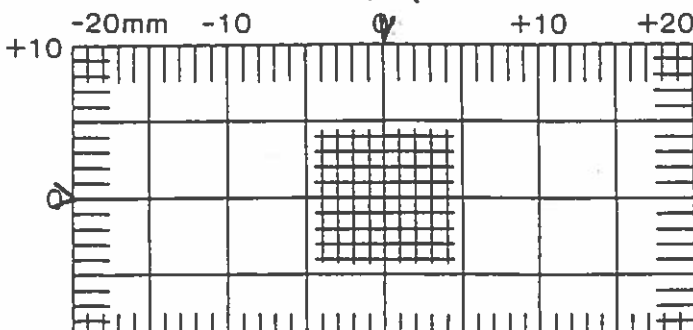
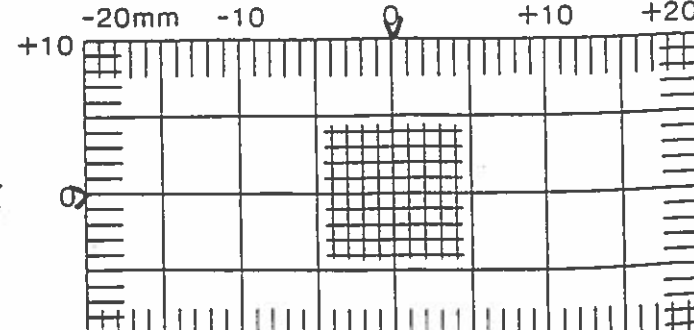
Wall 5 - Partition Wall Between Sports Hall and Corridor

Indicate on the diagrams below the TELL-TALE movement at each reading
+ represents crack opening - represents crack closing

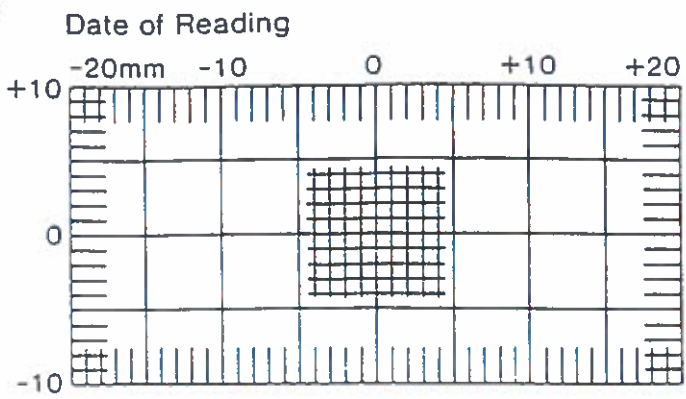
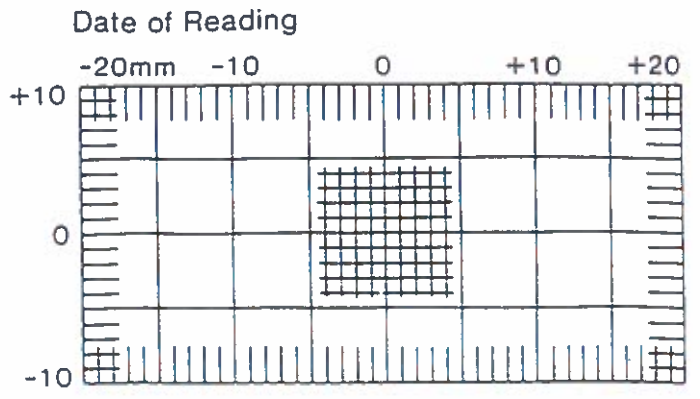
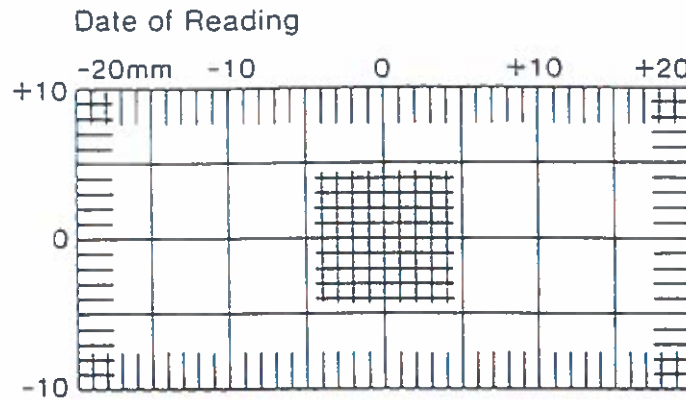
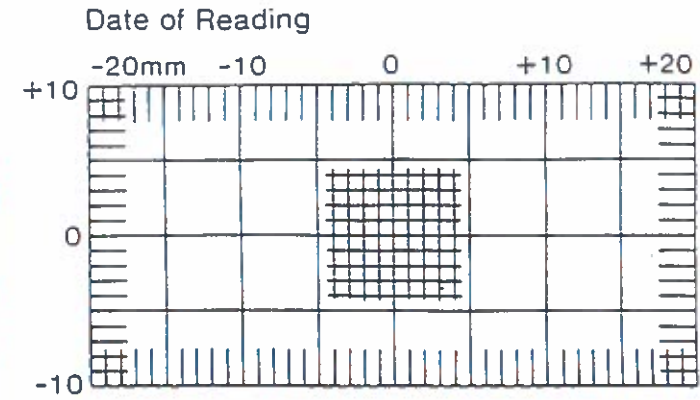
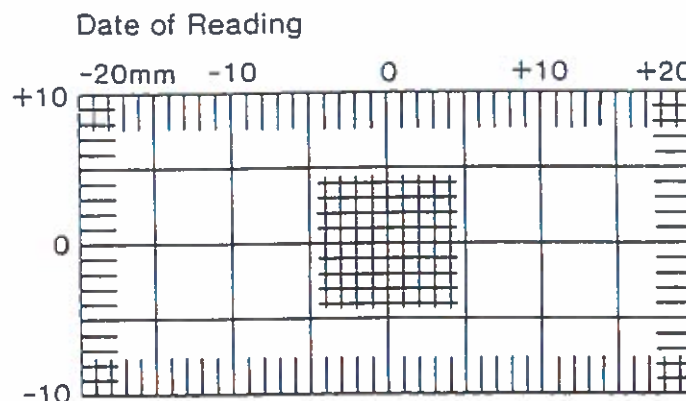
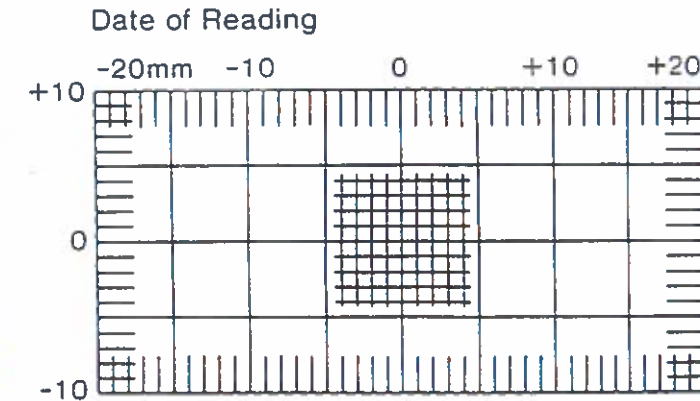
Wall 8 - Drama Store Wall

Diagrammatic Representation of Cracks

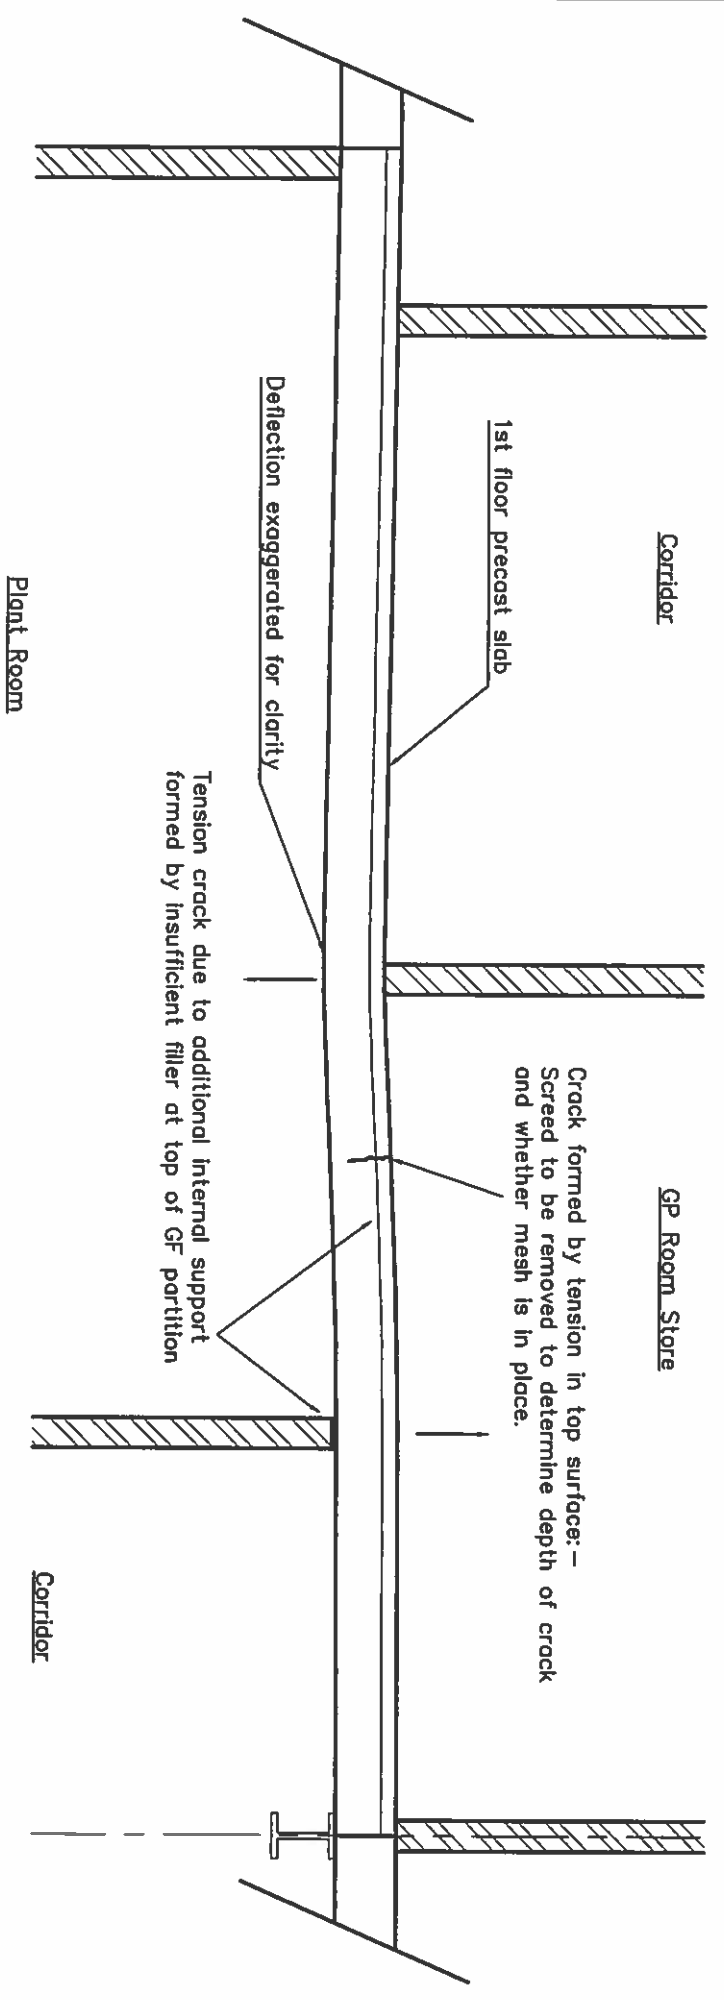
**SECTION A-A SHOWING FIRST FLOOR SLAB
ABOVE PLANT ROOM 1:25**

Angus Council ROADS DEPARTMENT DESIGN - DR. J. MURPHY ISE, P.M., C.E.M., M.I.C.E. MAPS, SURV. UNIT, I.C.S.M.S.		
LOCHSIDE LEISURE CENTRE, FORFAR STRUCTURAL SURVEY REPORT - JUNE 1998 SECTION A-A SHOWING CRACK TO 1ST FLOOR ABOVE PLANT ROOM		
Drawn by: 00	Date: JULY 1998	Project No. 115030005
	Scales: 1:50	Drawing No. CP2.3.181/002
