**ROADS DEPARTMENT
ENGINEERING & DESIGN SERVICES**

Structural Survey Report

*Lochside Leisure Centre
Forfar.*

26 July 2001

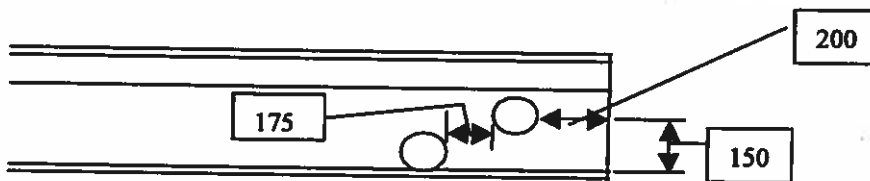
- A. Beam 2 has rotated anti-clockwise by approximately 2mm.
No padstone below bearing, this has resulted in signs of crushing and mortar loss to brick.
30mm service pipe through brick immediately below beam
Lack of access prevents full inspection
(Plate 2).
- B. 2no 100mm diameter ducts with 20mm insulation.
Take design size of ducts as 135mm to allow for weakening effect of burning on steel.

- C. No signs of cracking to soffit or concrete units, 2 no. 300mm wide infill panels in good condition.
- D. Beam 3 good condition continuous support over brick column good, but lack of concrete infill to slab edge (Plate 3).
No sign of crushing to bearings
Lack of access prevents full inspection.
- E. *Lack of access prevents full inspection*
10-15mm gap above Beam 4 padstone – no adjacent cracking, therefore gap likely to be due to poor construction.
Chasing cut in brickwork for services
(Plate 4)
- F. Padstone and bearings in good condition.

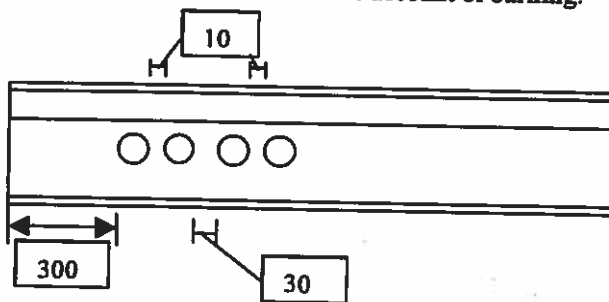
(Plate 5)

- G. 4 no. water pipes, listed from end of beam towards middle:
 35mm, 22mm, 25mm and 35mm.
 20mm insulation on all 4
 design diameters 80mm to take account of burning.

- H. Good condition, some loose mortar around padstone.
 I. Padstone in good condition.
 J. First 2m from lintel:
 Generally poor brickwork supporting slabs.
 Service ports directly under unit bearing, poorly filled
 Evidence of steel supporting units above wall.
