# Asbestos Survey Angus Council Property

## Lochside Leisure Centre Forfar

Survey No – 745712219-001

Survey Type – Refurbishment

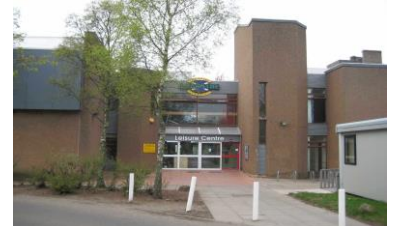
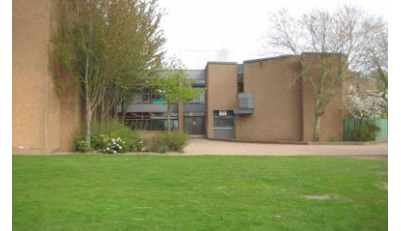
Externals	All Elevations	None Found

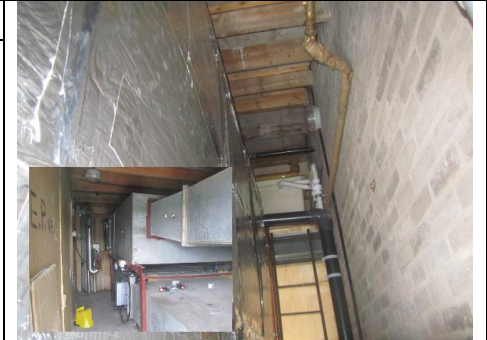
Floor	Room	Asbestos Materials	
External Roof	Water tank Main building	None Found

External Roof	Water Tank Housing X2	Unknown No access boarded over

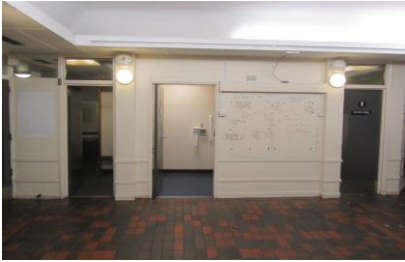
Floor	Room	Item/Area	Material	Asbestos Type	Sample Number	
Ground	Staff toilets/ Disabled toilet At changing rooms	Wall Sheeting	Boarding	Non Asbestos	2022653 G	
<b>Photo</b>
