**Summary of Primary Defects Report
of**

**Panmure Centre
141 Kinloch Street
Carnoustie
DD7 7JP**

Angus Council

February 2021

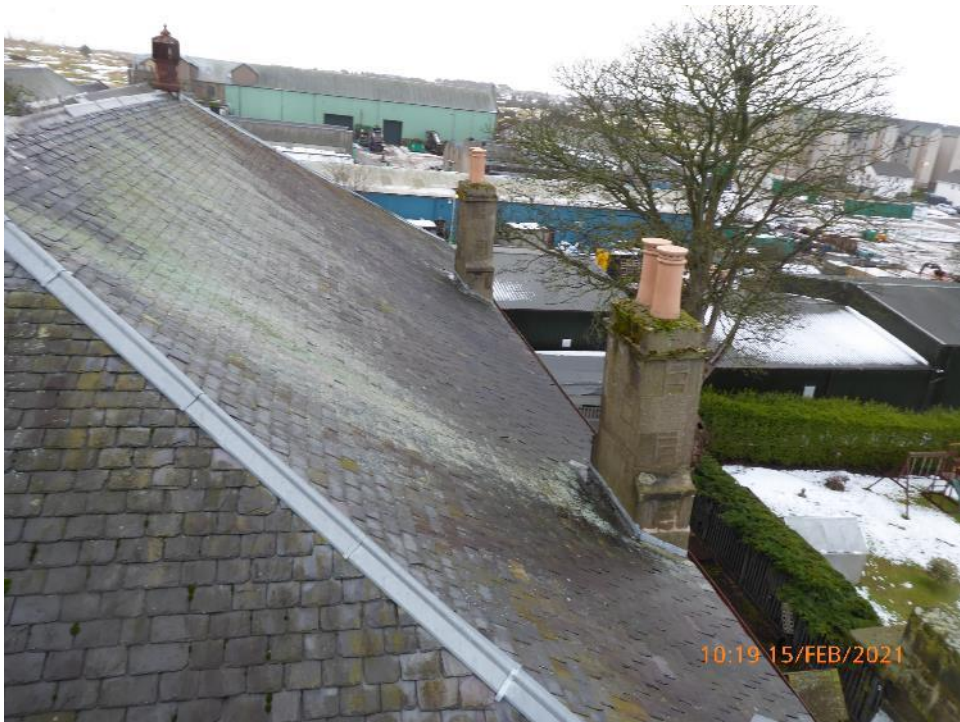
22. West facing roof slope

- a) Inspection of the slate roof coverings from cherry picker revealed slating to be generally intact, but with isolated loose, missing, chipped and dislodged slates. We suspect that the nail fixings are nearing the end of their life expectancy (and we did not identify under slating felt, when viewed from within the roof void– indicating the roof has unlikely to have been recovered during its life). Whilst regular ongoing maintenance should ensure that the slate covering lasts for a further number of years you should budget for its stripping and renewal as part of any modernisation and refurbishment.
